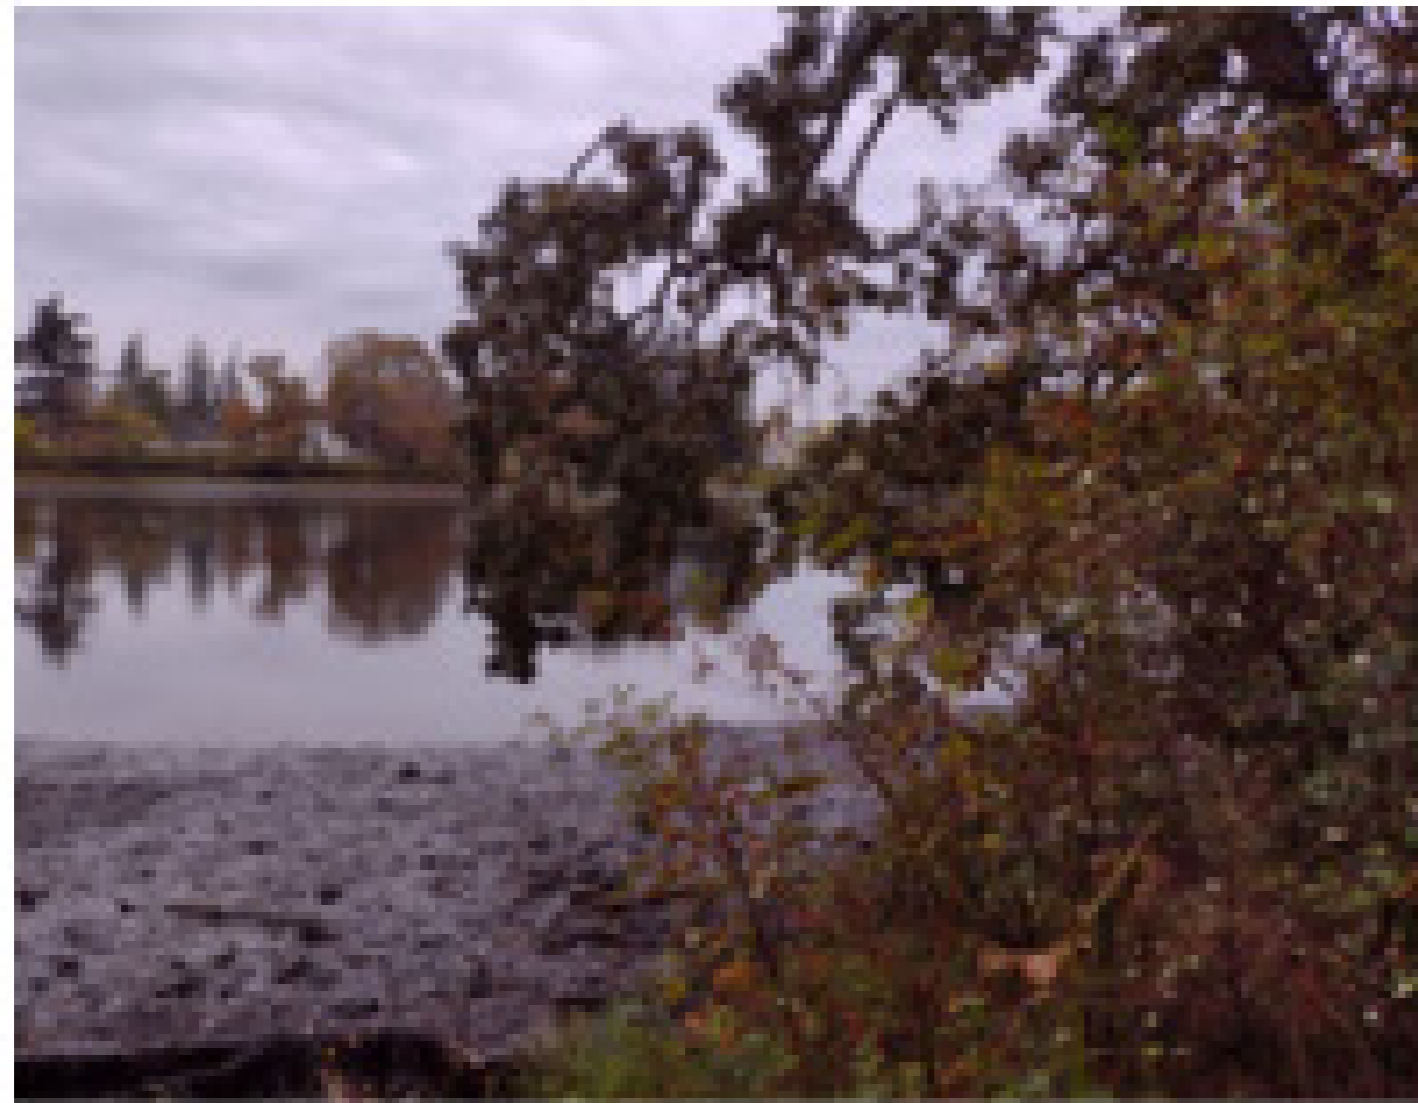
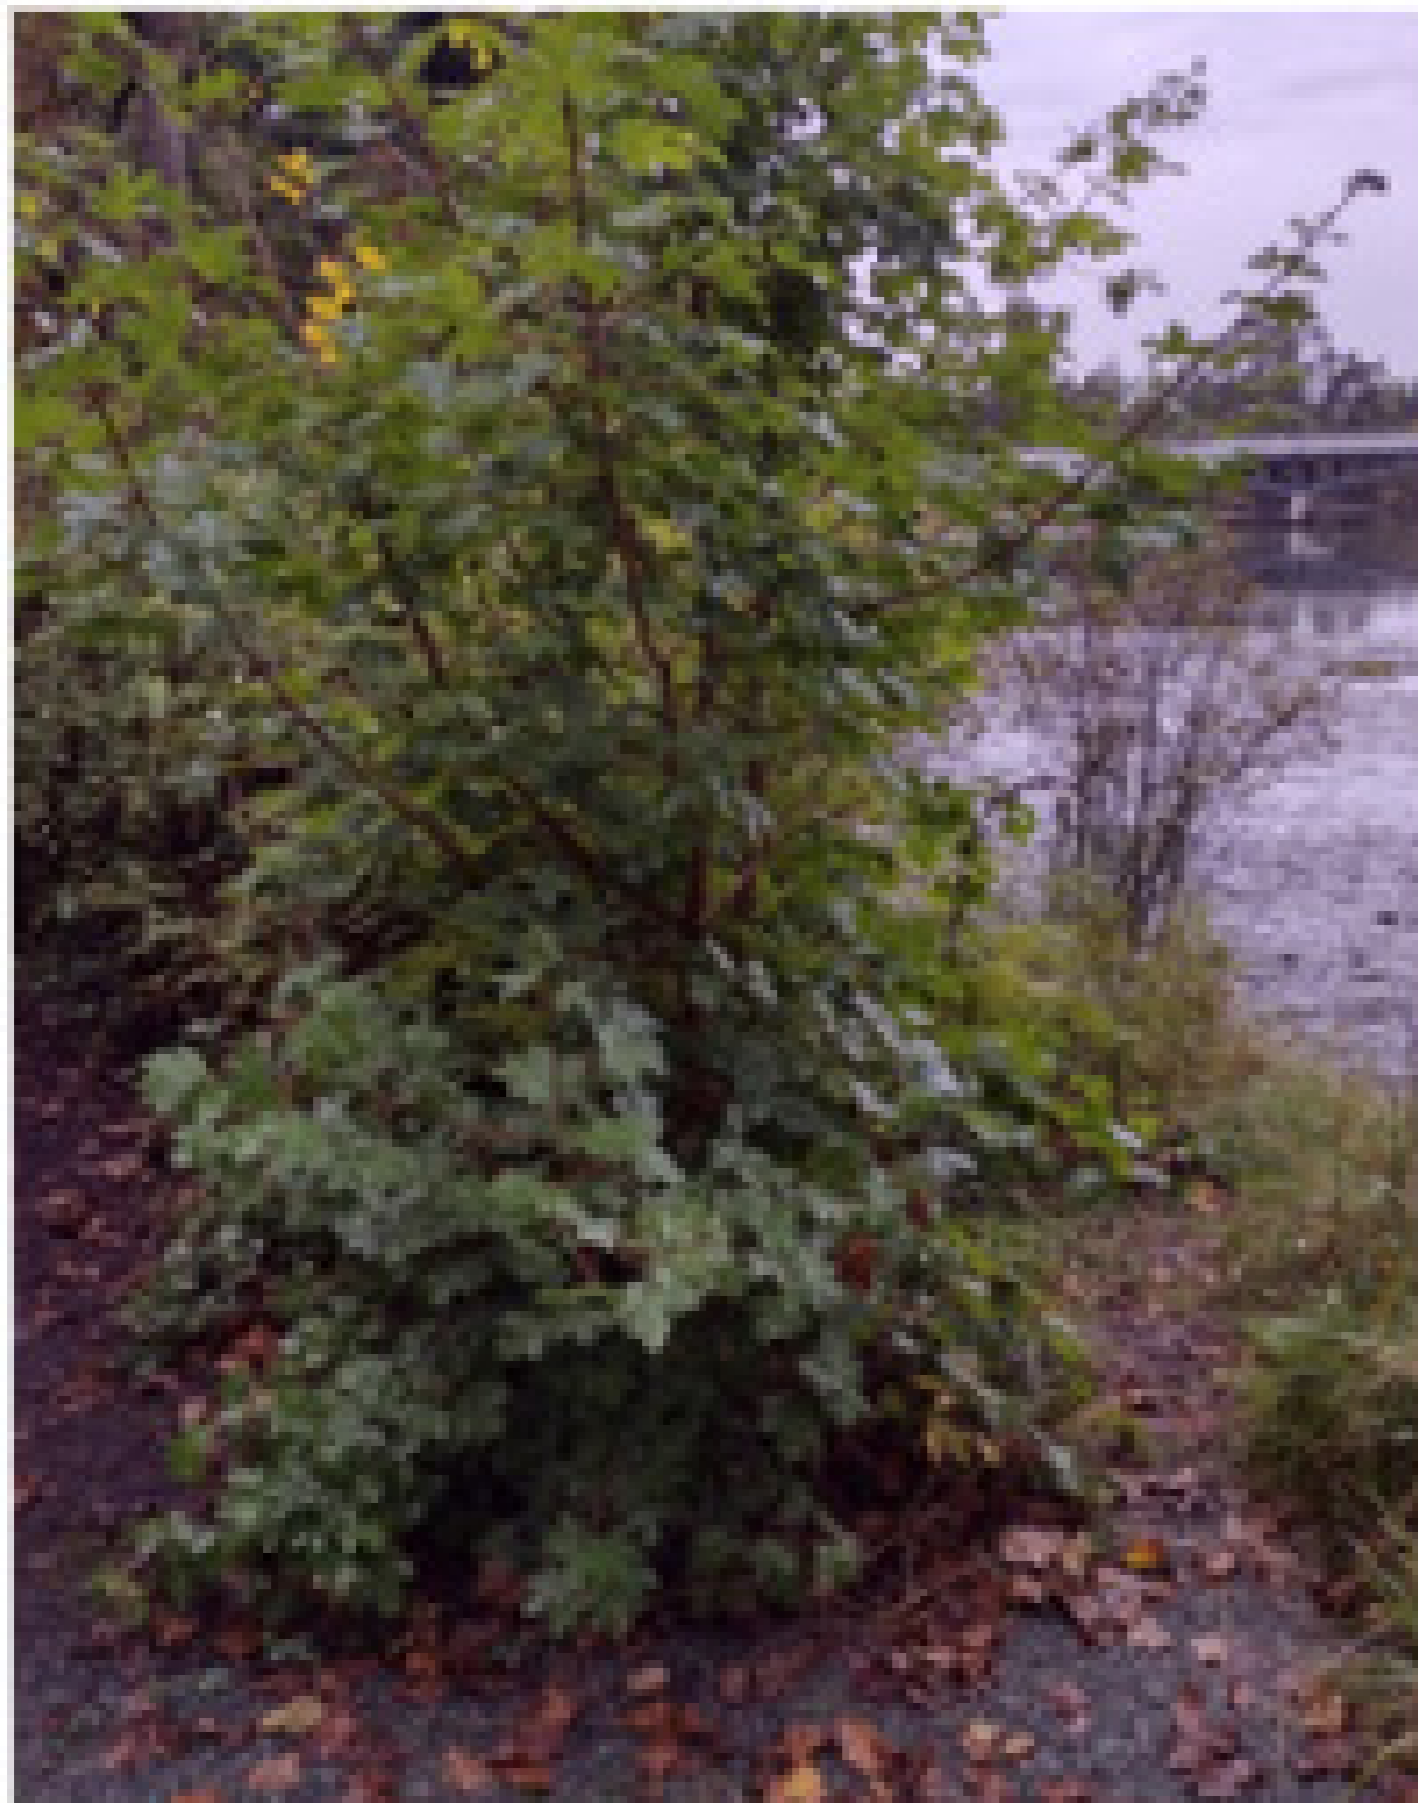
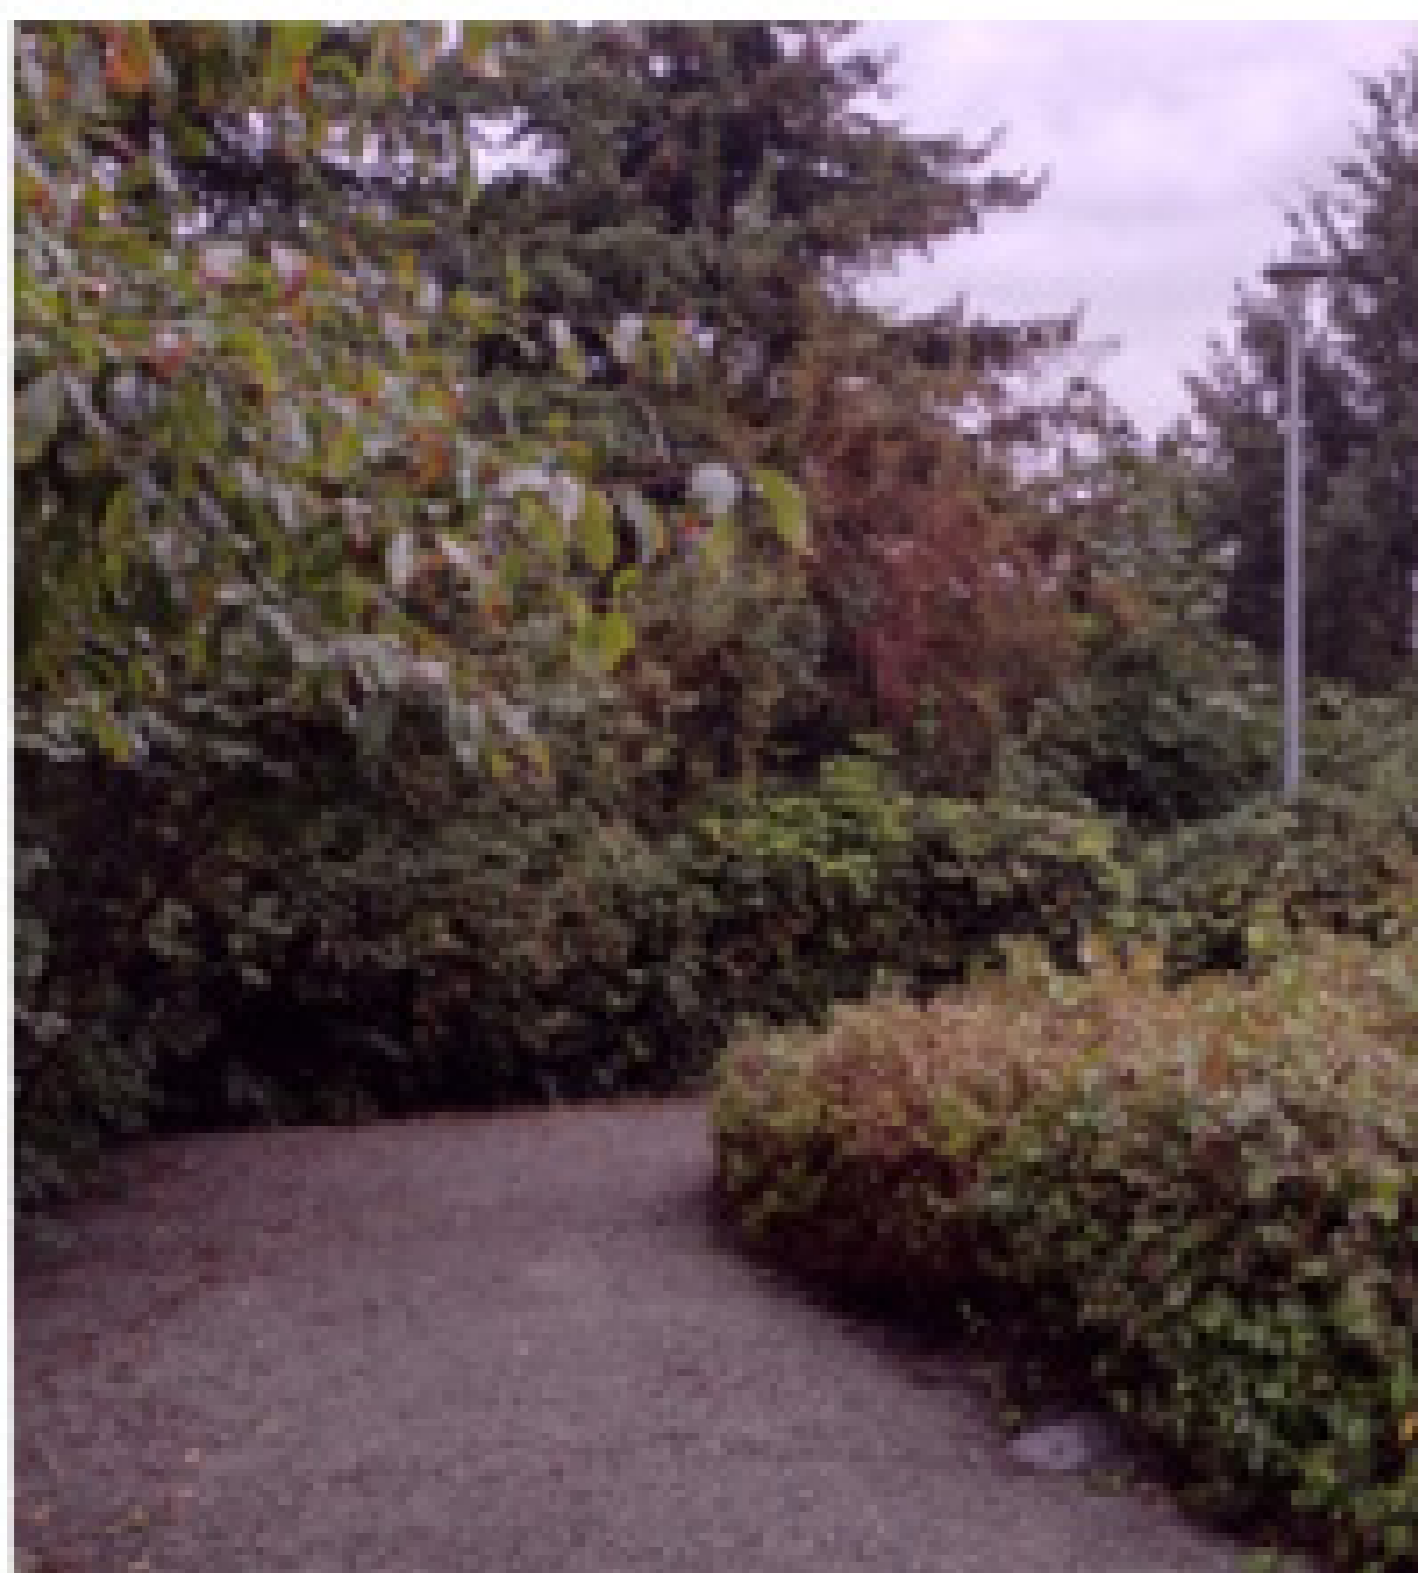
Yarrow Place

- 3 Current: Wider section, mild current to consider
- 3 Proximity to Motor Boat Traffic: Wide section, motor boats in area
- 3 Human Health Rating of outfalls: Low risk

- 0 Conservation Concern: Olympia oysters present
- 0 Sensitive Vegetation: Eelgrass present
- 0 Overhanging vegetation: Yes

- 0 Intertidal Slope: Very shallow
- 3 Upland Slope: Gradual

- 0 Vehicle Parking: None, residential street parking only
- 3 Accessibility: Dirt path with gentle incline, no stairs, no parking

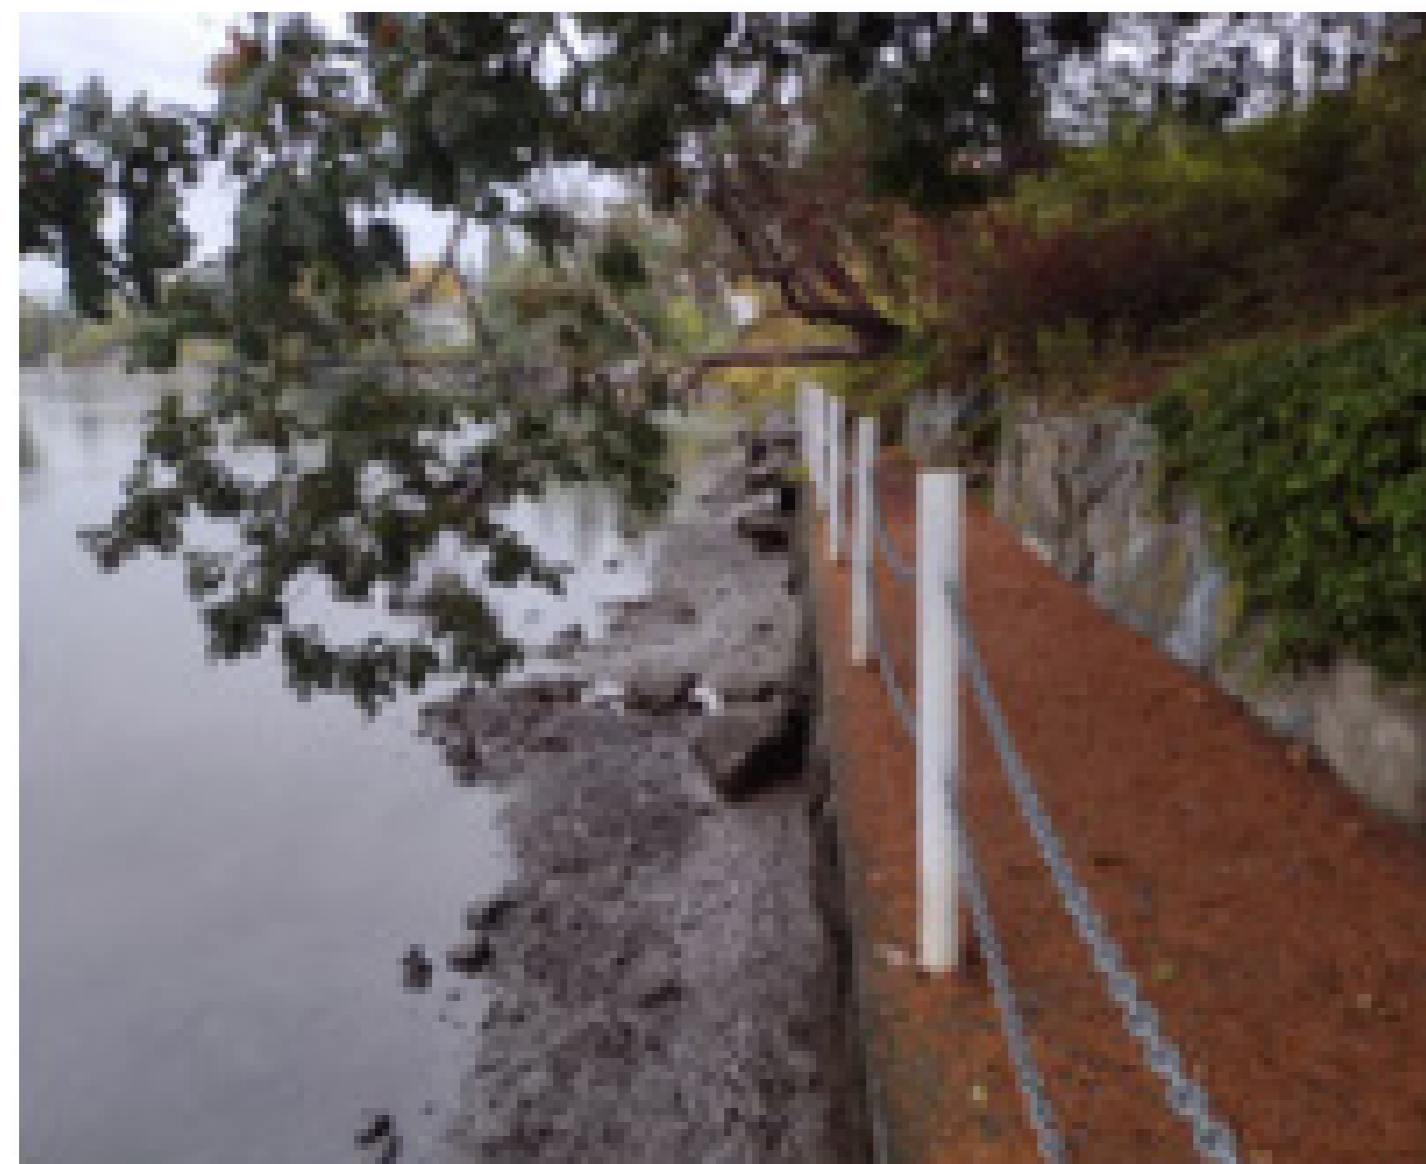
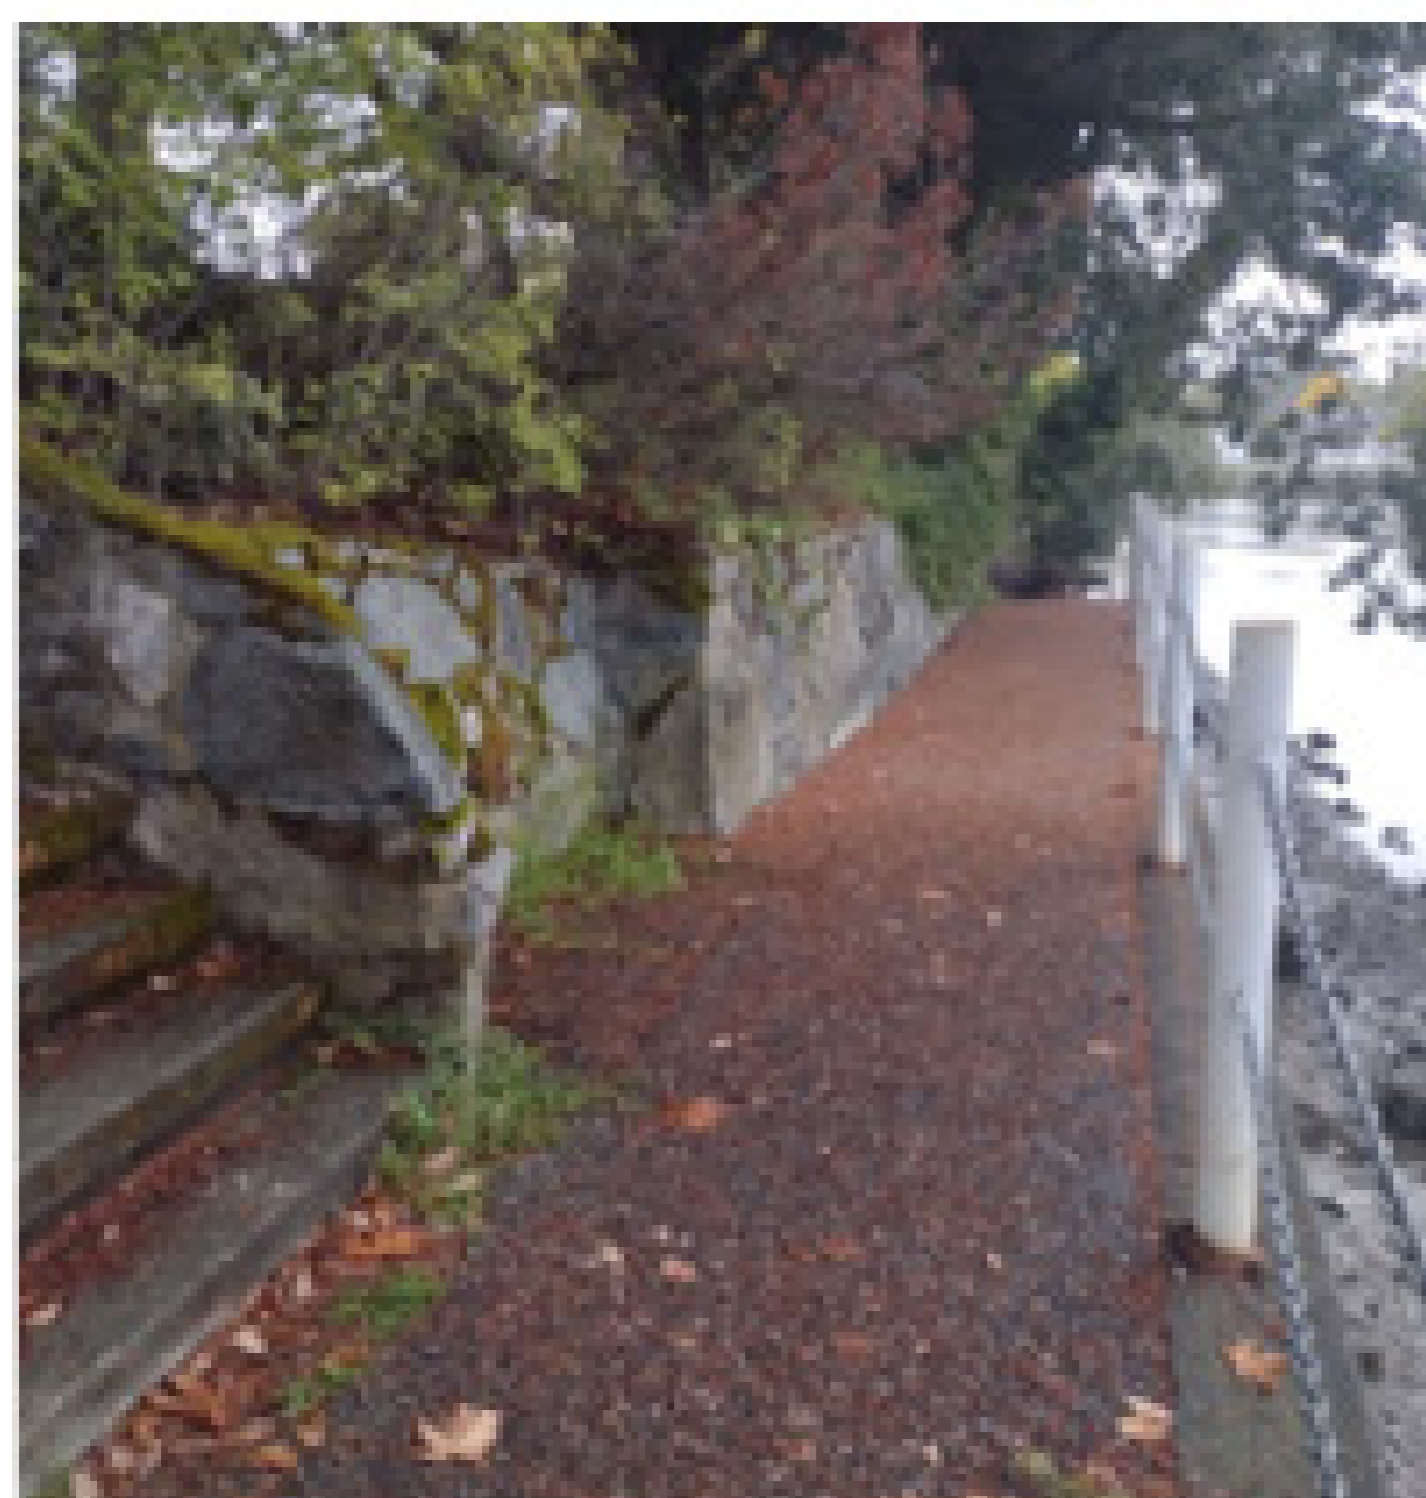
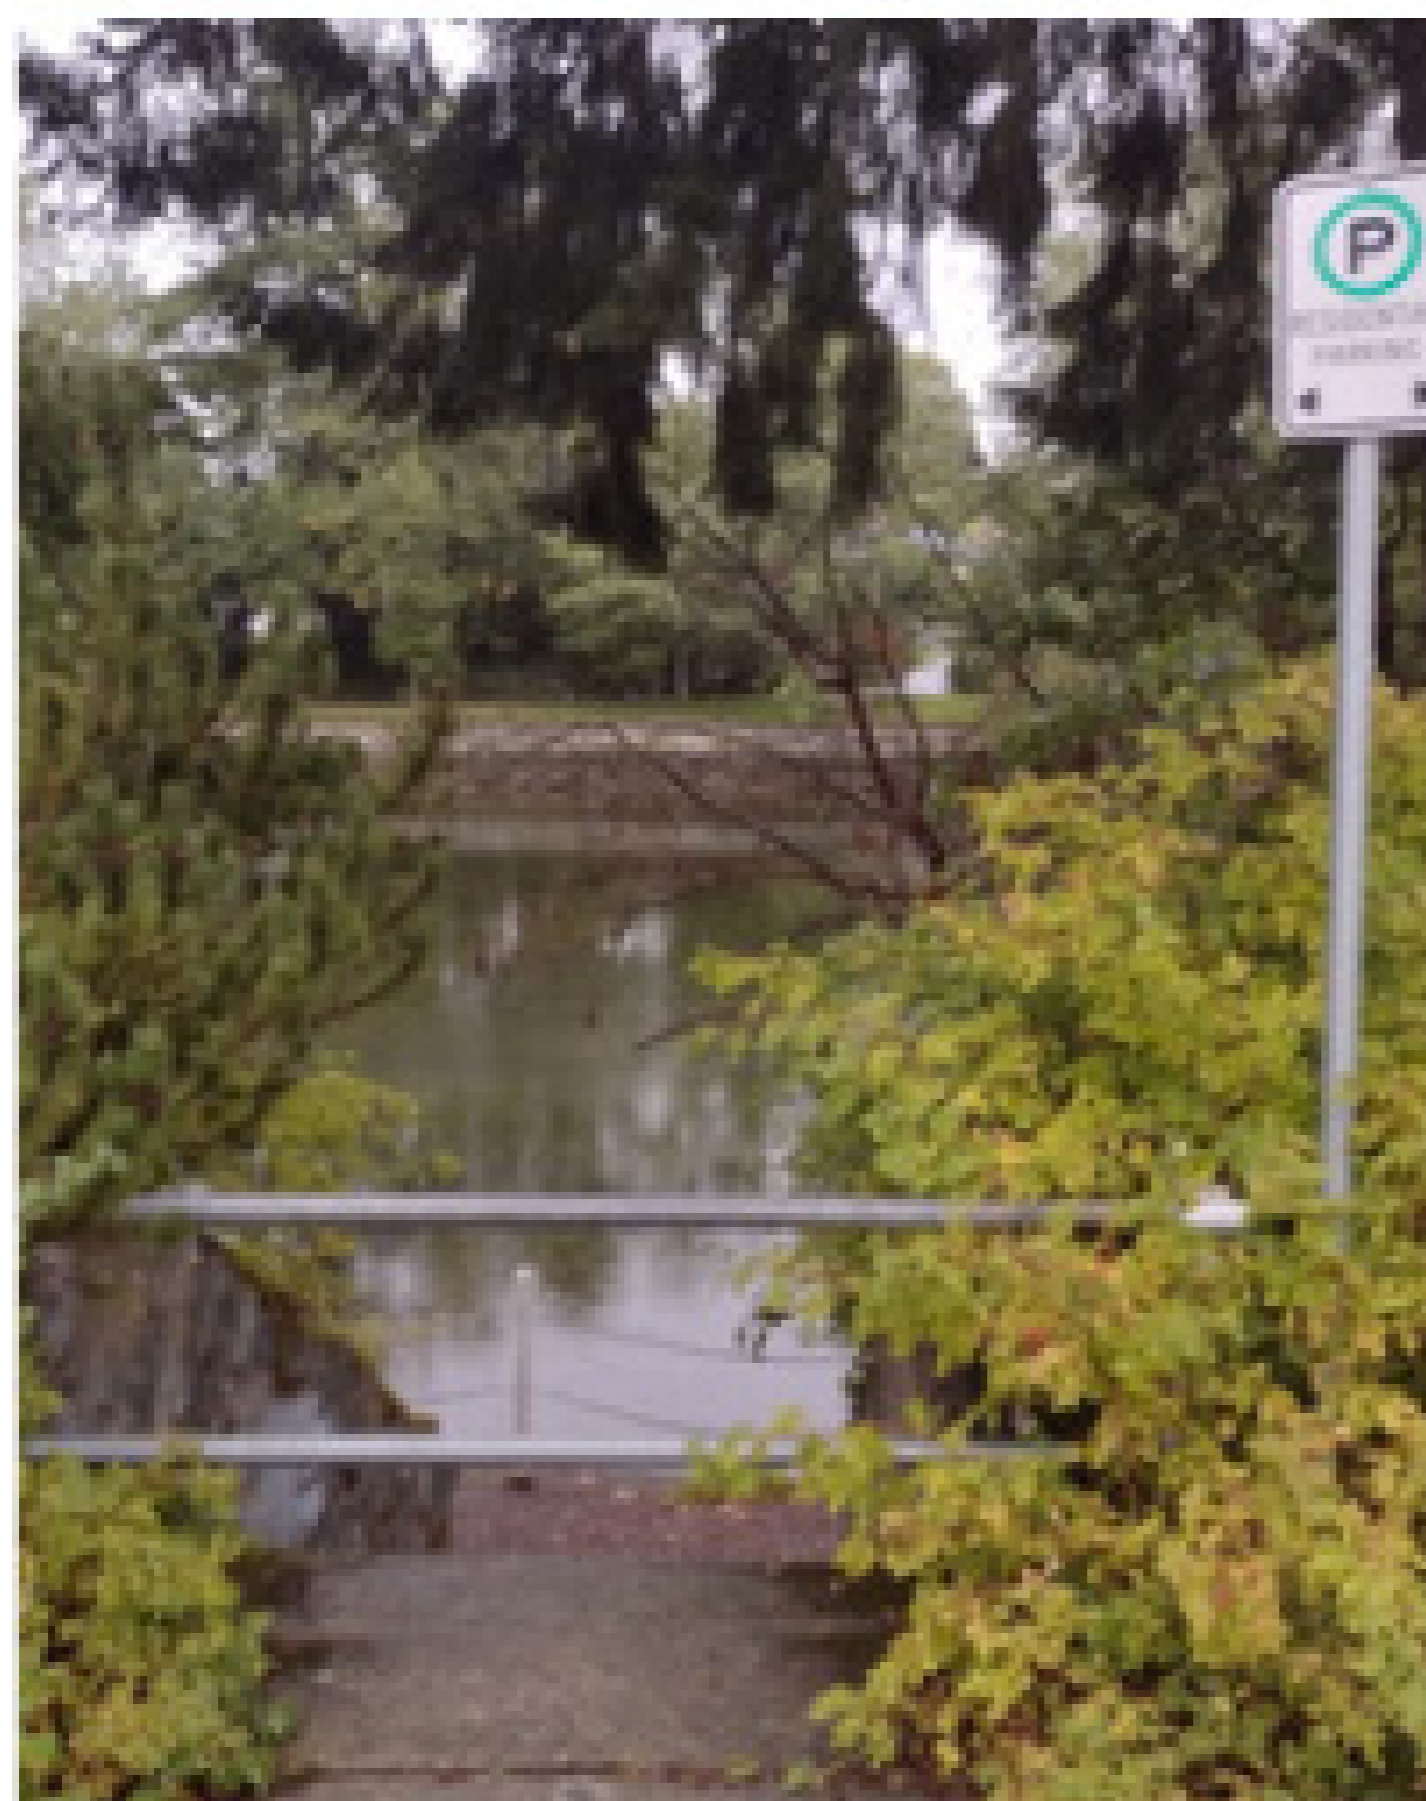
Dellwood Road

- 3 Current: Narrow section, current to be considered
- 0 Proximity to Motor Boat Traffic: Narrow section, close proximity
- 3 Human Health Rating of outfalls: Low risk

- 0 Conservation Concern: Olympia oysters present
- 3 Sensitive Vegetation: Close proximity to eelgrass
- 3 Overhanging vegetation: Limited, hard armoured shore

- 0 Intertidal Slope: Shallow angle
- 3 Upland Slope: Sloping site, ~12 steps from street to view point

- 0 Vehicle Parking: None, residential street parking only
- 0 Accessibility: View point blocked to public, steps to viewpoint

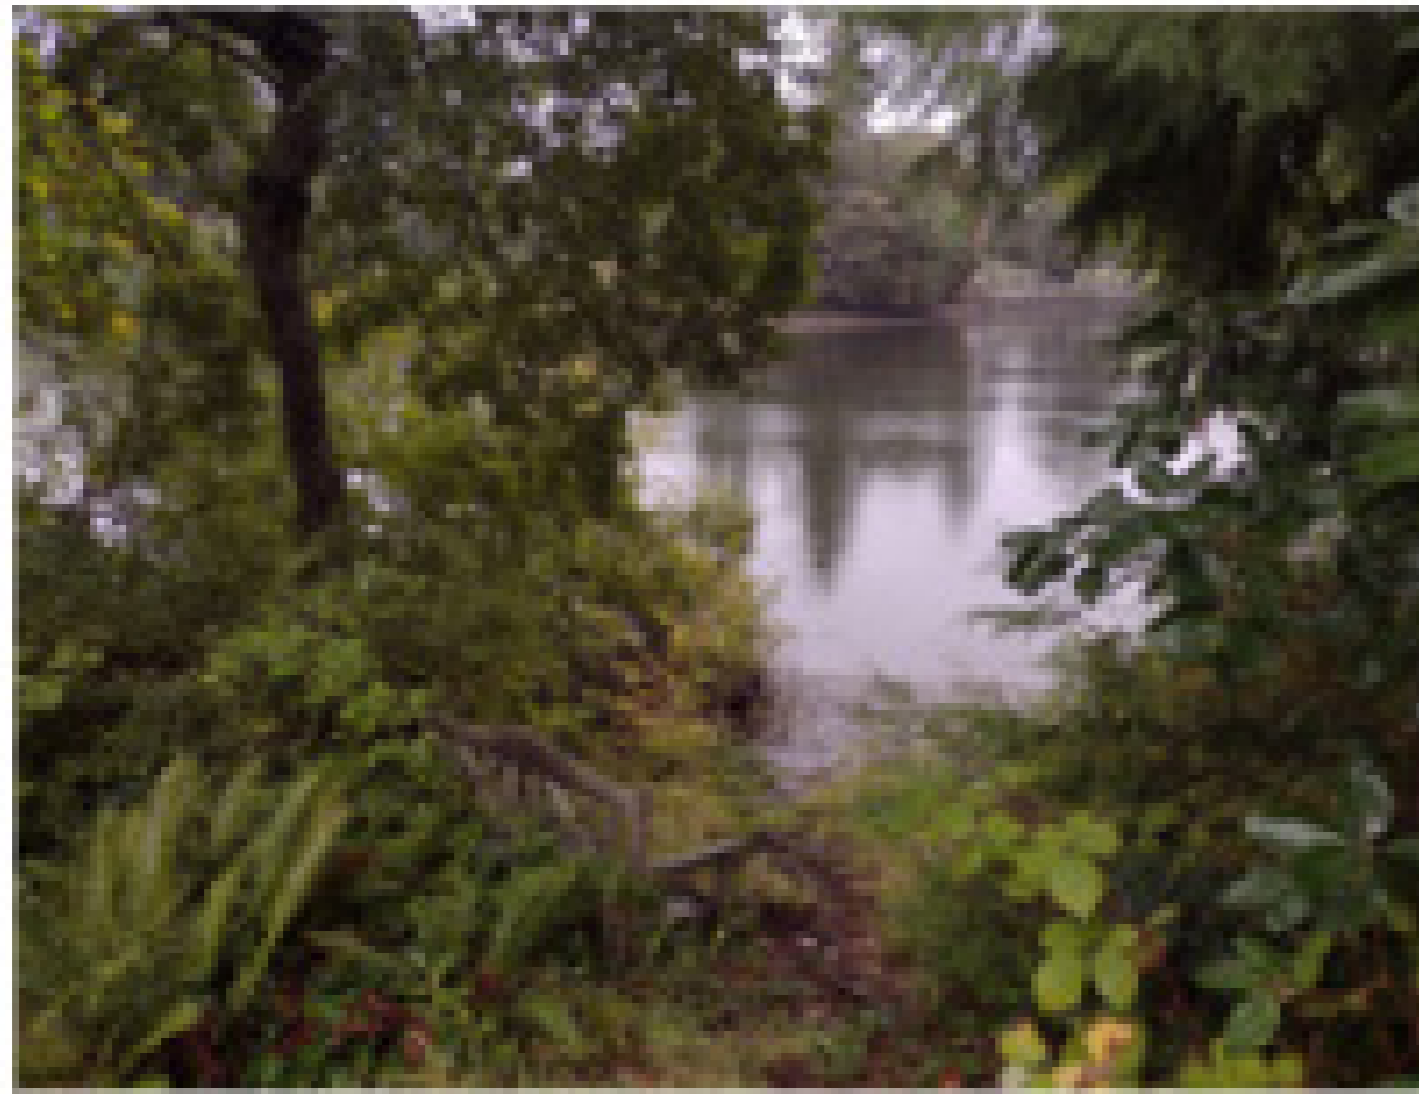
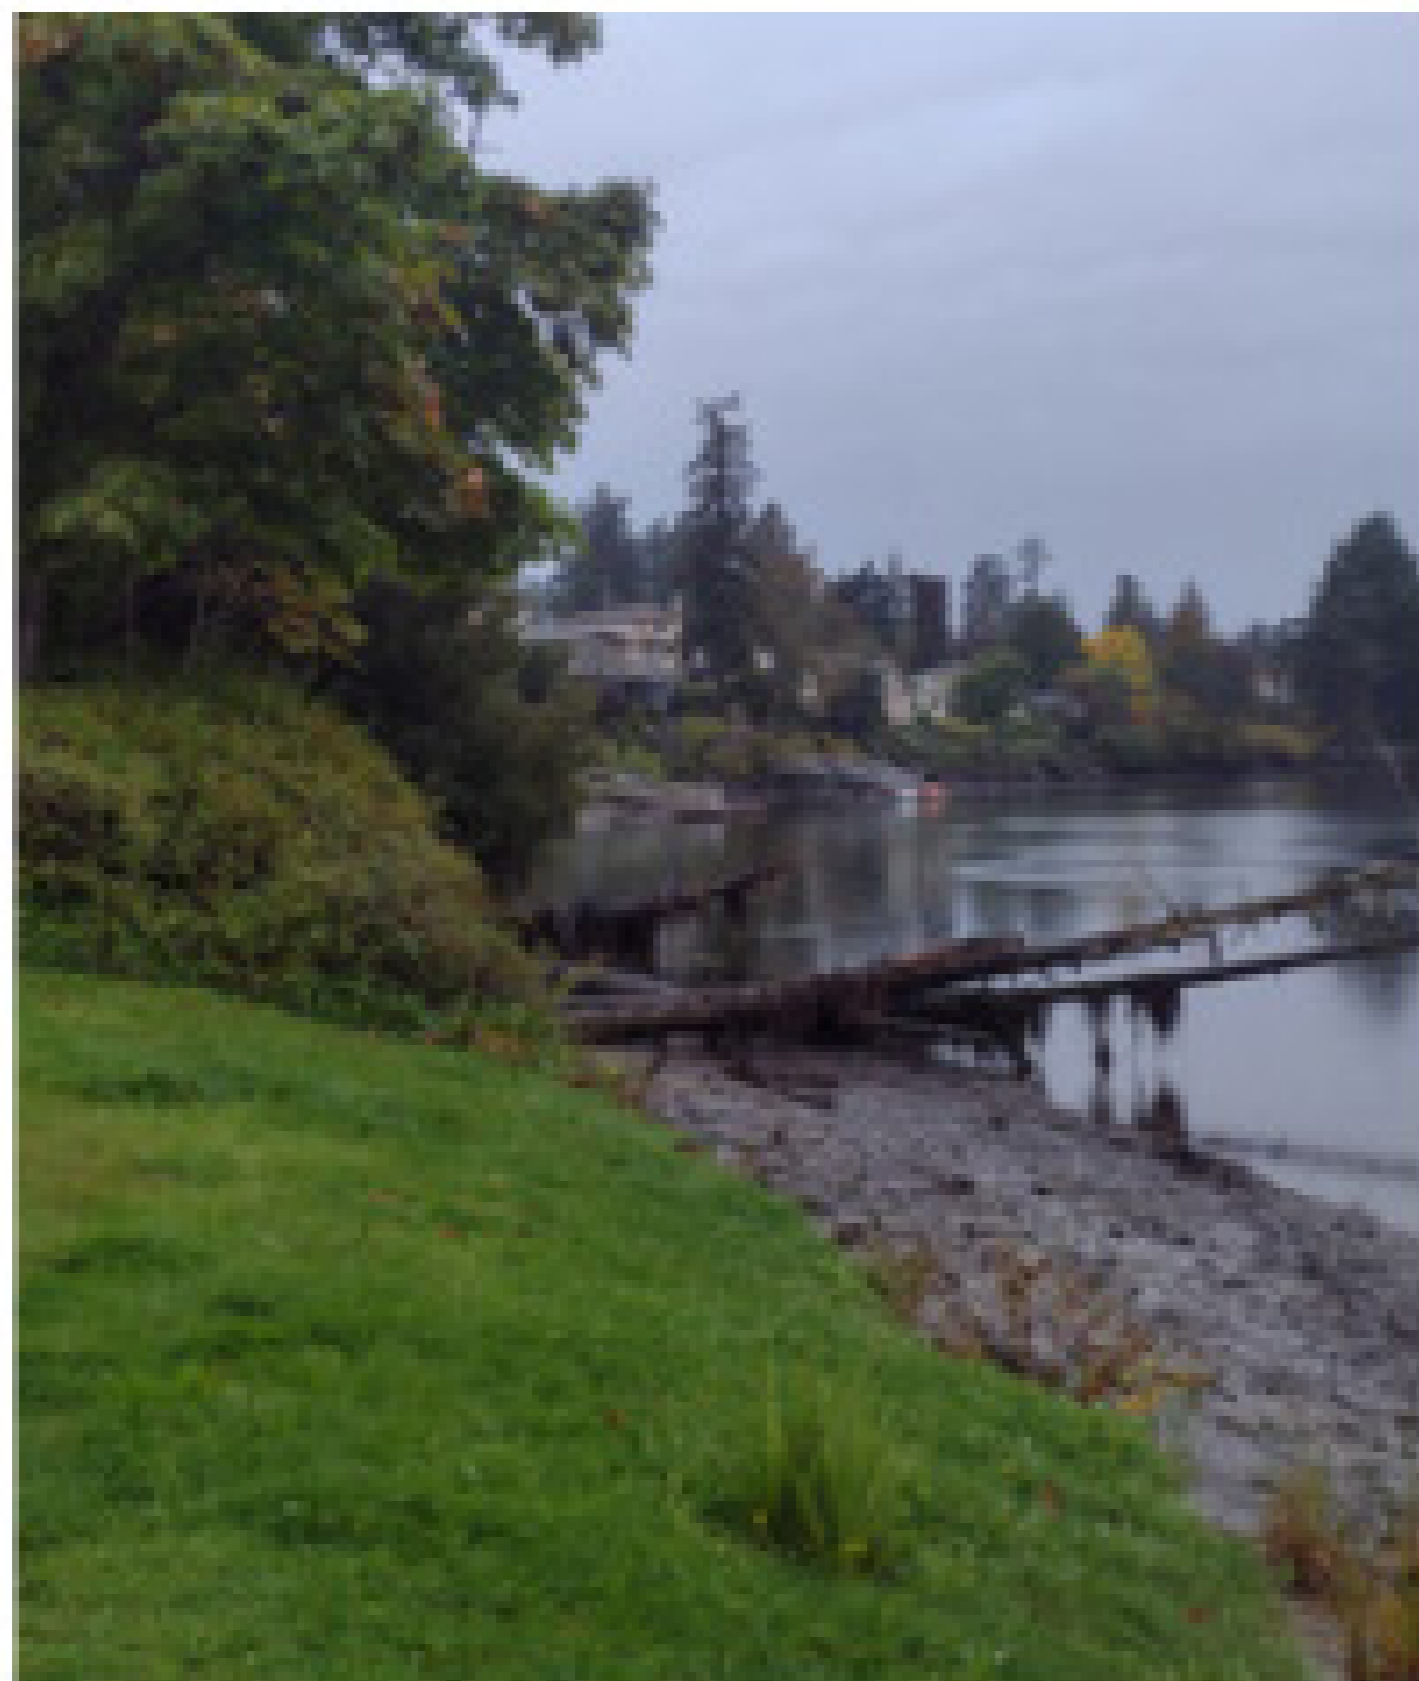
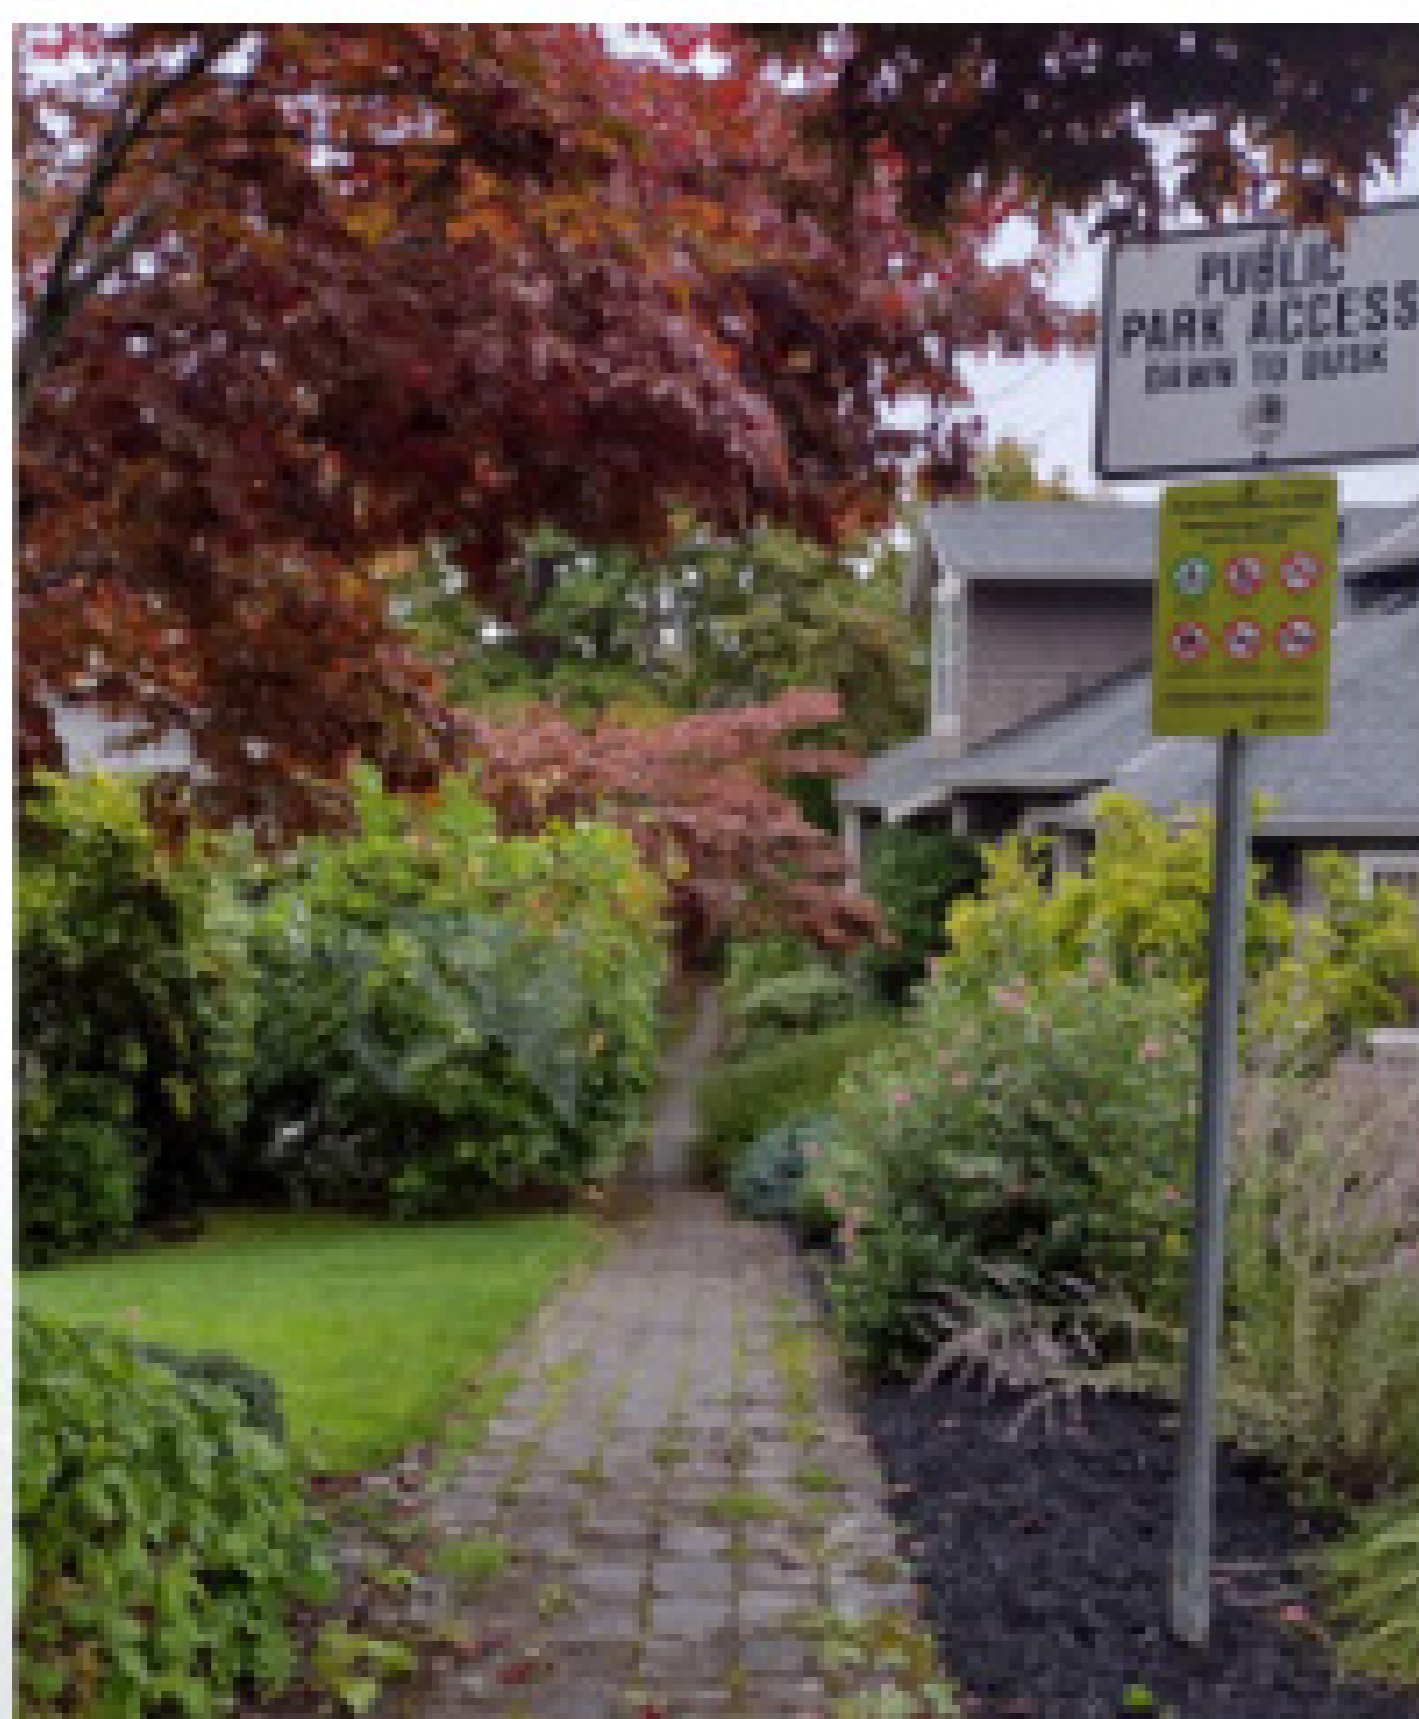
Glen Vale Road

- 3 Current: Wide section, mild current to consider
- 0 Proximity to Motor Boat Traffic: Wider section, motor boats in area
- 0 Human Health Rating of outfalls: High risk

- 0 Conservation Concern: Olympia oysters present
- 0 Sensitive Vegetation: Eelgrass present
- 0 Overhanging vegetation: Yes

- 0 Intertidal Slope: Shallow angle
- 3 Upland Slope: Gradual

- 0 Vehicle Parking: Limited street parking, no accessible stalls
- 3 Accessibility: Dirt path needs improvement, no stairs
