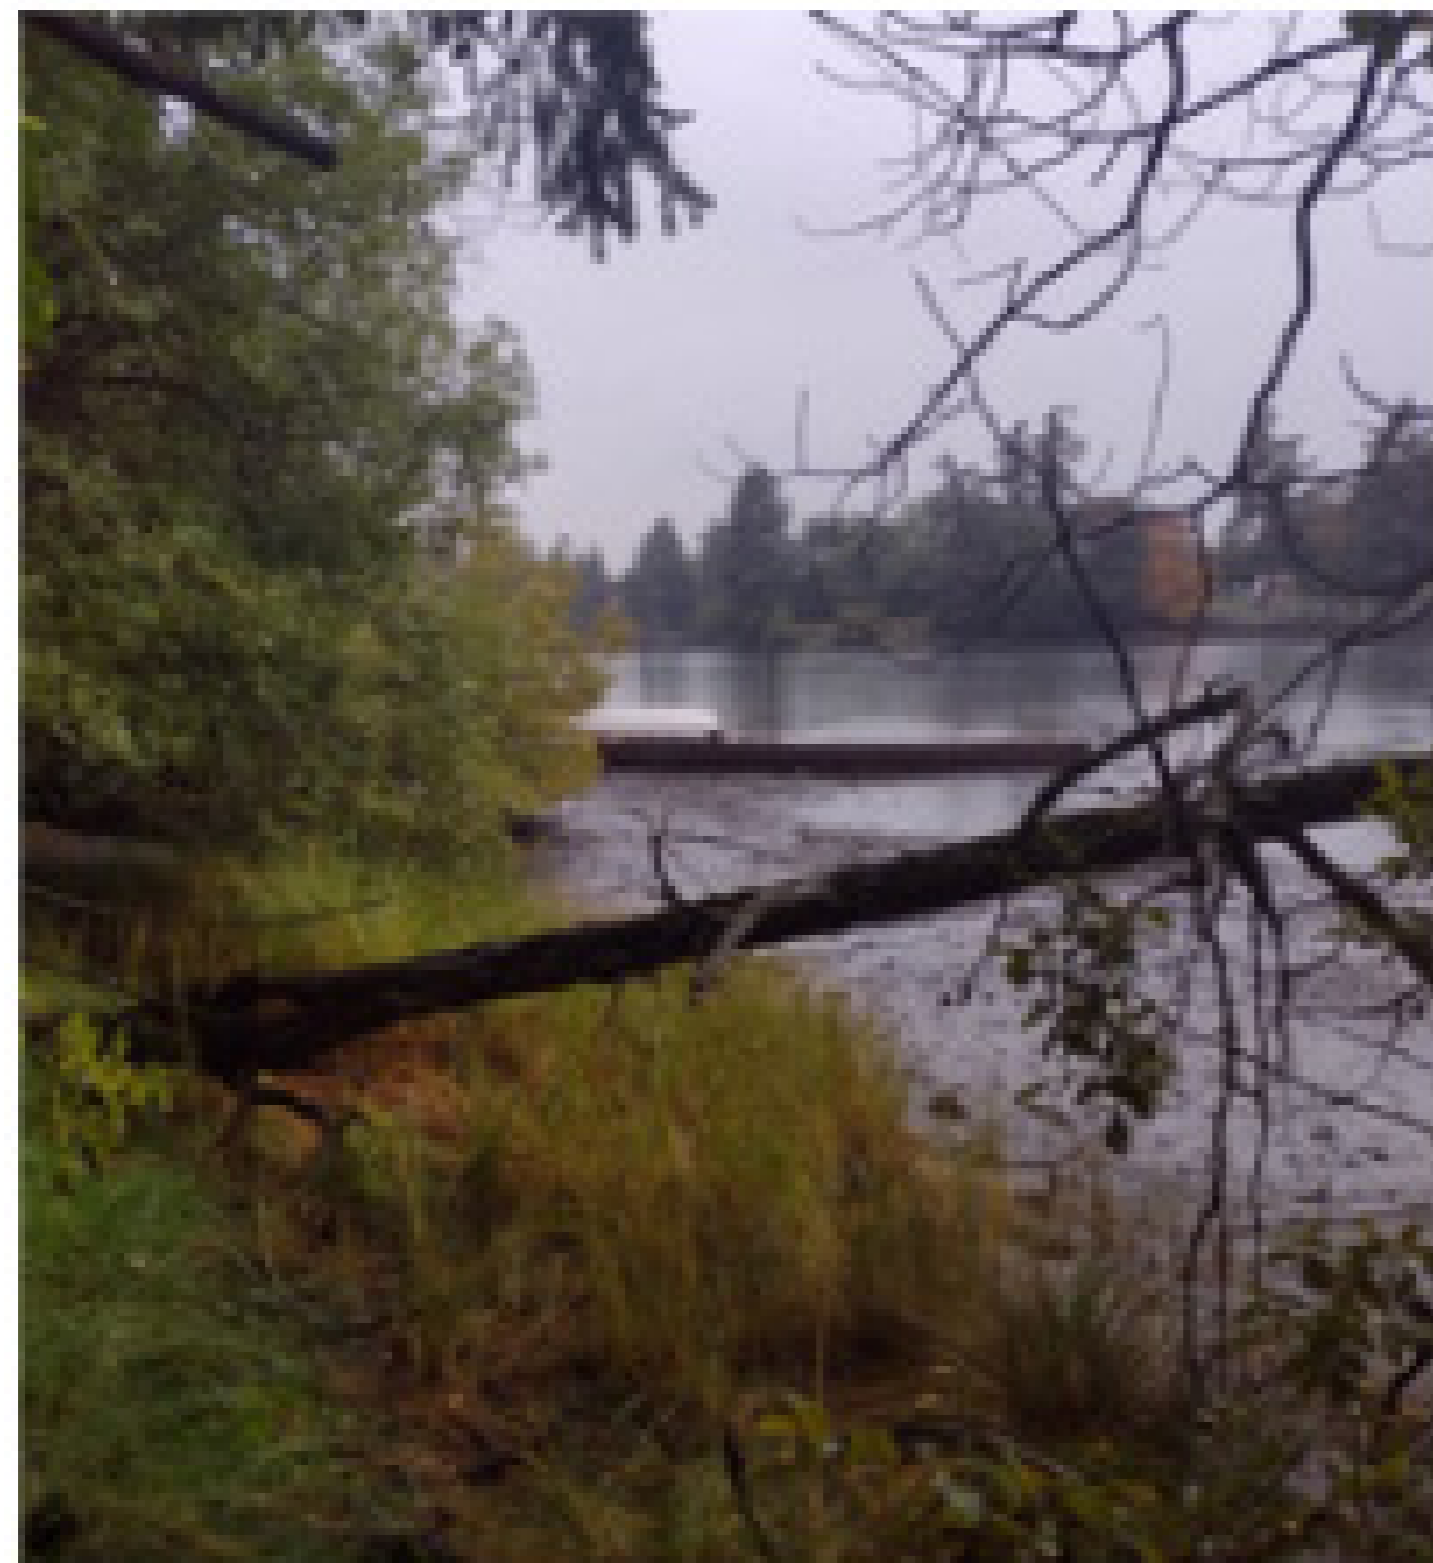
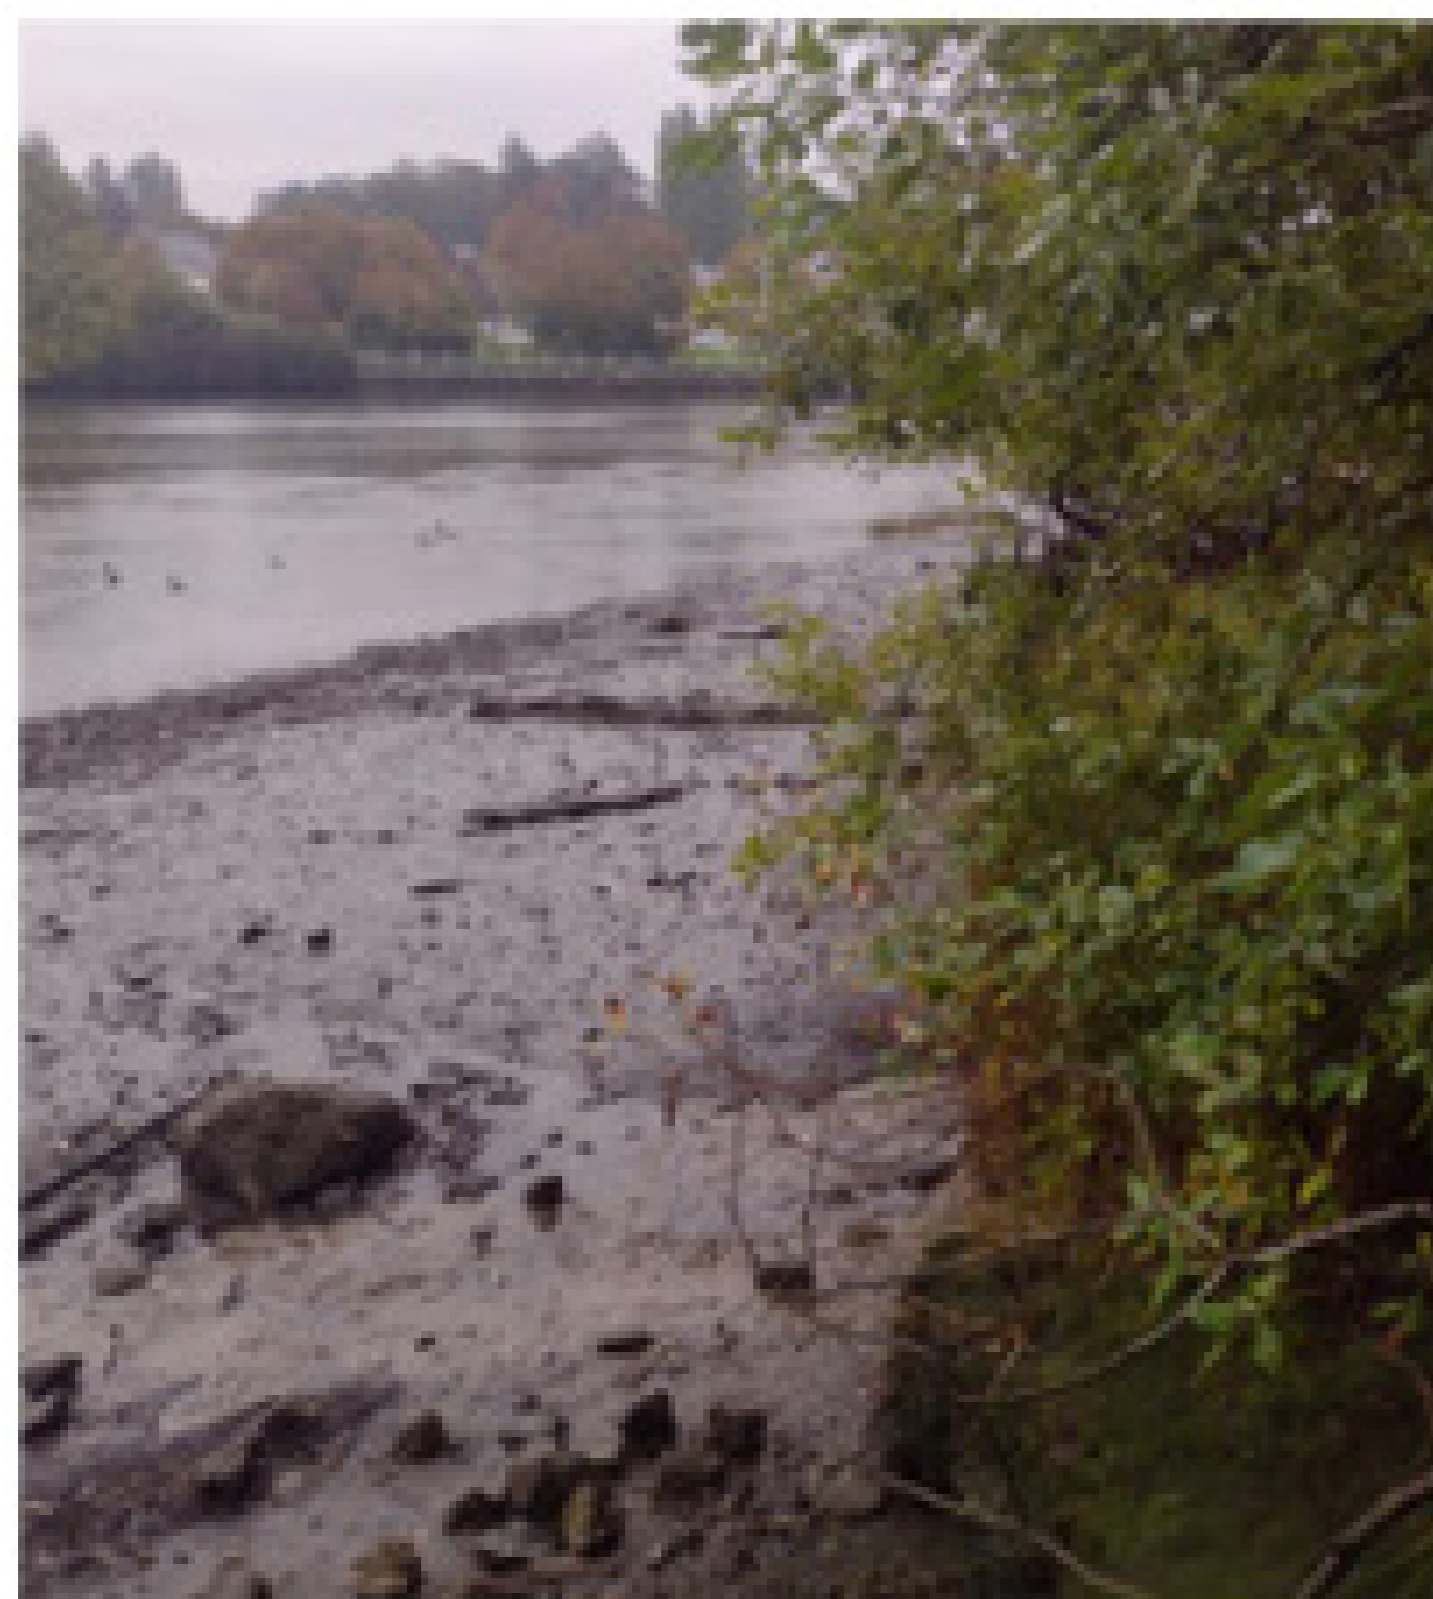
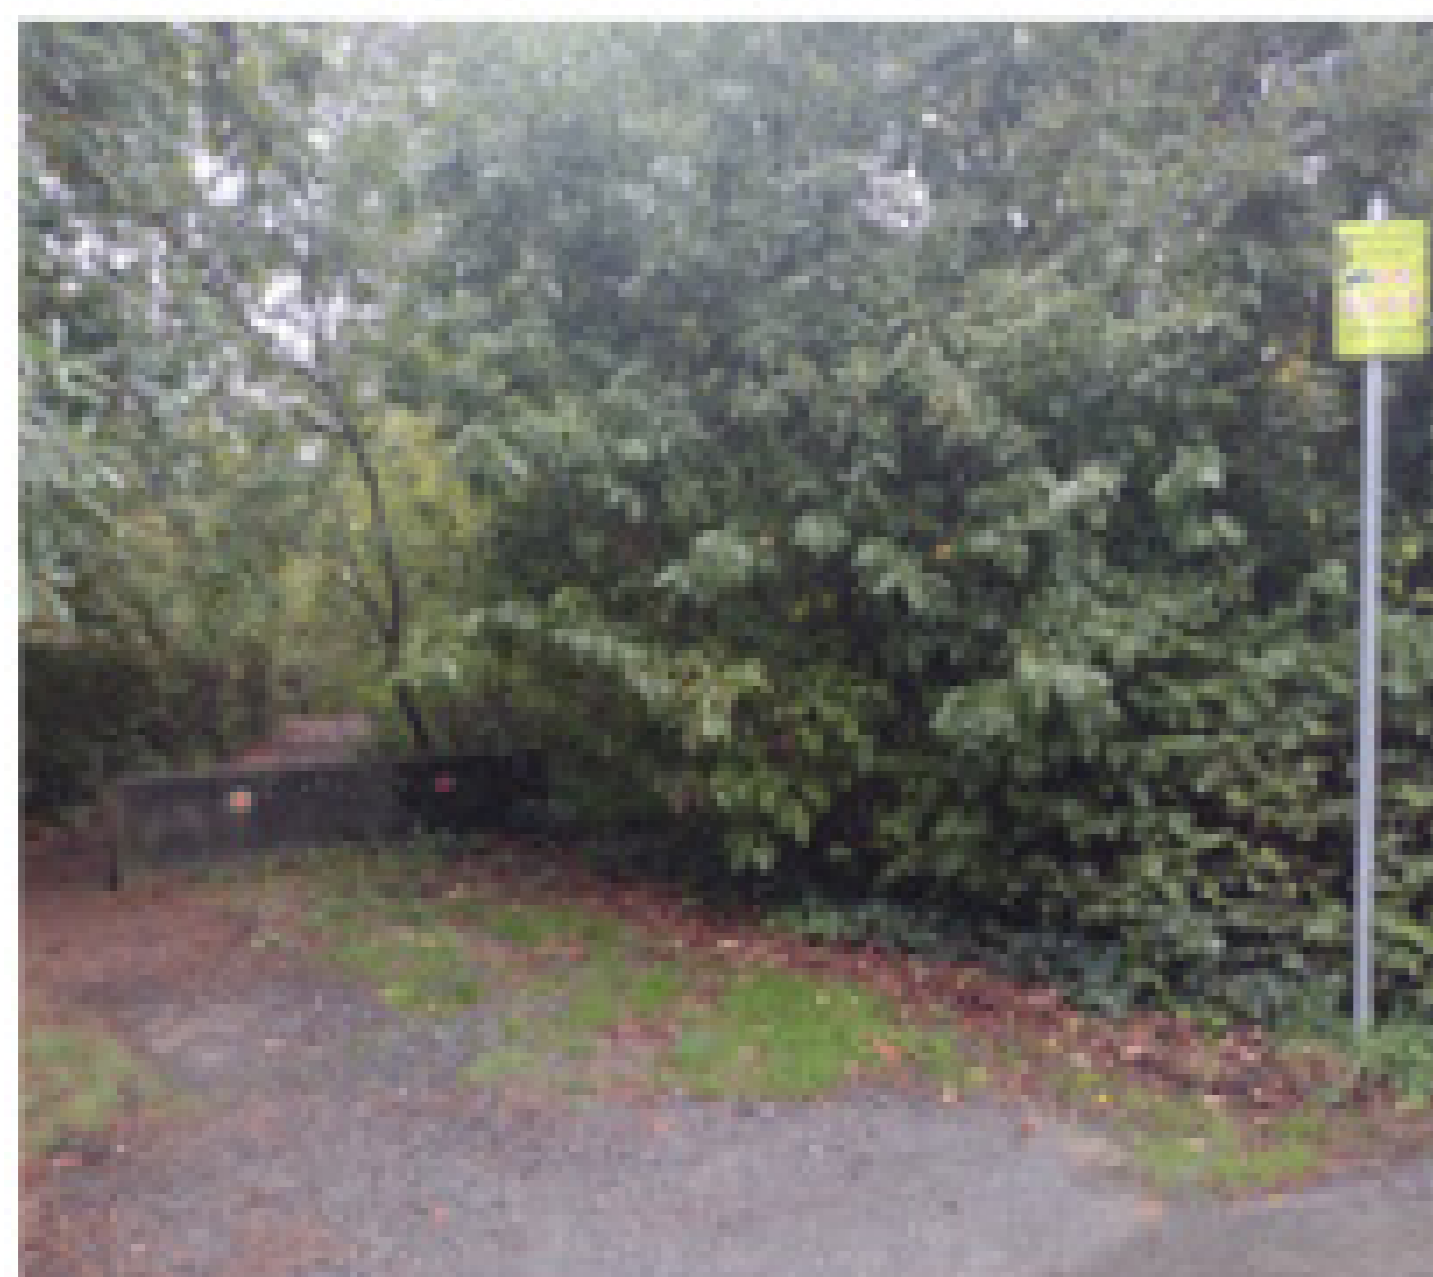
Garthland Road

- 3 Current: Wider section, mild current to consider
- 0 Proximity to Motor Boat Traffic: Wide section, motor boats in area
- 3 Human Health Rating of outfalls: Low risk

- 0 Conservation Concern: Olympia oysters present
- 3 Sensitive Vegetation: Eelgrass present
- 0 Overhanging vegetation: Yes

- 0 Intertidal Slope: Shallow angle
- 3 Upland Slope: Gradual

- 0 Vehicle Parking: Limited parking, 3-4 vehicles, no accessible stalls
- 0 Accessibility: Path needs improvement, no stairs

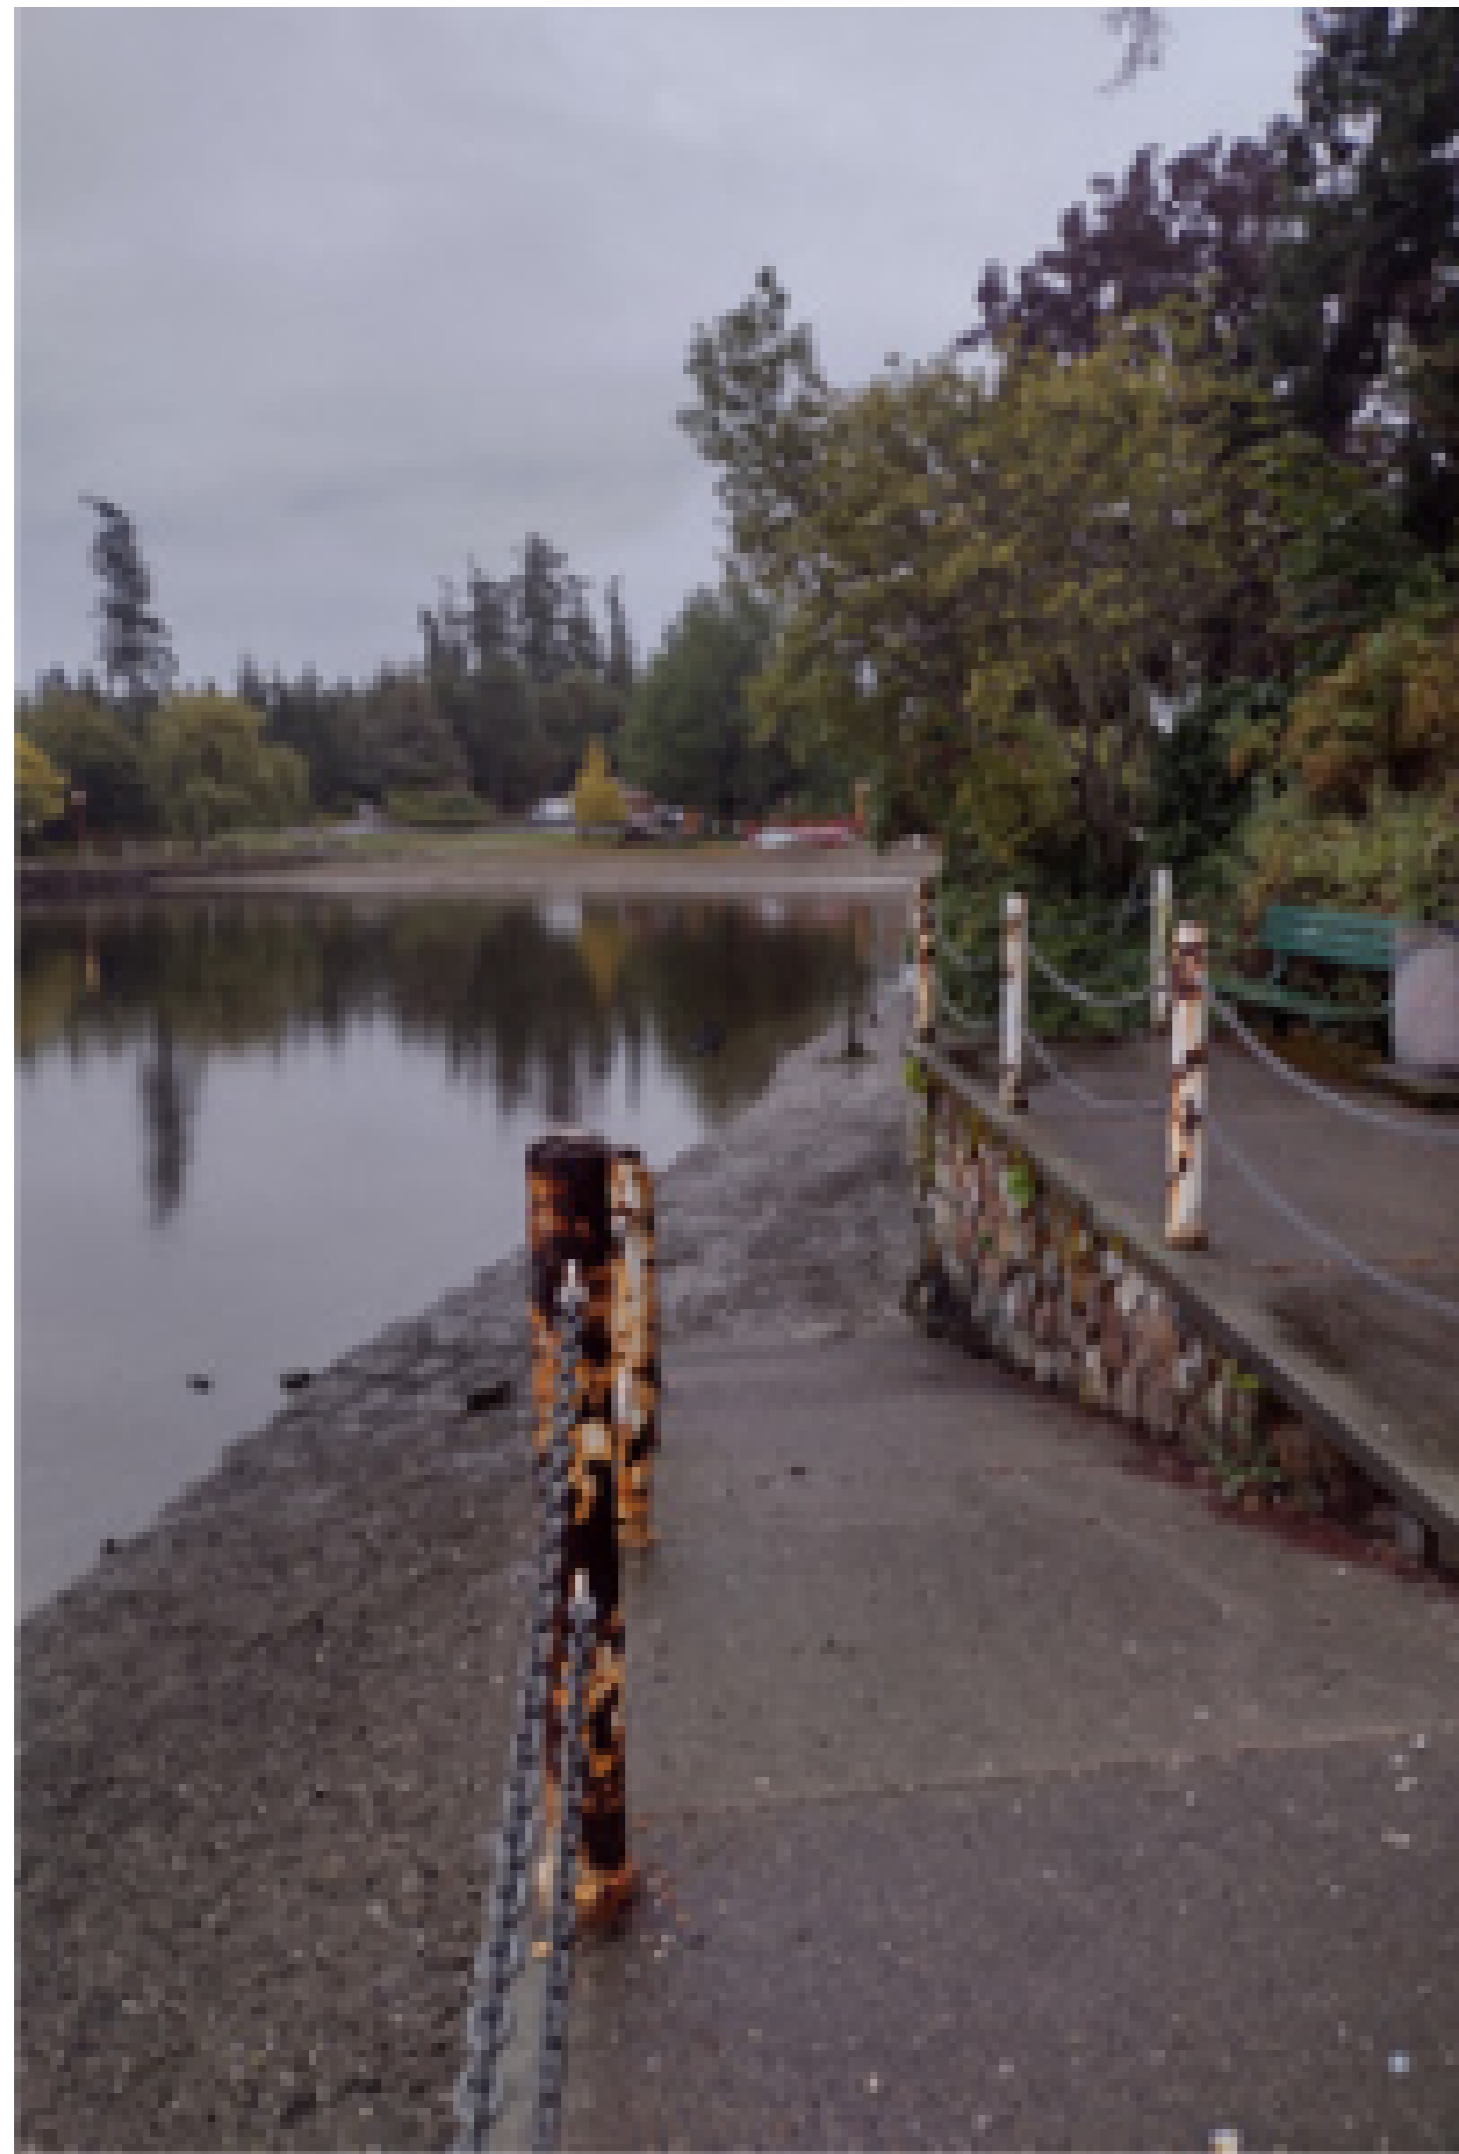
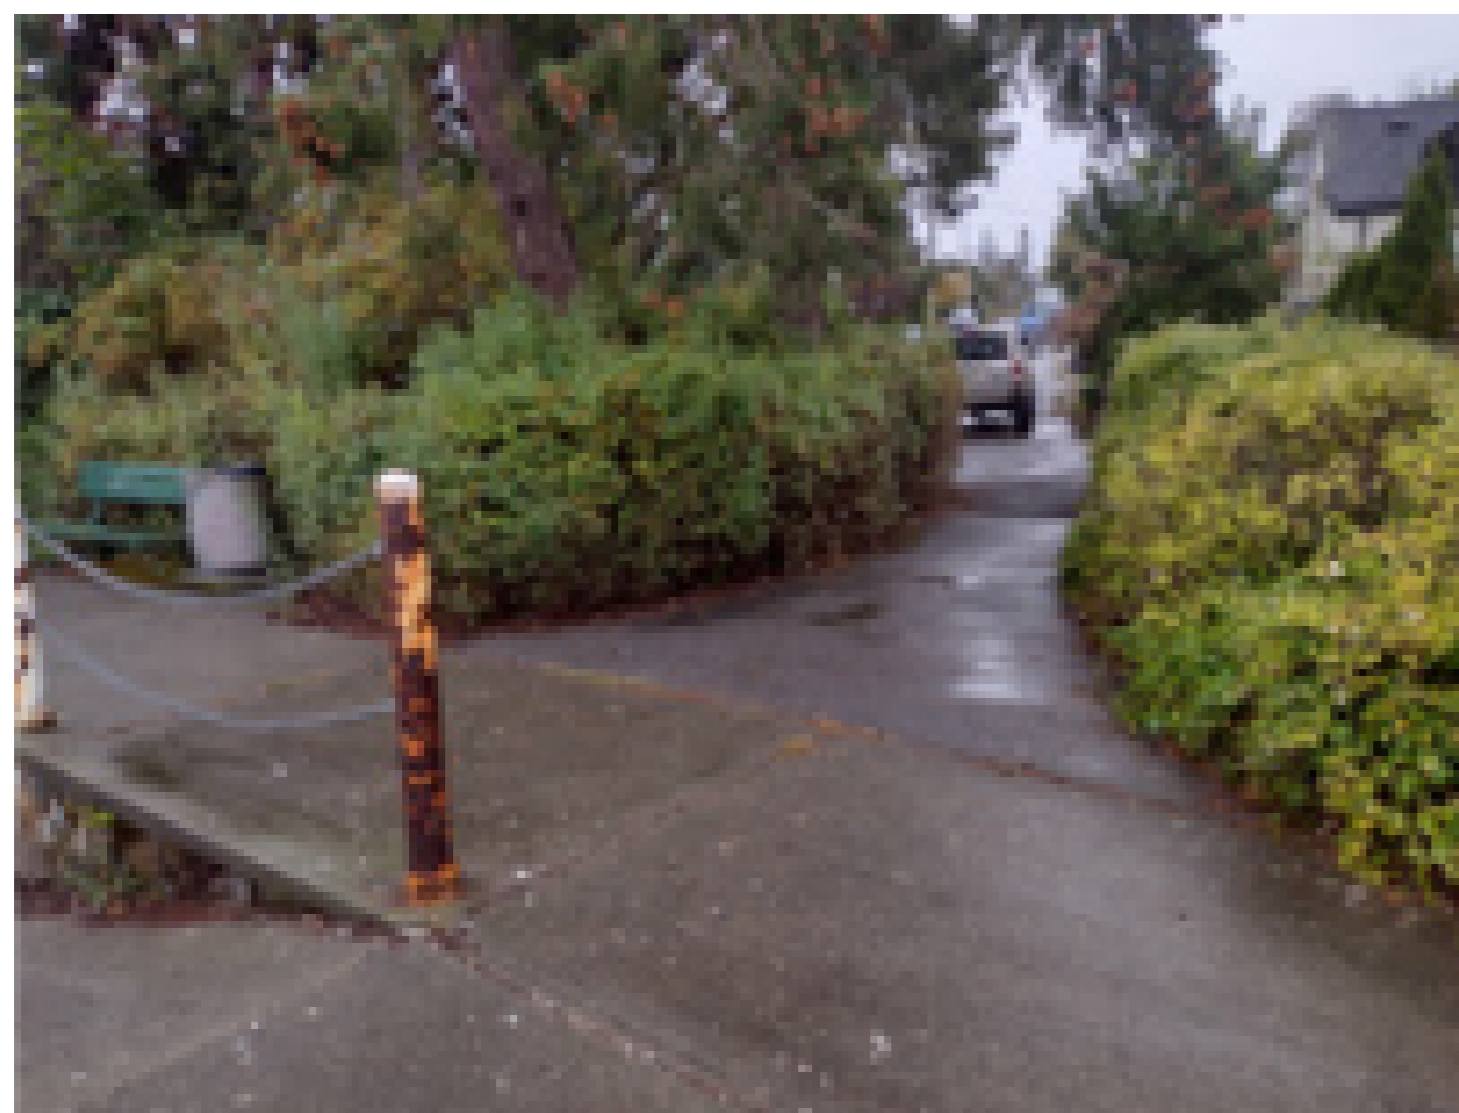
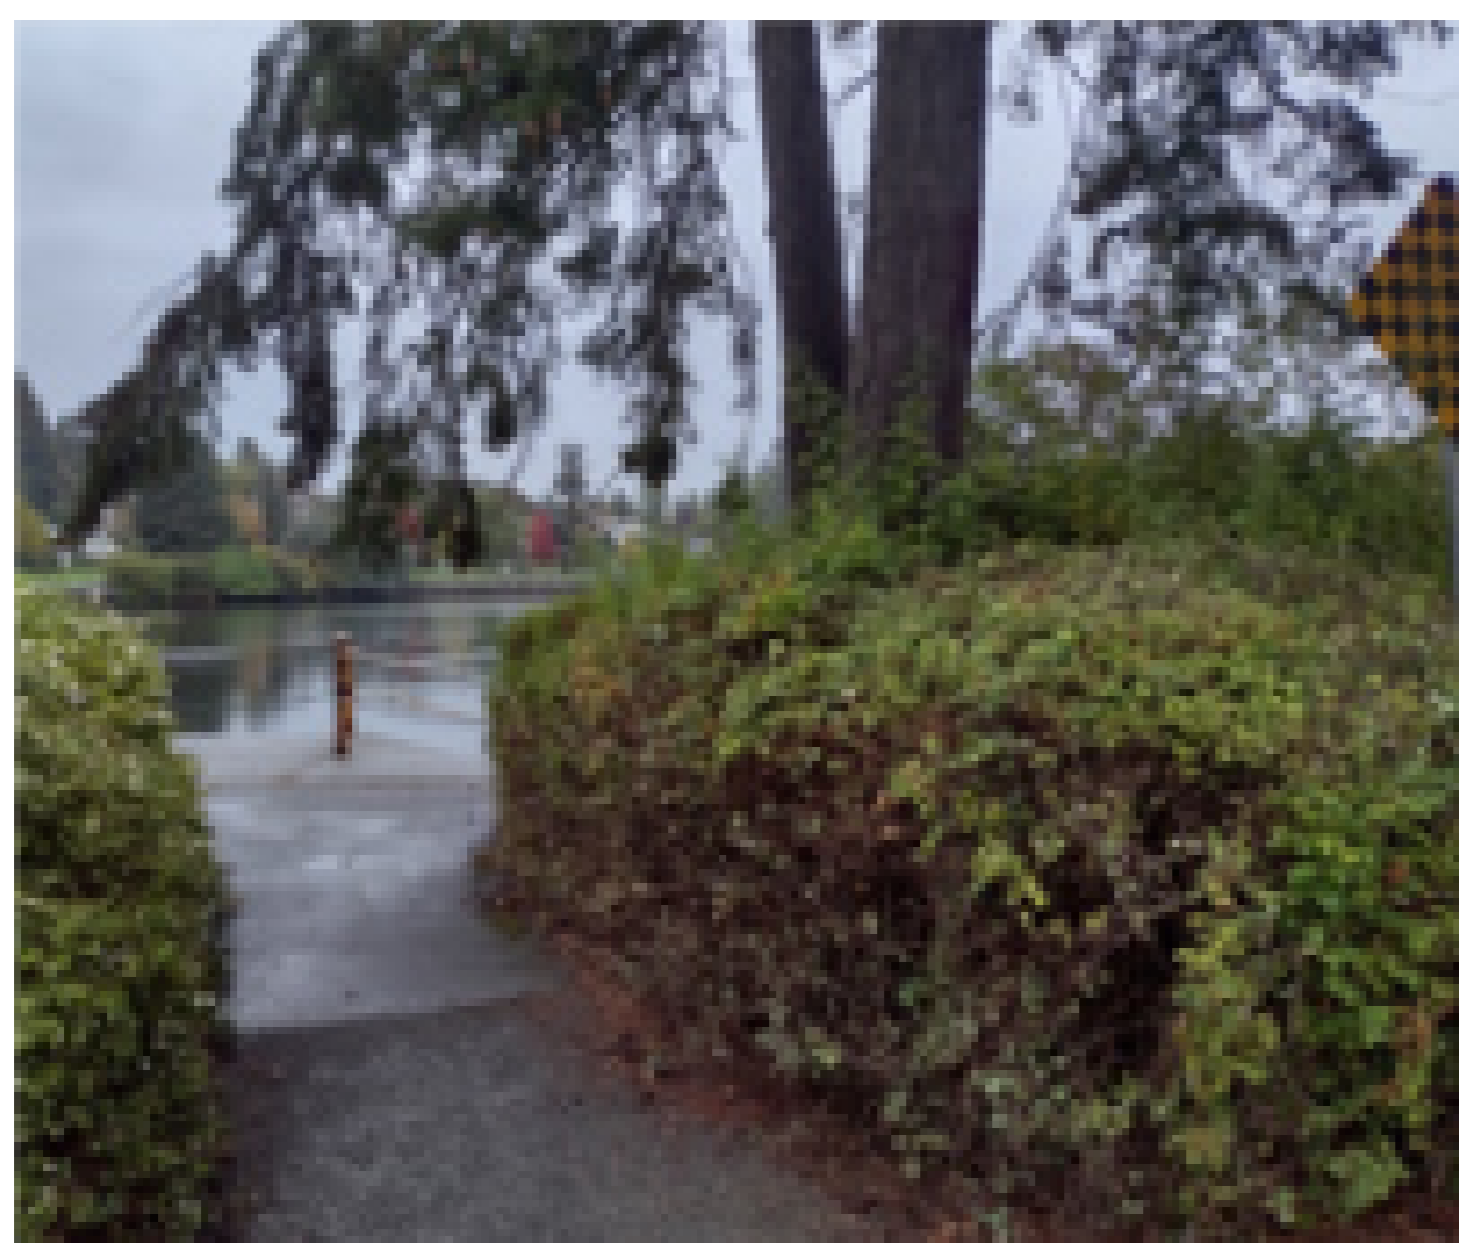
Forshaw Road

- 3 Current: Wide section, mild current to consider
- 3 Proximity to Motor Boat Traffic: Wide section, motor boats in area
- 0 Human Health Rating of outfalls: High risk outfall upstream

- 0 Conservation Concern: Olympia oysters present
- 0 Sensitive Vegetation: Significant presence of eelgrass
- 3 Overhanging vegetation: No, hard armoured shore

- 0 Intertidal Slope: Shallow angle
- 3 Upland Slope: Gentle incline to viewpoint, steep ramp to water

- 0 Vehicle Parking: Limited street parking, no accessible stalls
- 3 Accessibility: Paved path, steep ramp to water

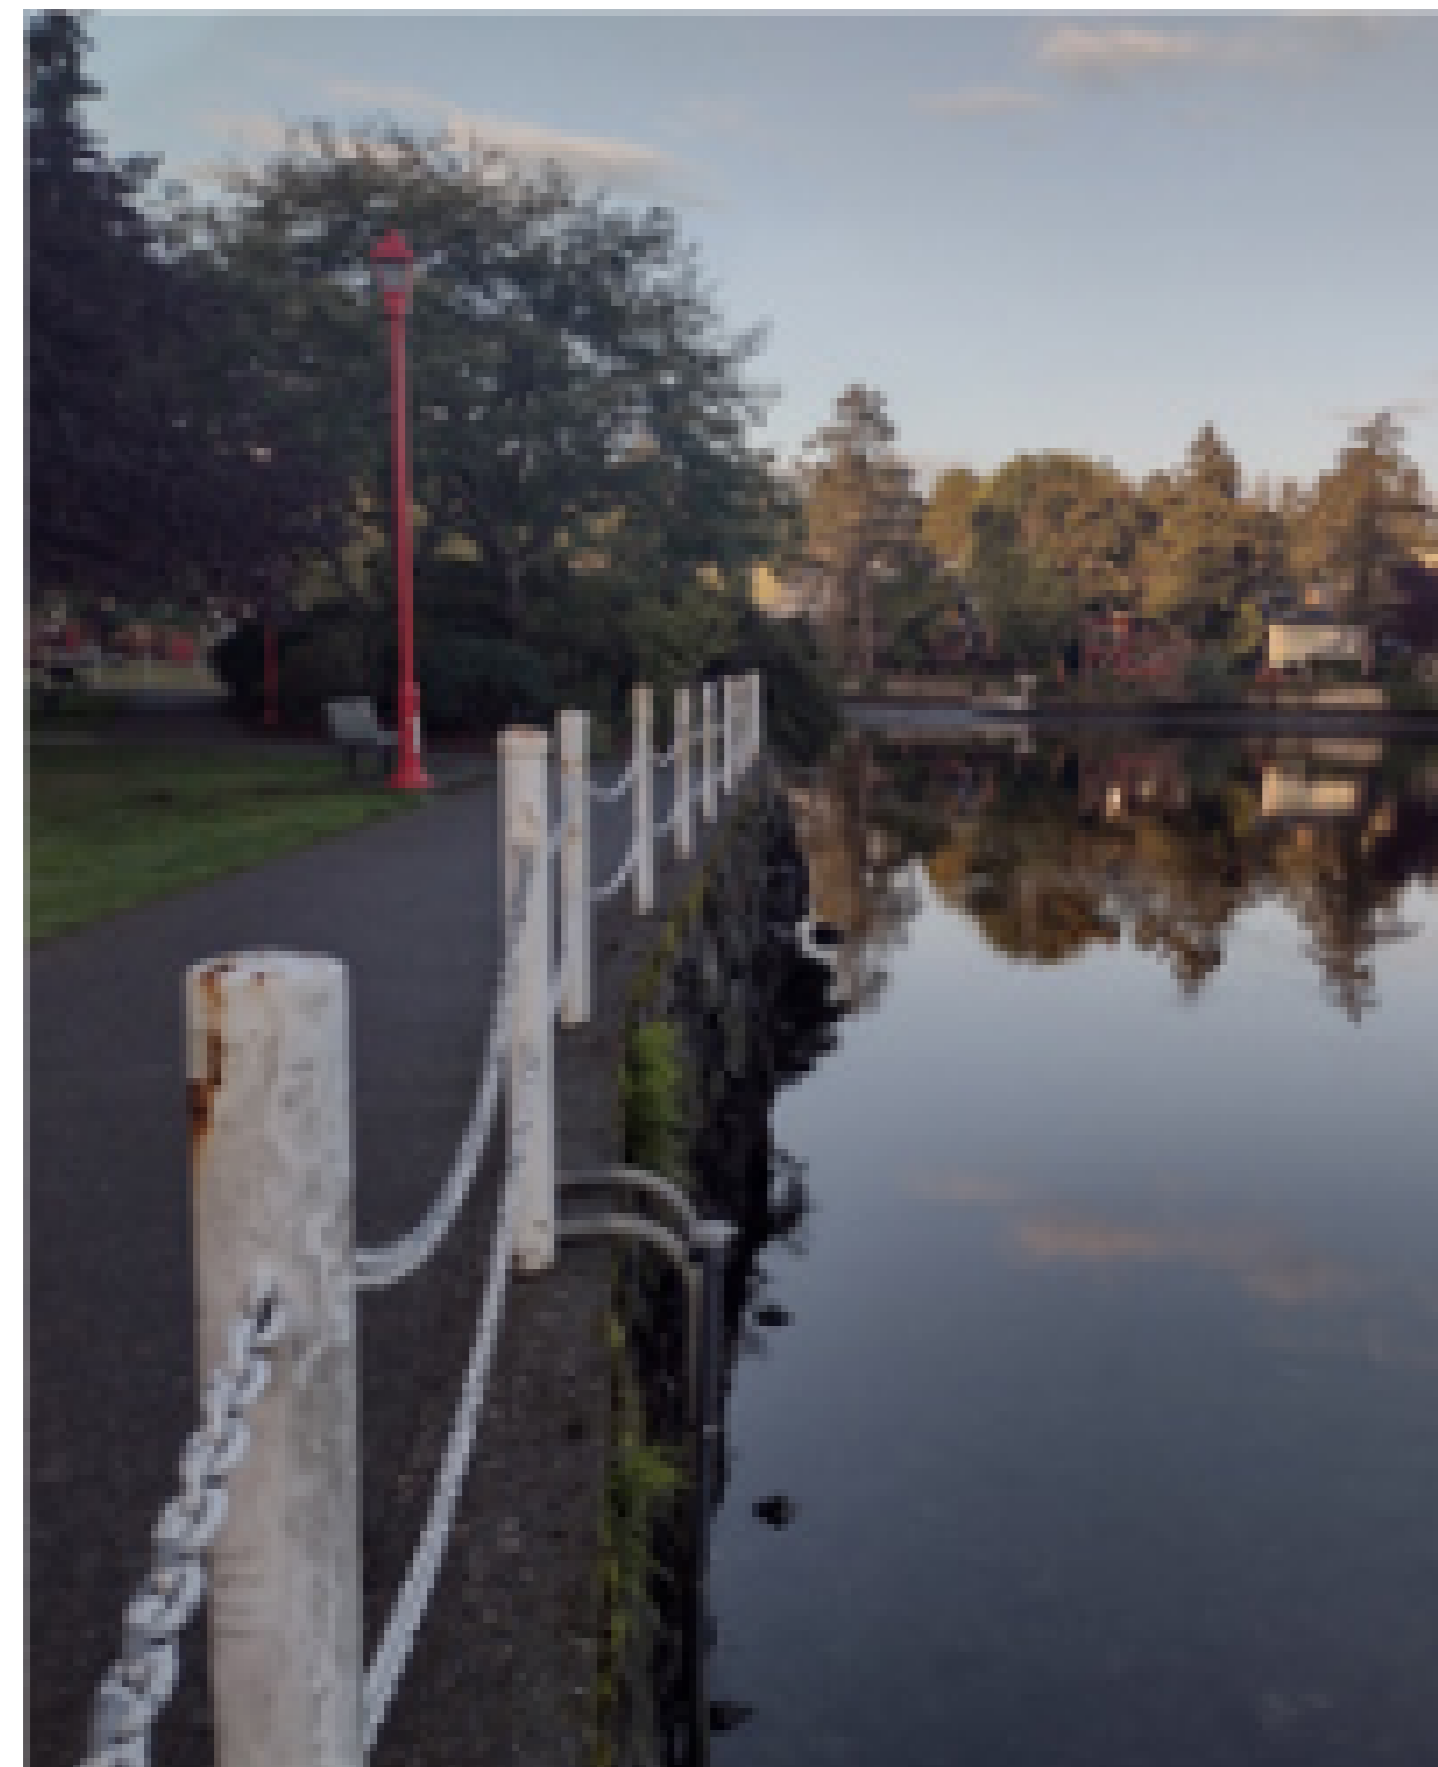
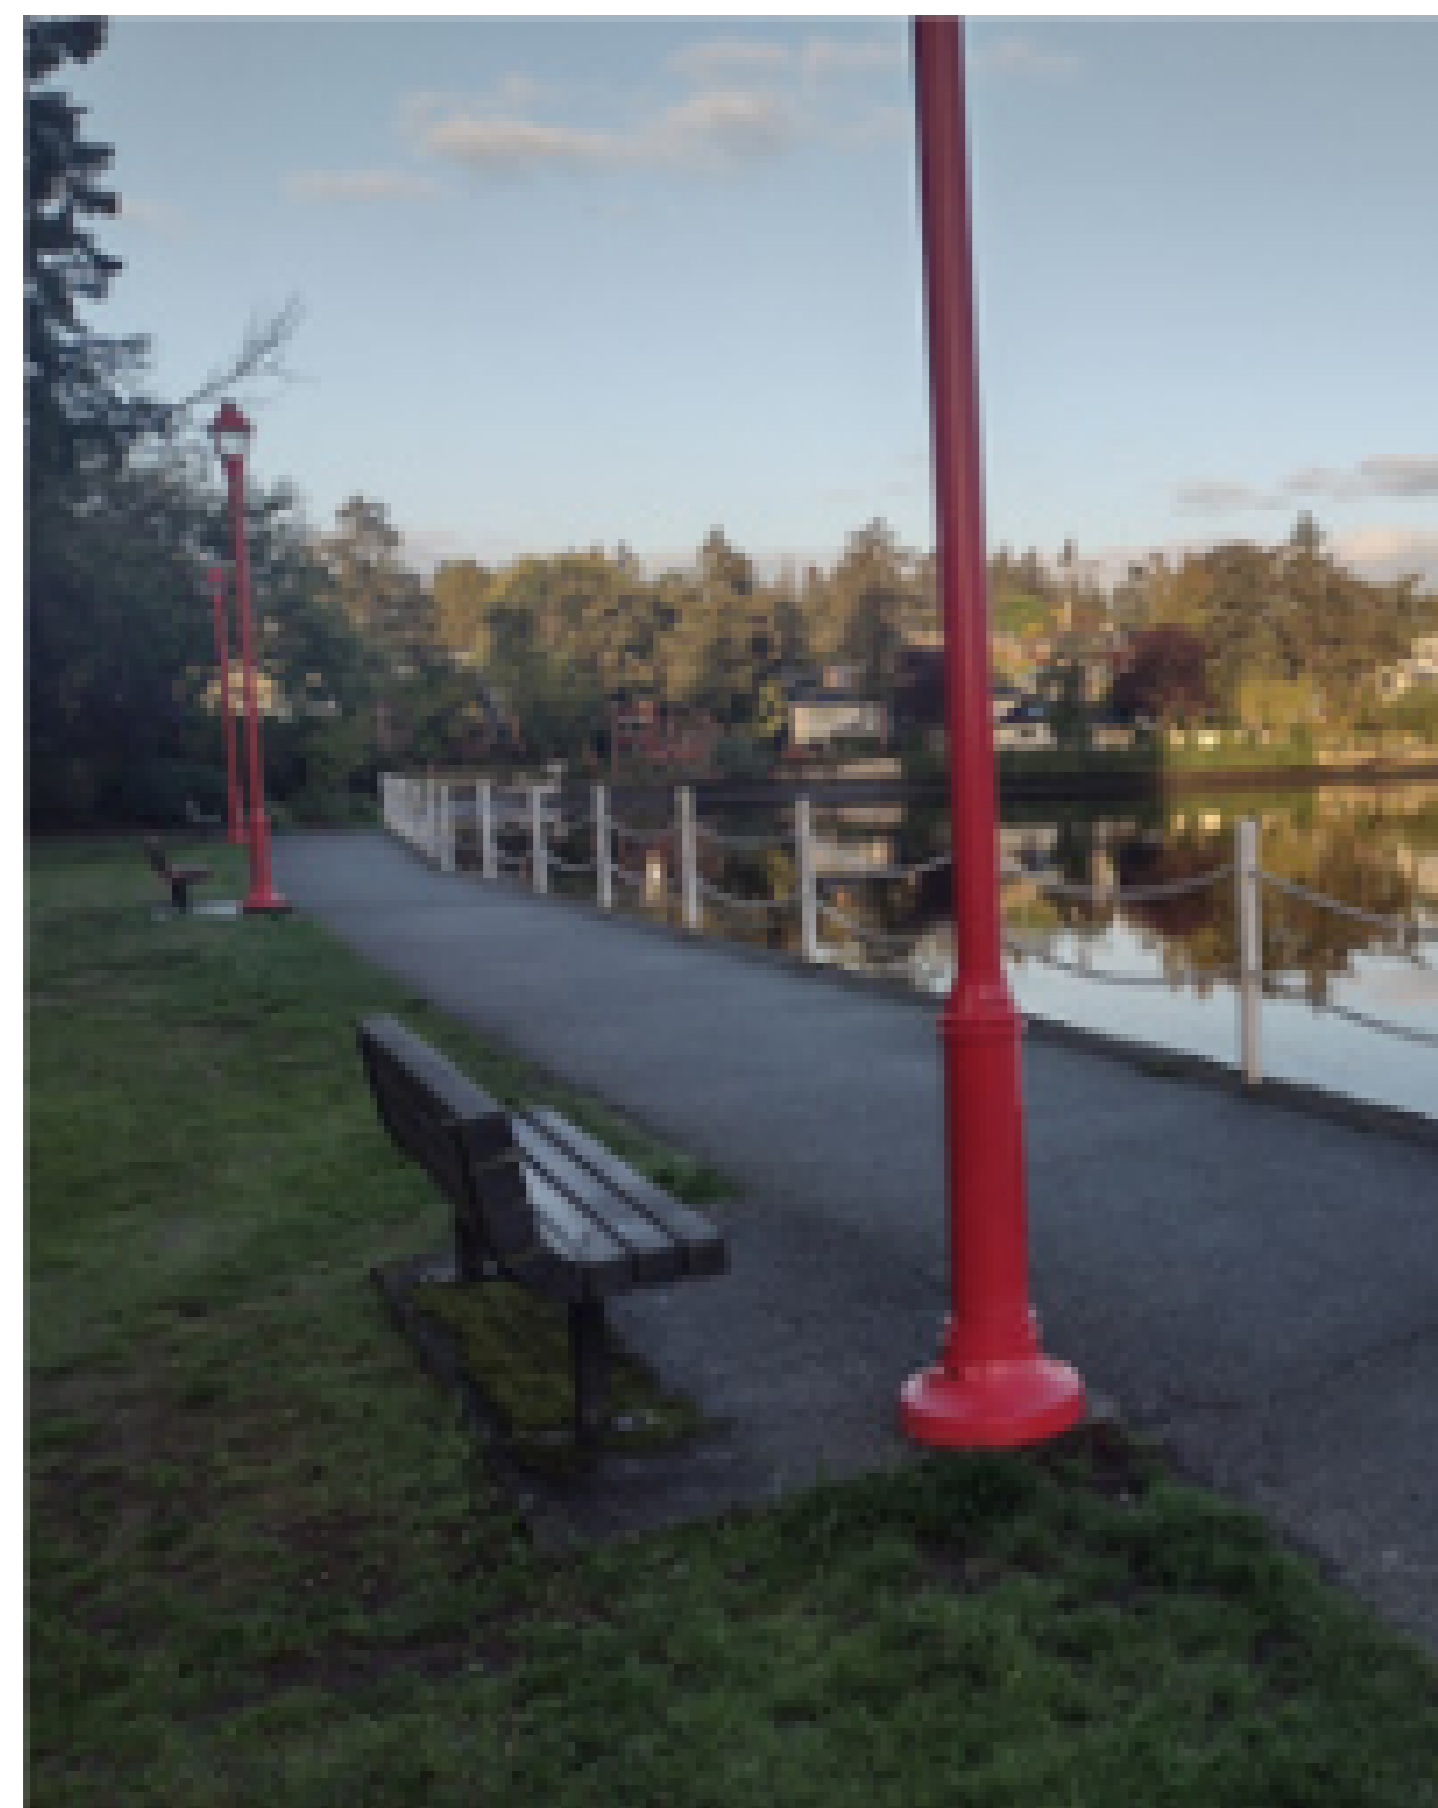
Esquimalt Gorge Park West

- 3 Current: Wide section, mild current to consider
- 3 Proximity to Motor Boat Traffic: Wide section, motor boats in area
- 0 Human Health Rating of outfalls: High risk outfall upstream

- 0 Conservation Concern: Significant presence of Olympia Oysters
- 0 Sensitive Vegetation: Eelgrass ranges from abundant - present
- 3 Overhanging vegetation: No, hard armoured shore

- 0 Intertidal Slope: Medium angle
- 3 Upland Slope: Gradual incline through park, paved paths

- 3 Vehicle Parking: Plentiful, including accessible and EV charging
- 3 Accessibility: Paved path, gentle incline, neighbourhood sidewalks
