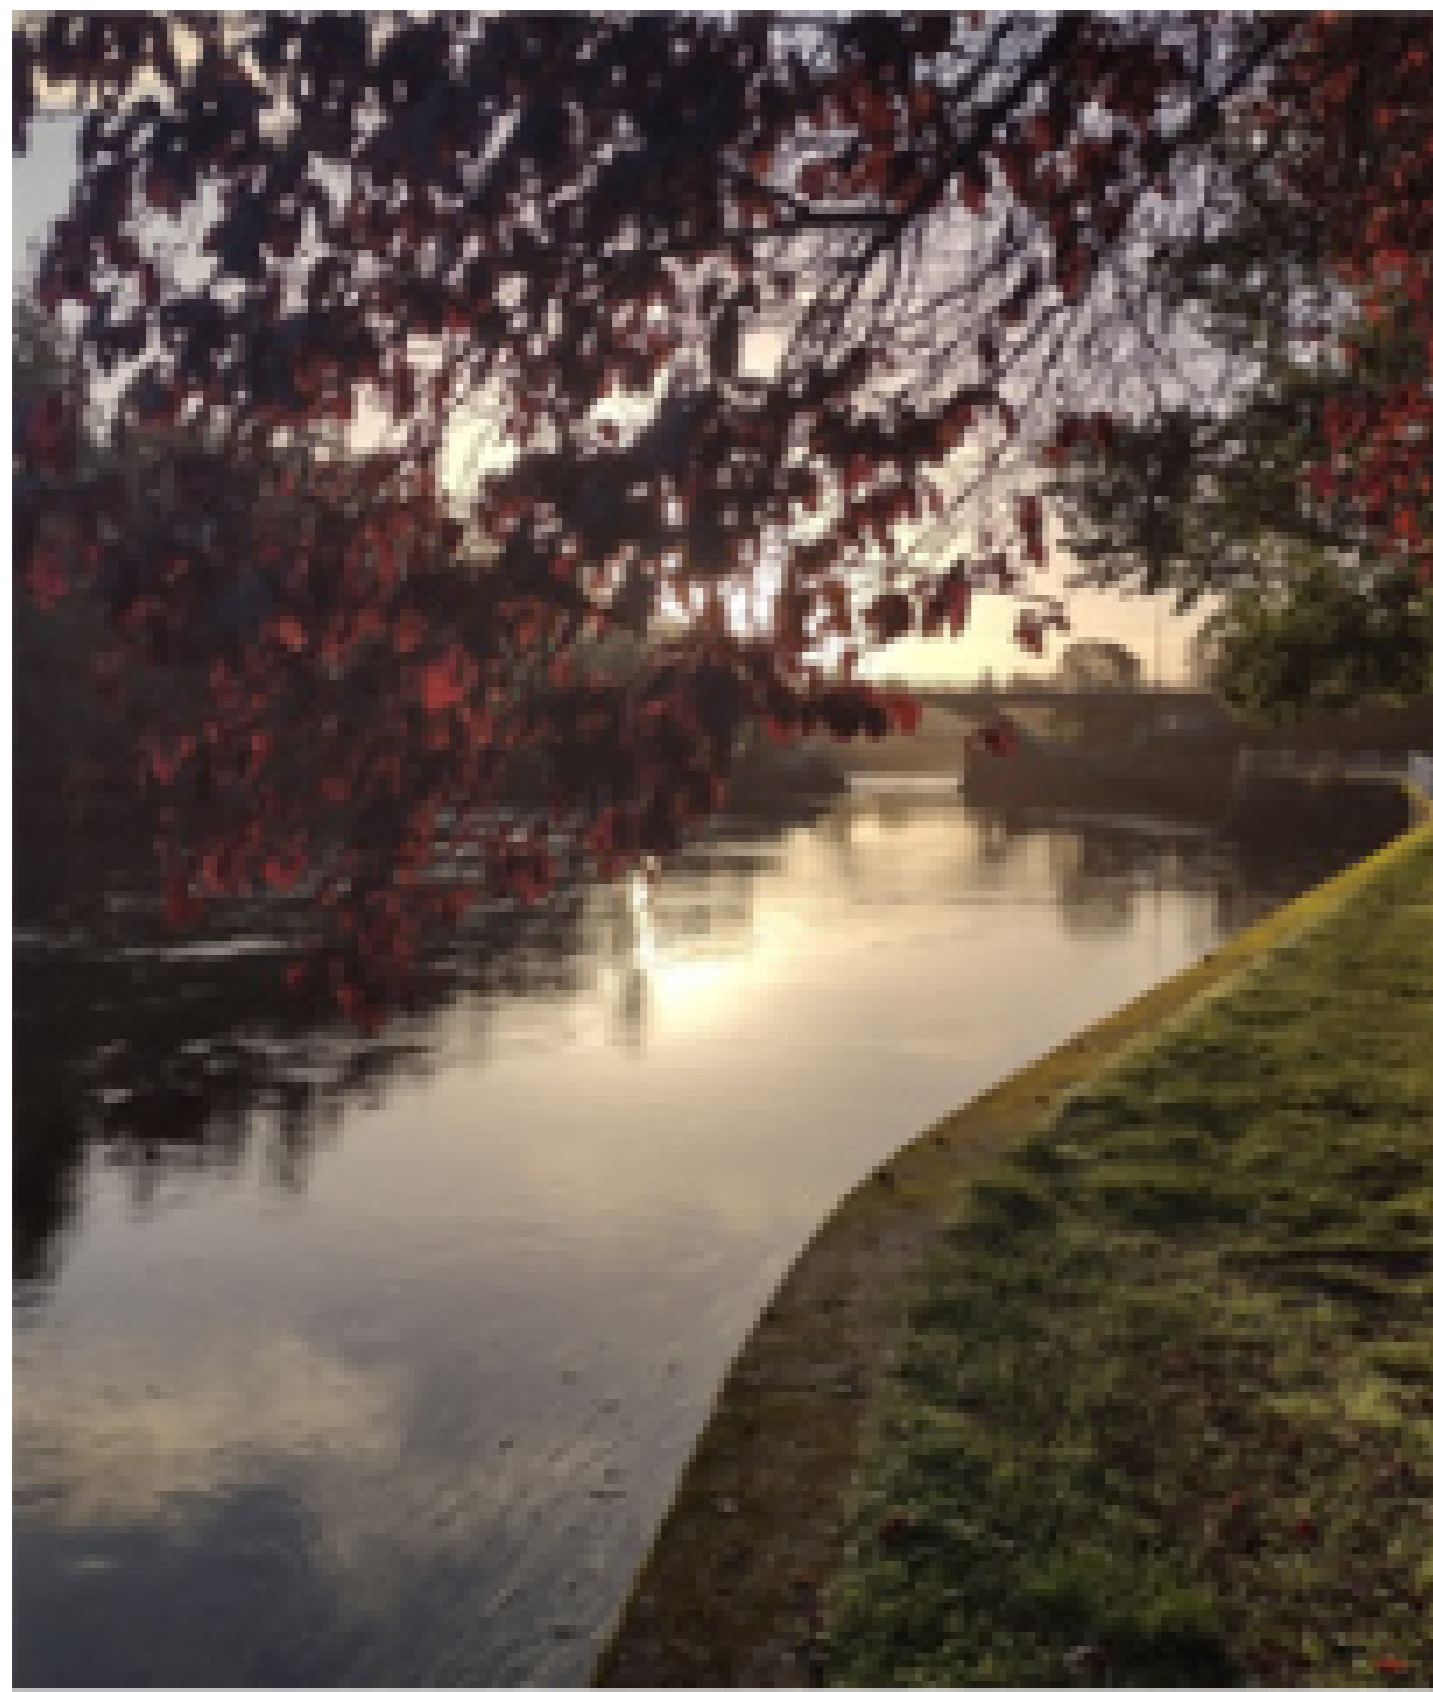
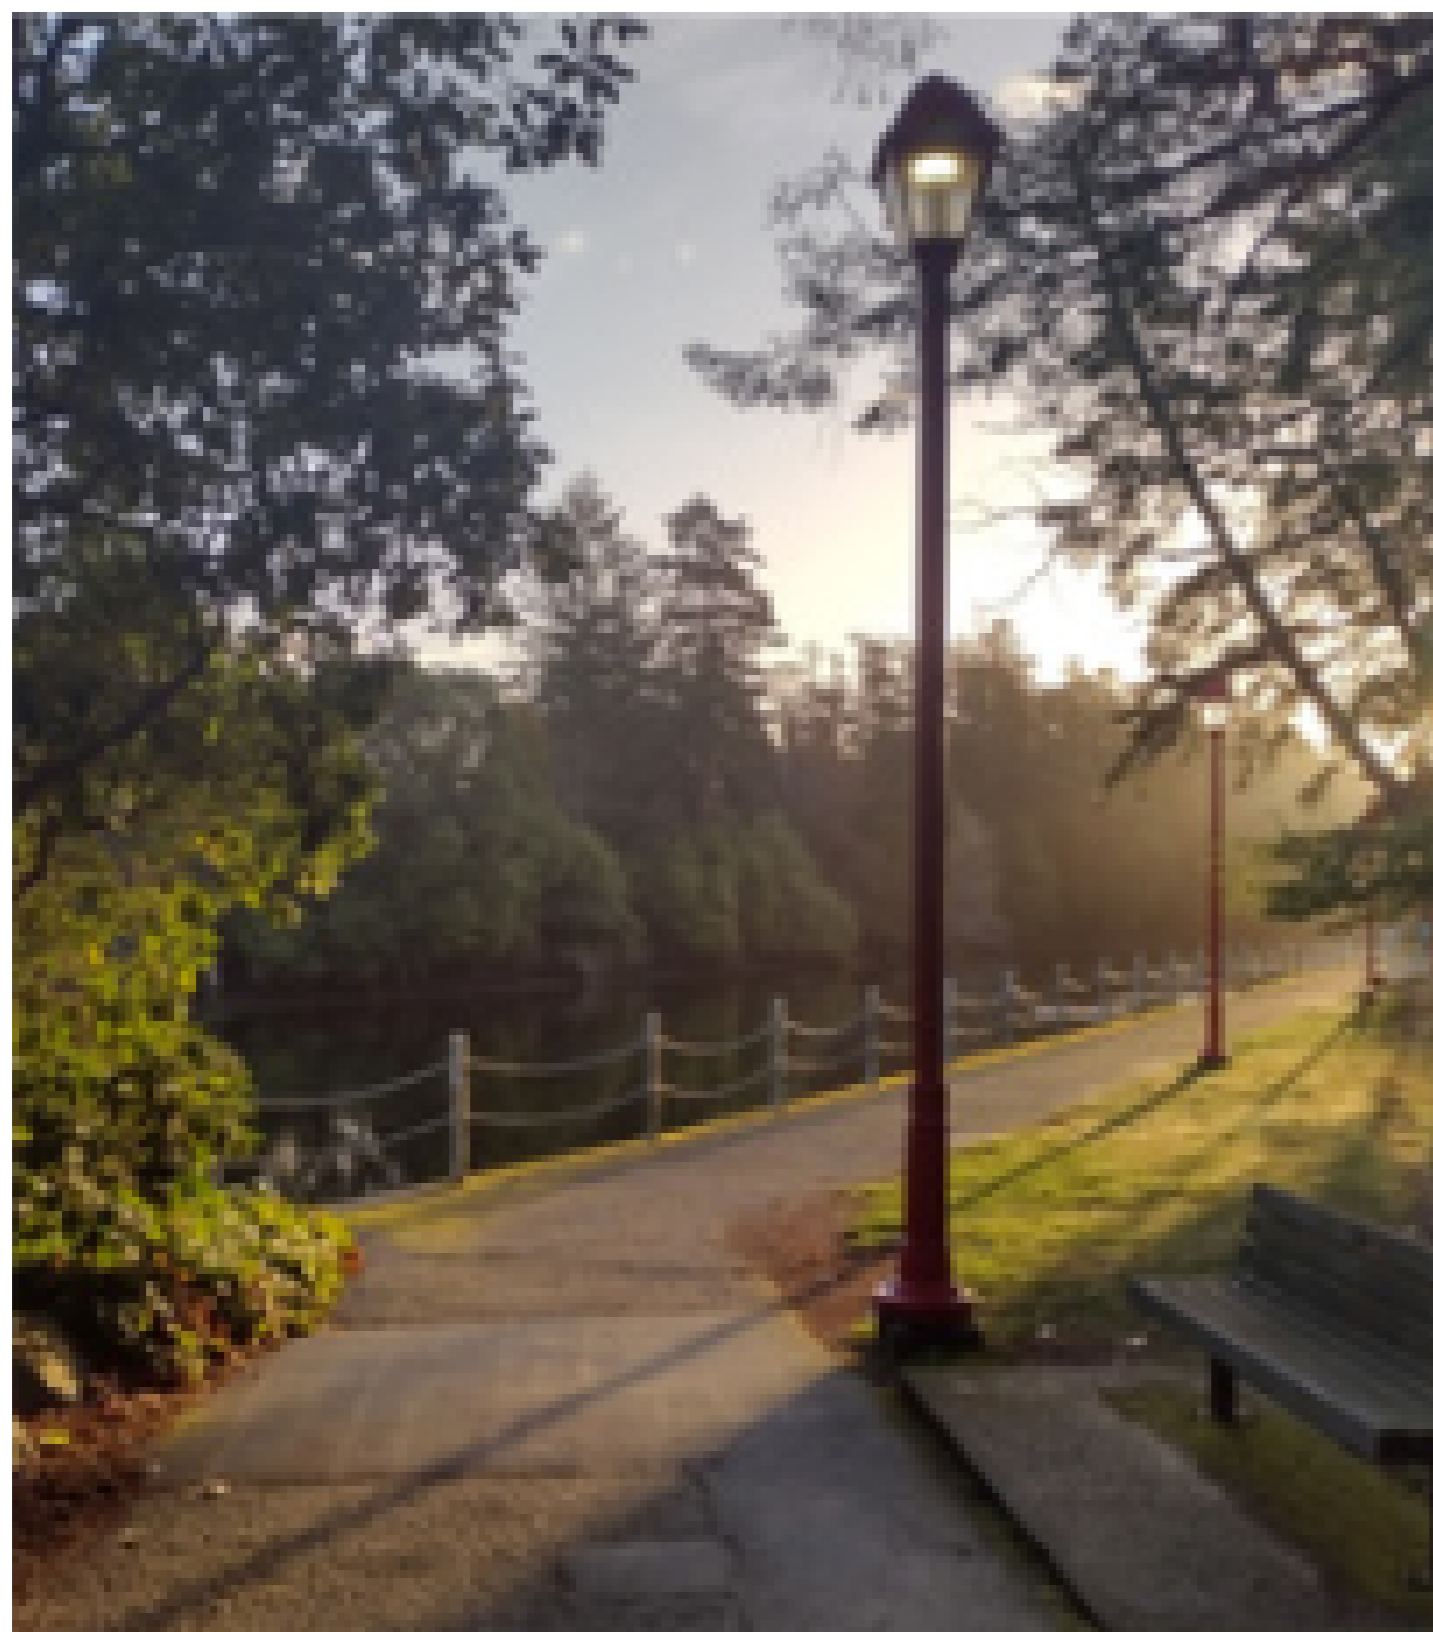
Esquimalt Gorge Park *East*

- 0 Current: Narrow section + reversing falls create current
- 0 Proximity to Motor Boat Traffic: Narrow section, close proximity
- 3 Human Health Rating of outfalls: Low risk

- 0 Conservation Concern: Significant presence of Olympia oysters
- 0 Sensitive Vegetation: Eelgrass ranges from abundant - present
- 3 Overhanging vegetation: Hard armoured shore

- 0 Intertidal Slope: Medium angle
- 3 Upland Slope: Gradual

- 3 Vehicle Parking: Plentiful, including accessible and EV charging
- 3 Accessibility: Paved path with gentle incline

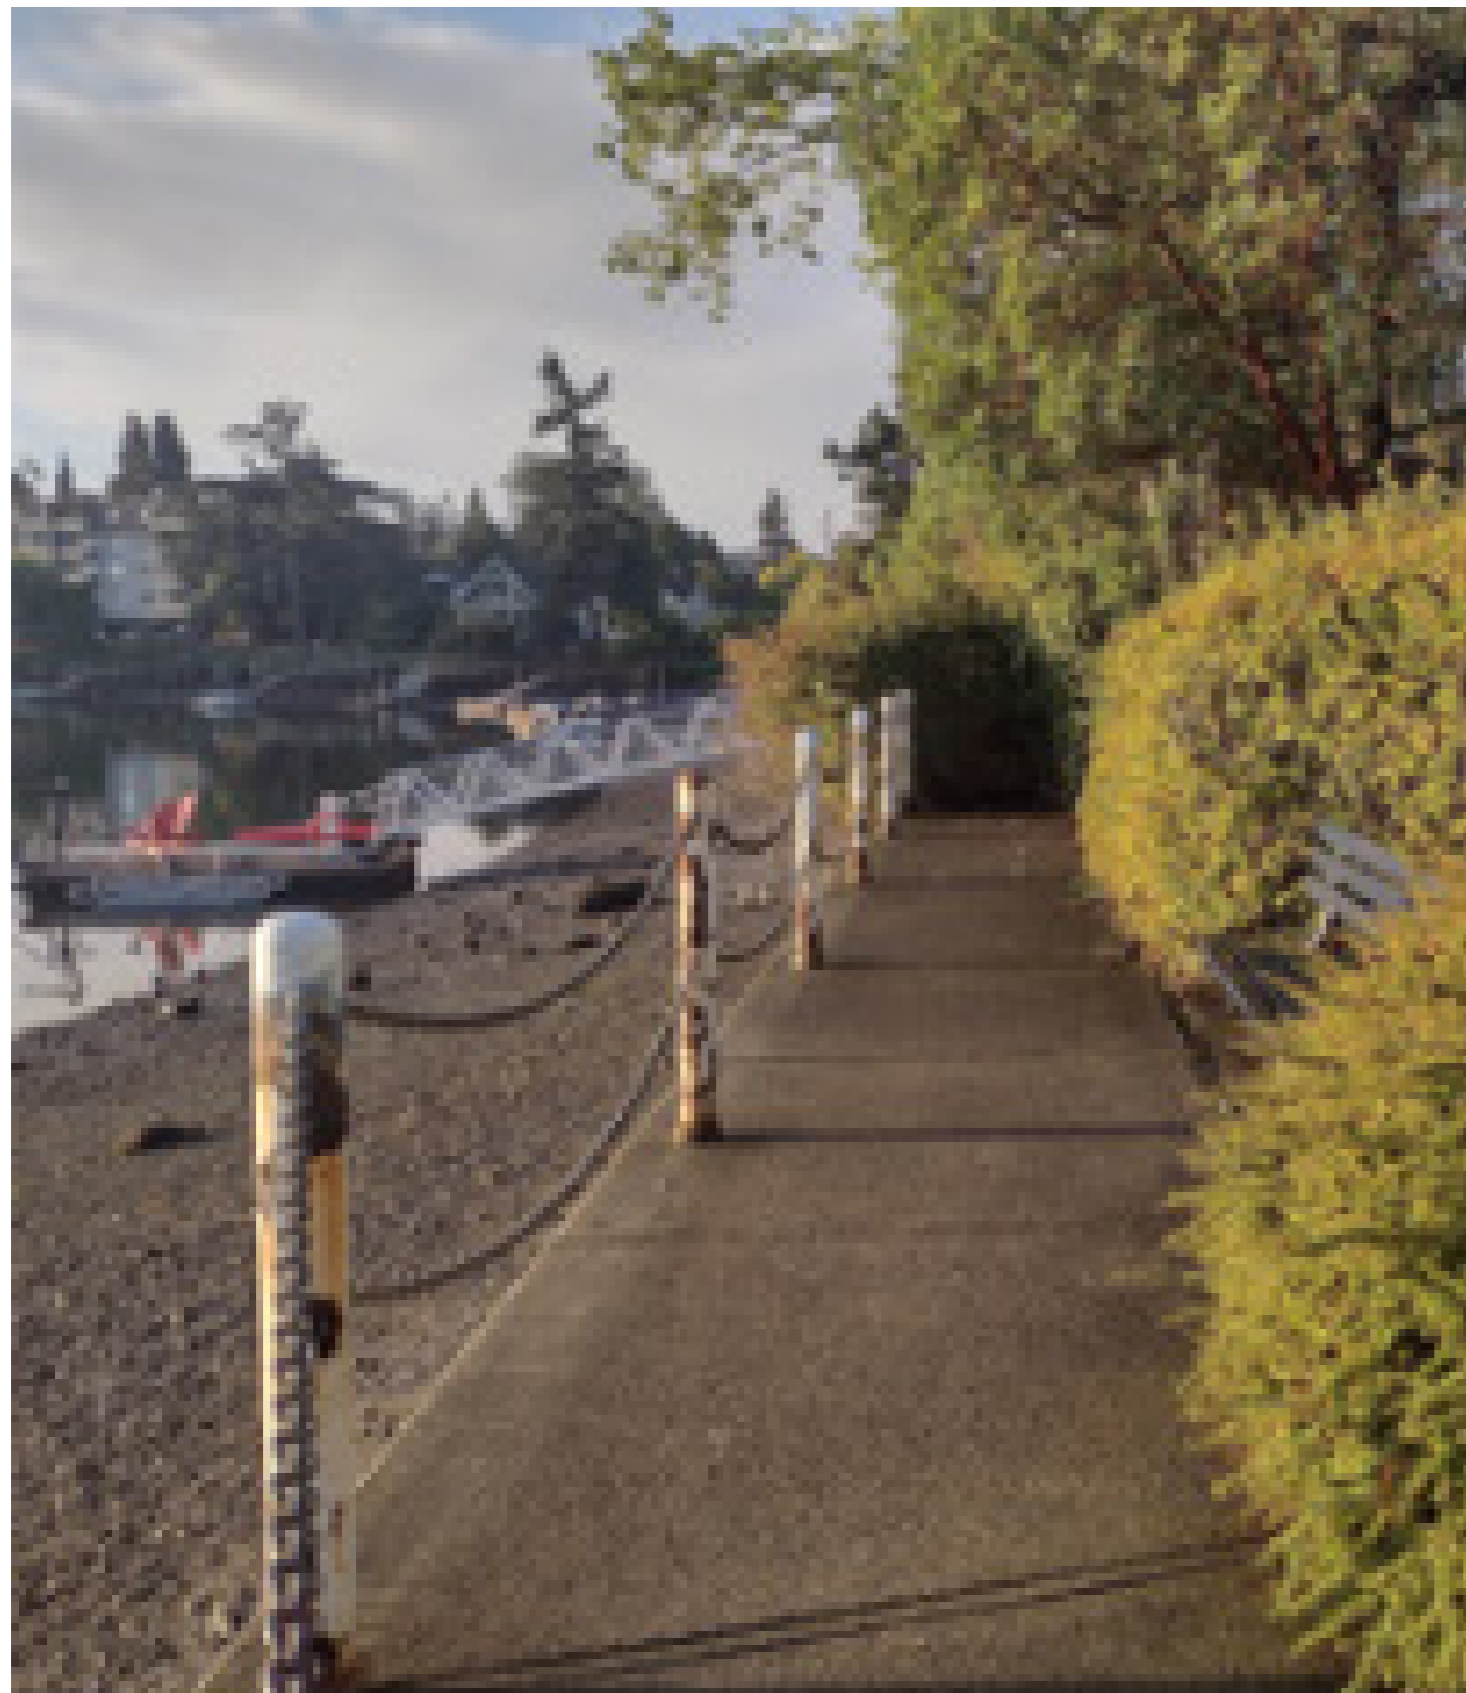
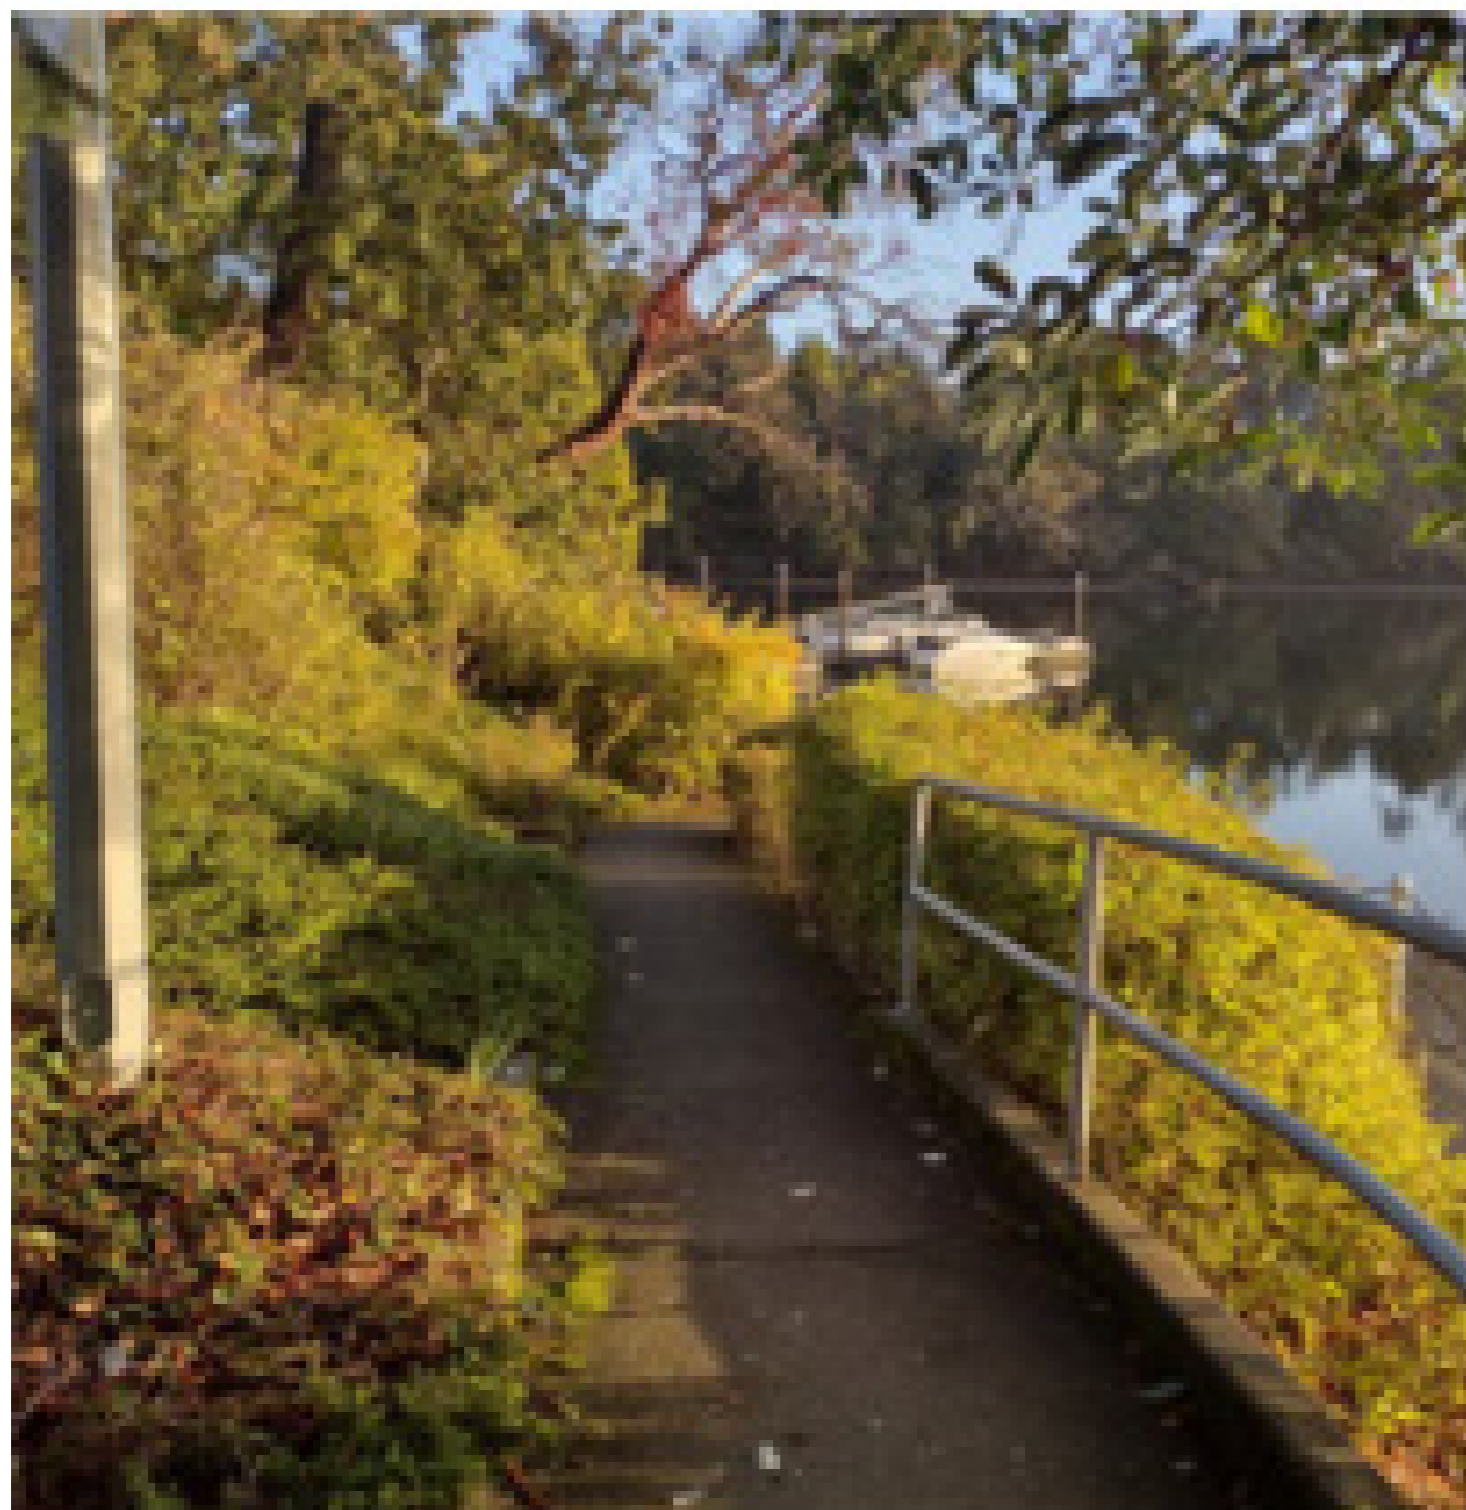
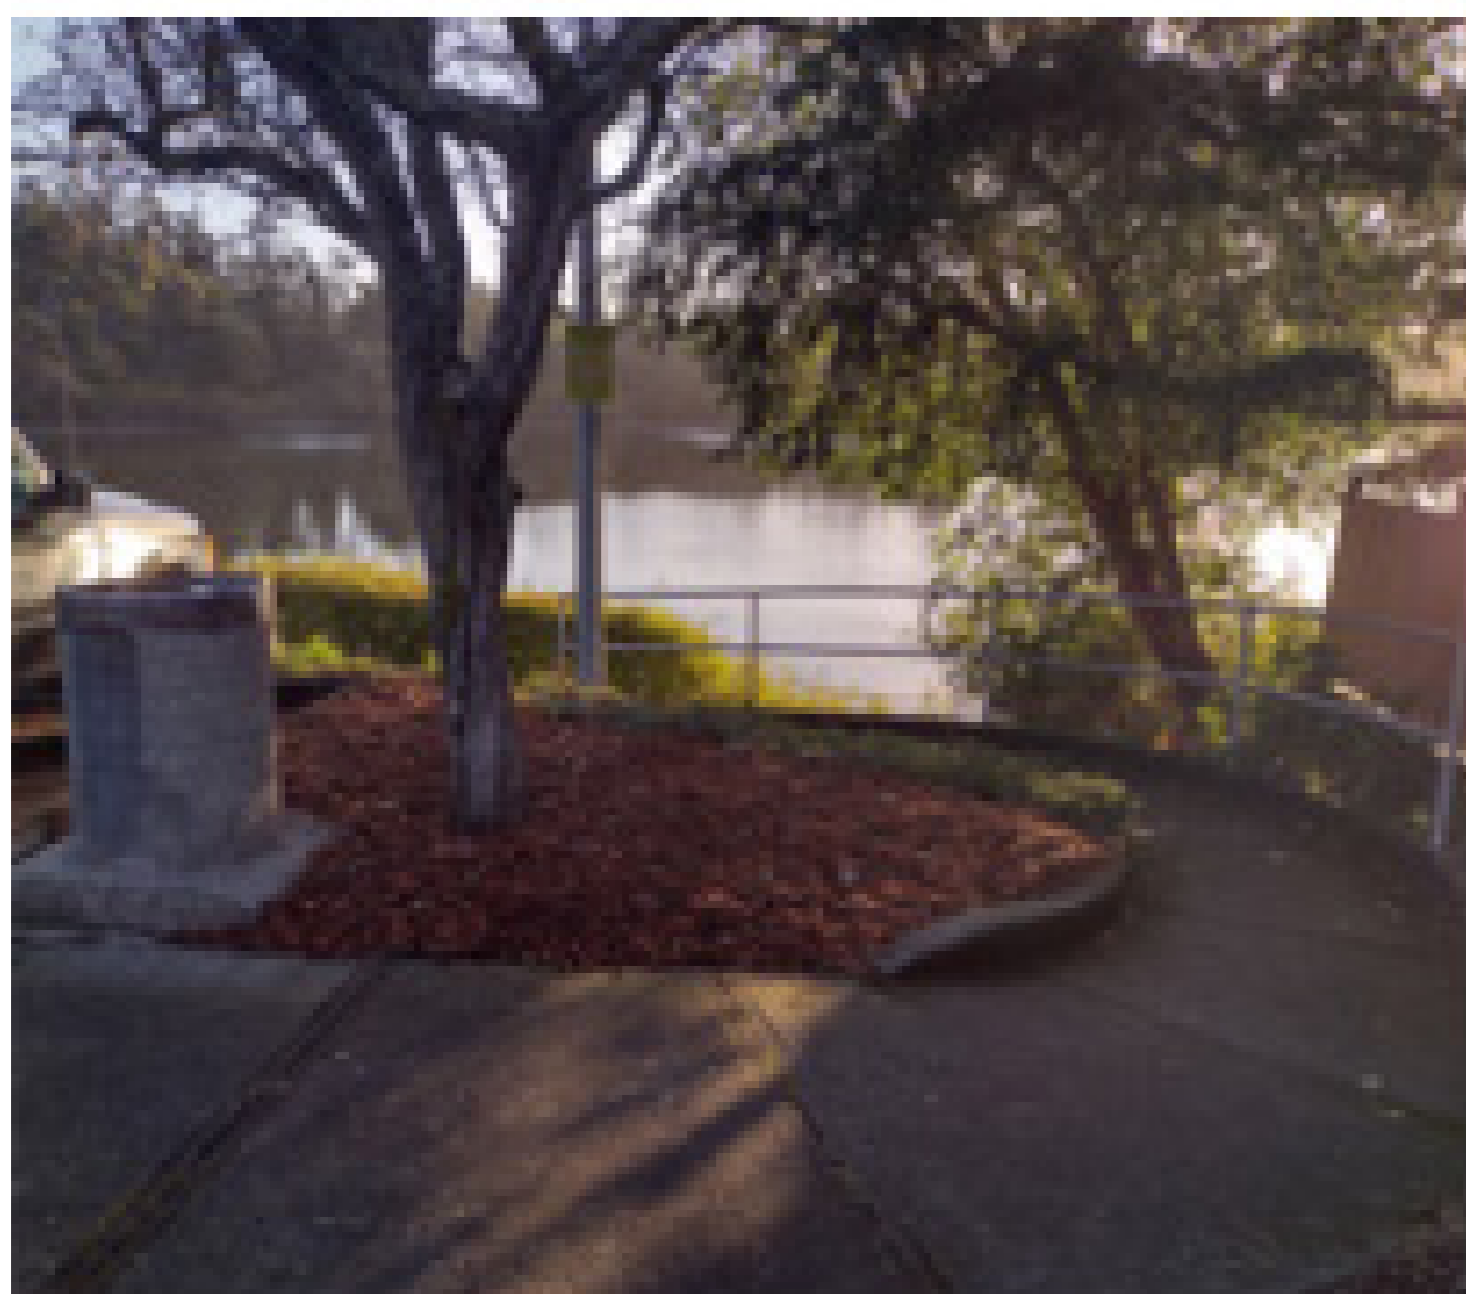
McNaughton Avenue

- 3 Current: Wider section, mild current to consider
- 0 Proximity to Motor Boat Traffic: Wide section, motor boats in area
- 3 Human Health Rating of outfalls: Low risk

- 0 Conservation Concern: Olympia oysters present
- 3 Sensitive Vegetation: Eelgrass present
- 3 Overhanging vegetation: No, hard armoured shore

- 0 Intertidal Slope: Shallow angle
- 3 Upland Slope: Gradual slope

- 0 Vehicle Parking: Limited, 3-4 vehicles, no accessible stalls
- 3 Accessibility: Paved path, gentle incline, ramp to viewpoint

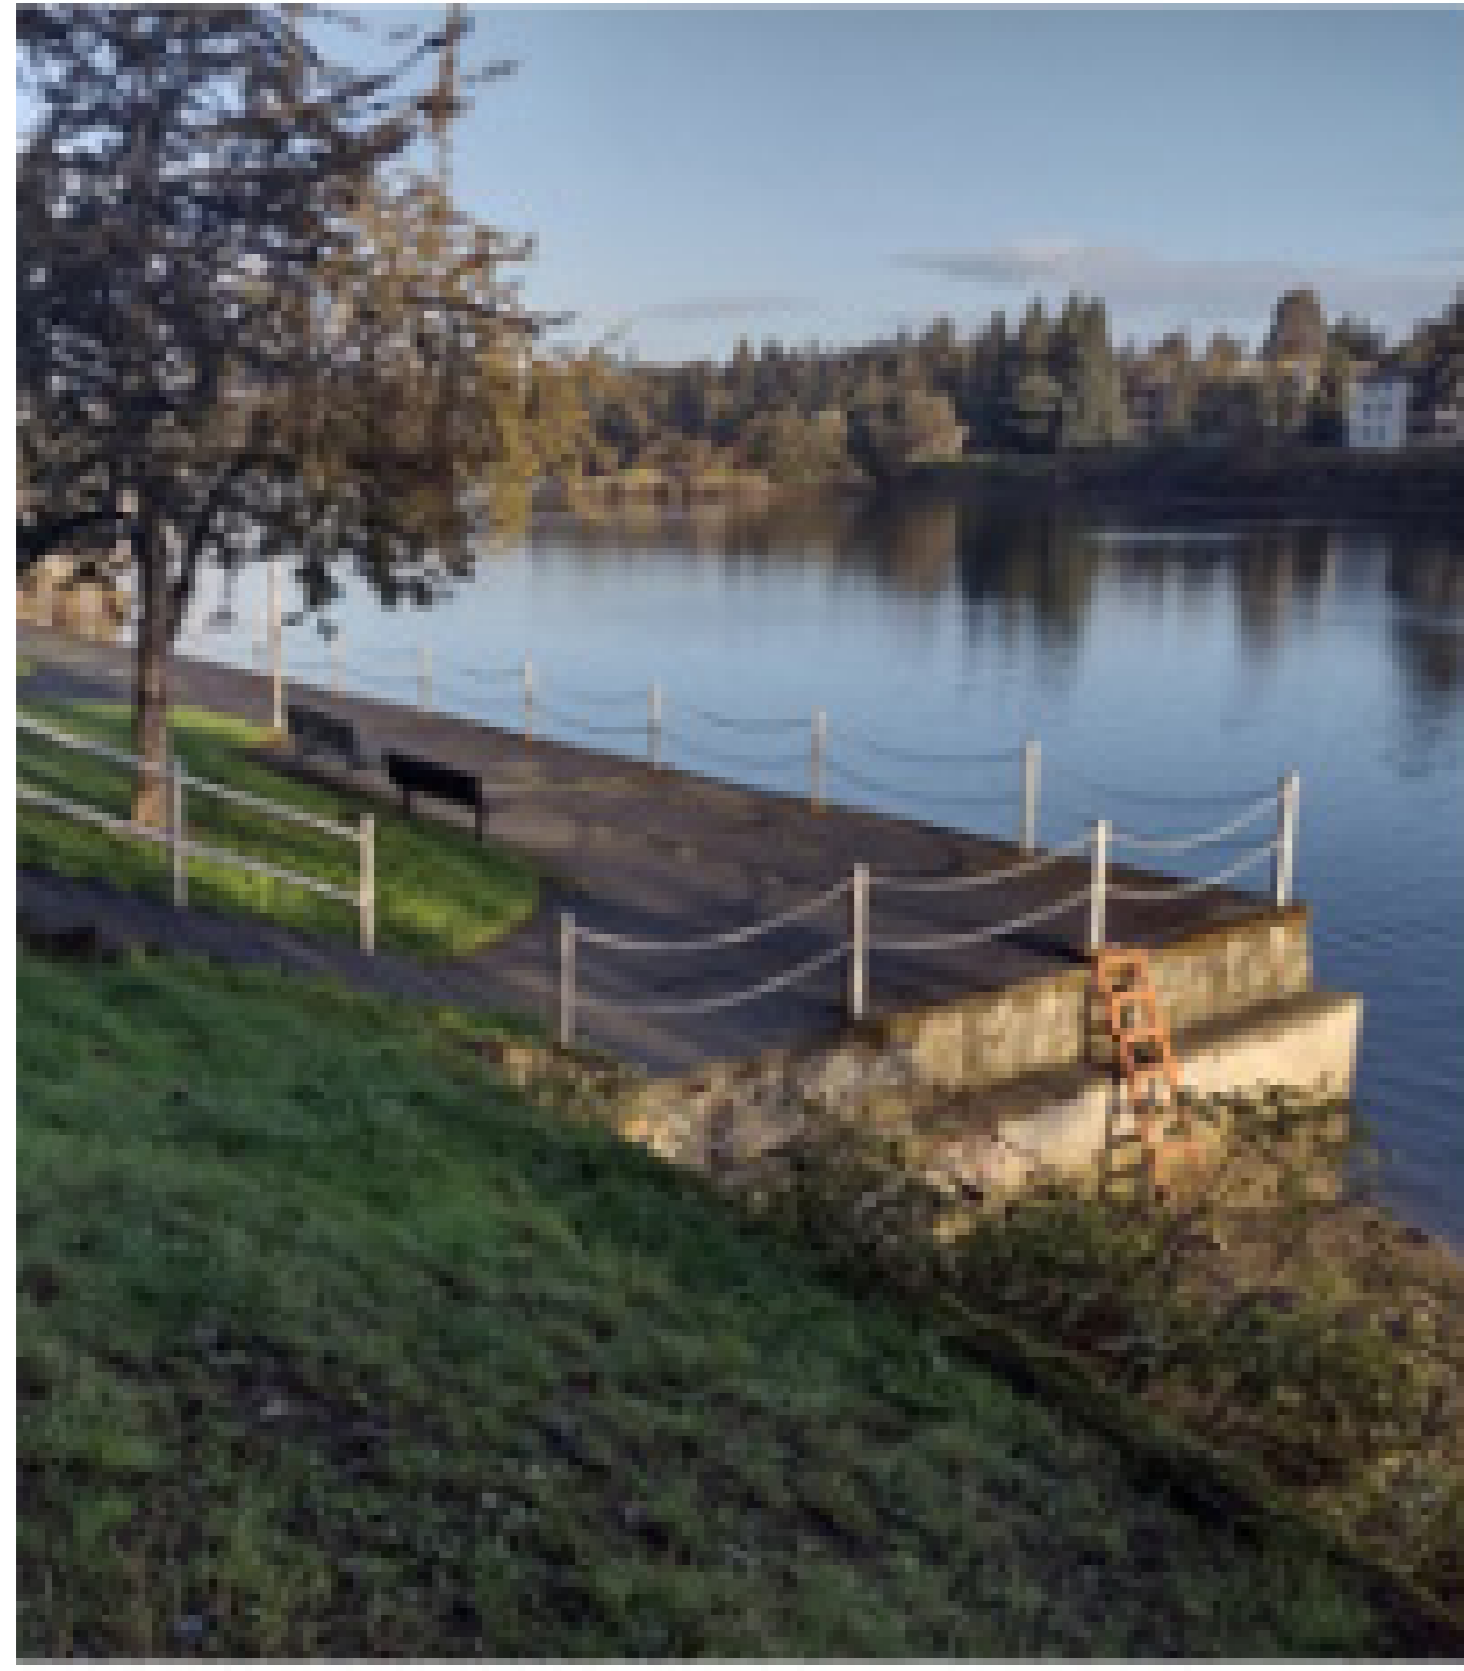
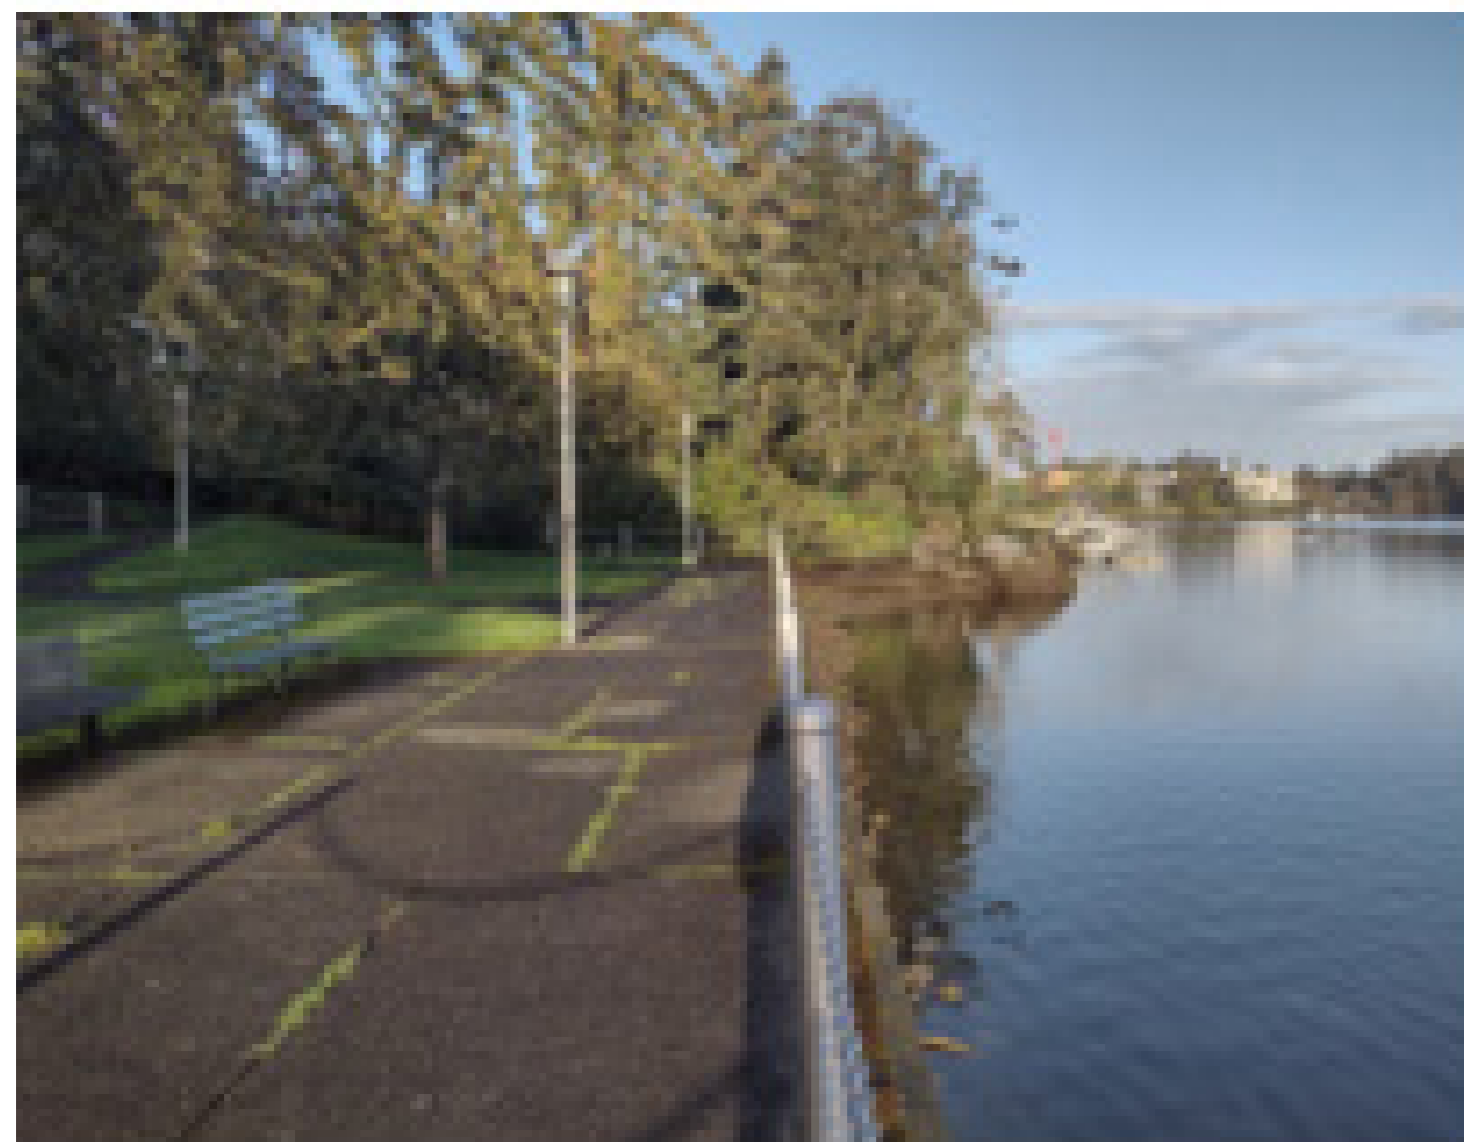
Arm Street

- 3 Current: Narrow section + reversing falls create current
- 0 Proximity to Motor Boat Traffic: Narrow section, close proximity
- 3 Human Health Rating of outfalls: Low risk

- 0 Conservation Concern: Significant presence of Olympia Oysters
- 0 Sensitive Vegetation: Eelgrass present
- 3 Overhanging vegetation: Natural and hard armoured shore

- 3 Intertidal Slope: Medium angle
- 0 Upland Slope: Steep

- 0 Vehicle Parking: Limited
- 3 Accessibility: Steep slope navigated by paved ramp or stairs

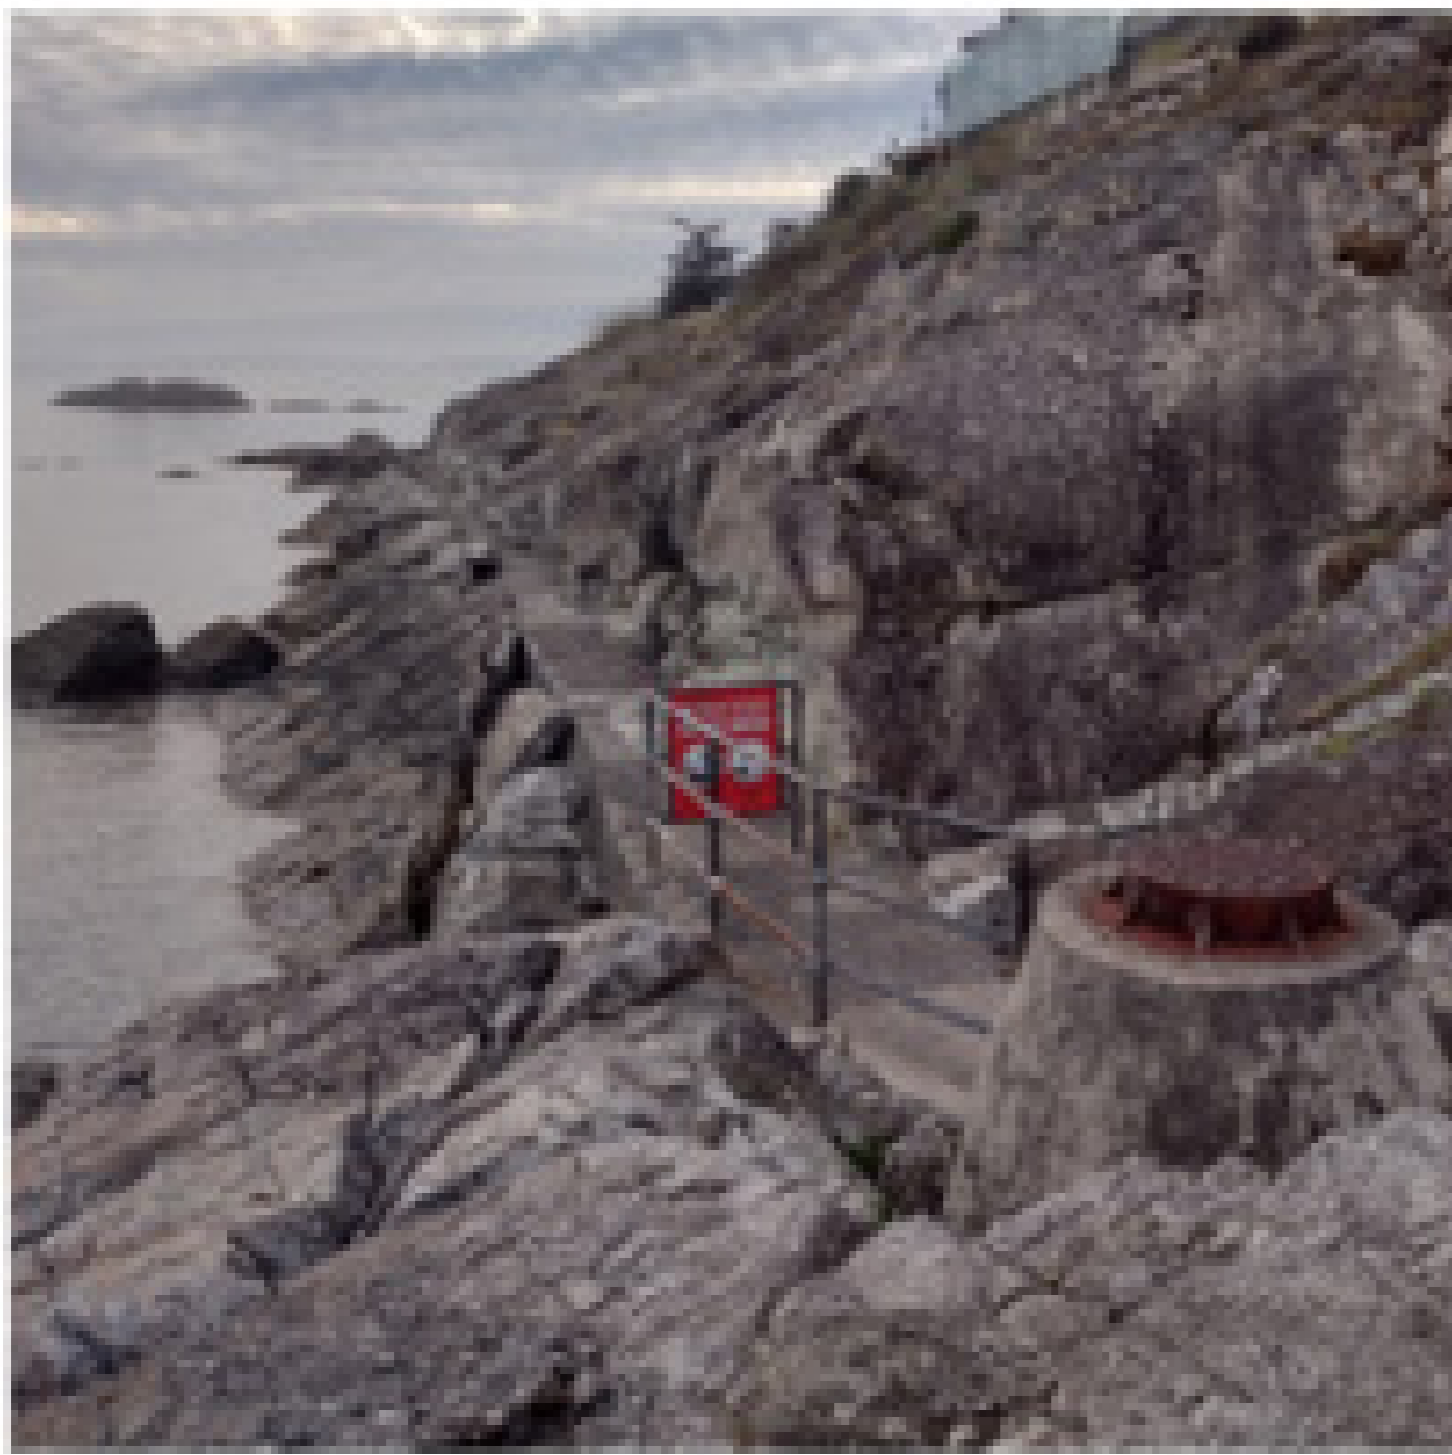
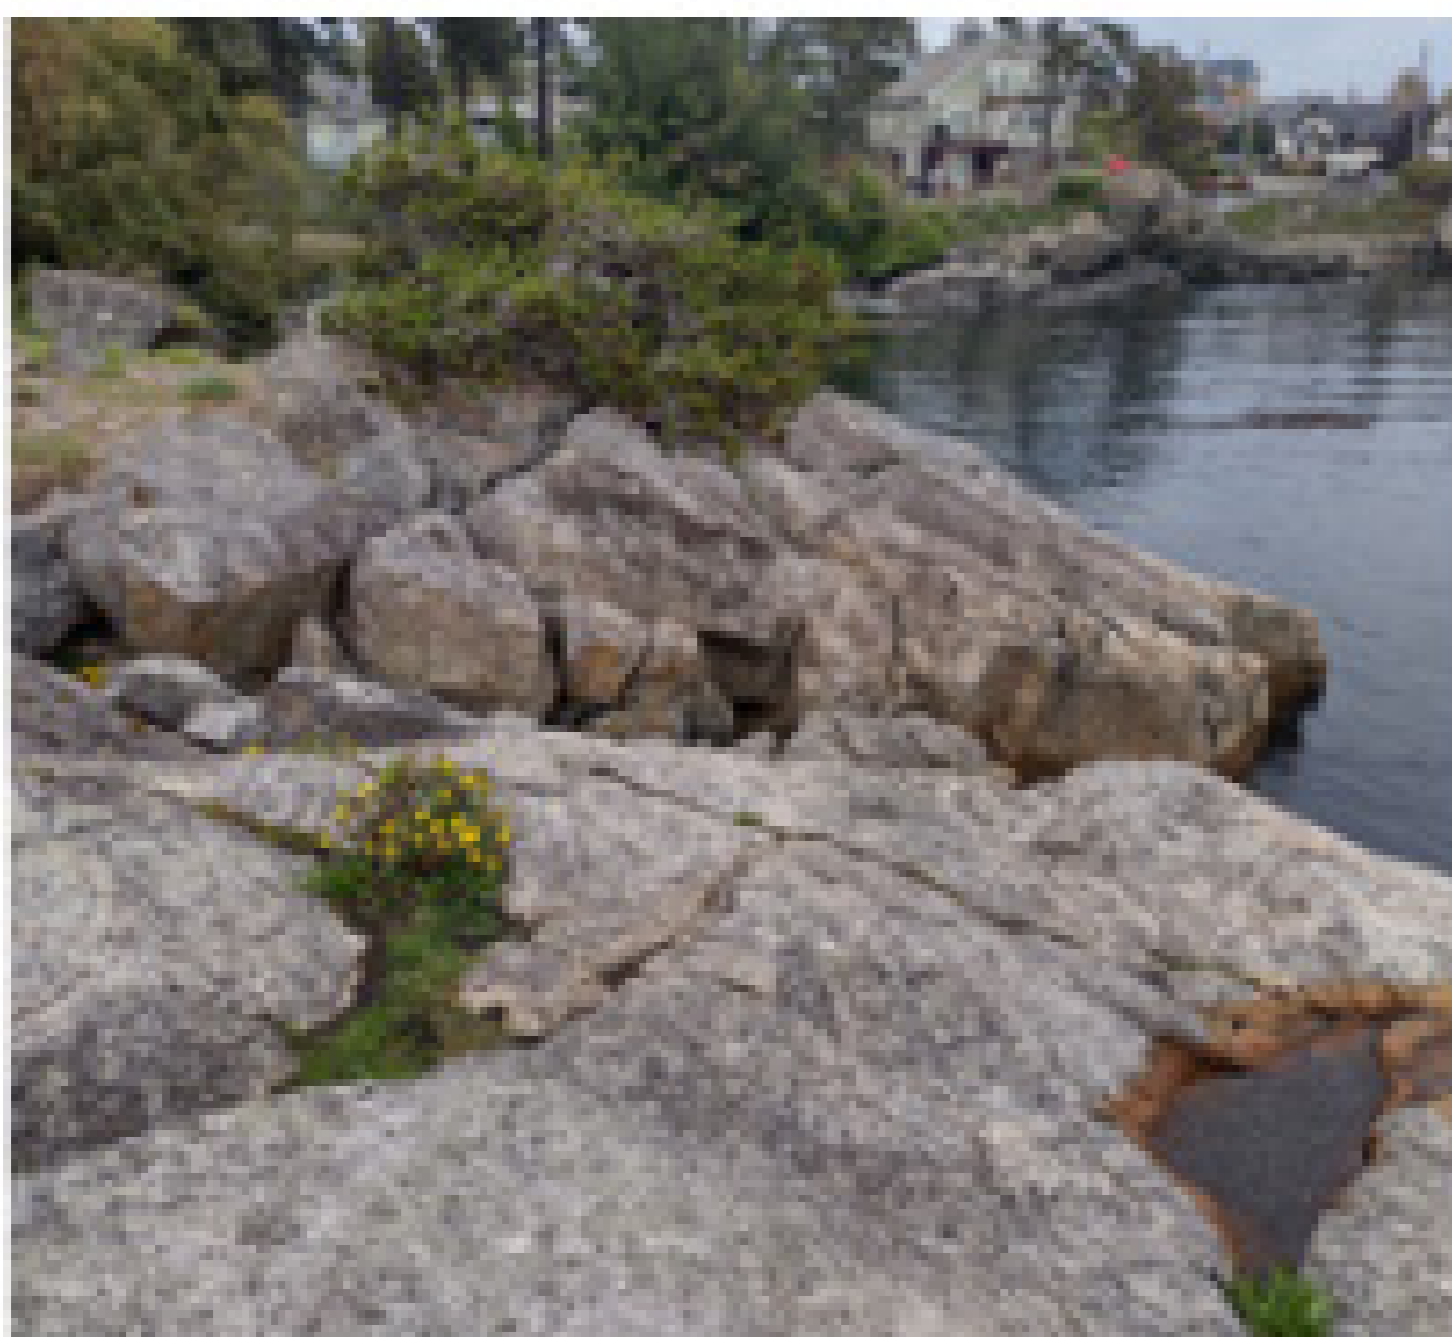
Denniston Park

- 0 Exposure: Exposed to strong wind and wave activity
- 3 Proximity to Motor Boat Traffic: Motor boats in area
- 0 Human Health Rating of outfalls: Moderate risk

- 0 Conservation Concern: Northern abalone
- 0 Sensitive Vegetation: Bull kelp
- 3 Overhanging vegetation: Yes at vegetated part of site

- 3 Intertidal Slope: Steep angle
- 3 Upland Slope: Gradual in park, rocky shore has steep parts

- 0 Vehicle Parking: Limited parking for 4 vehicles, no accessible stalls
- 3 Accessibility: Paved path with gentle incline, no stairs
