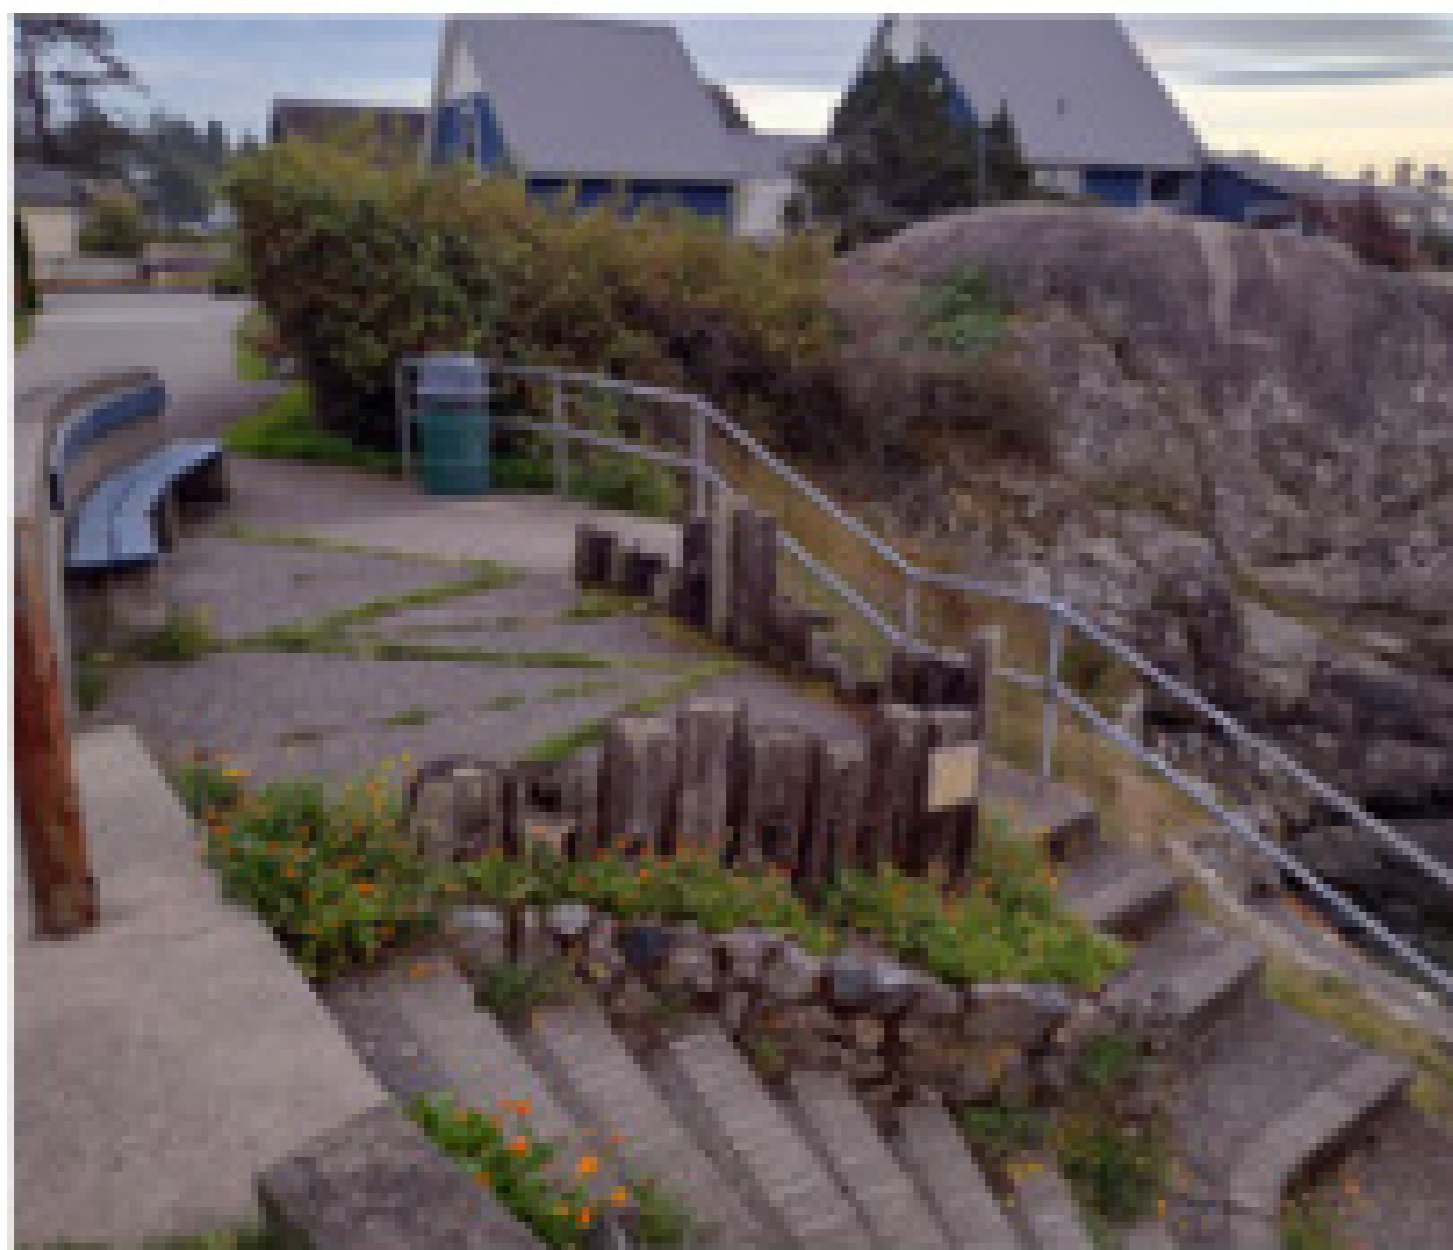
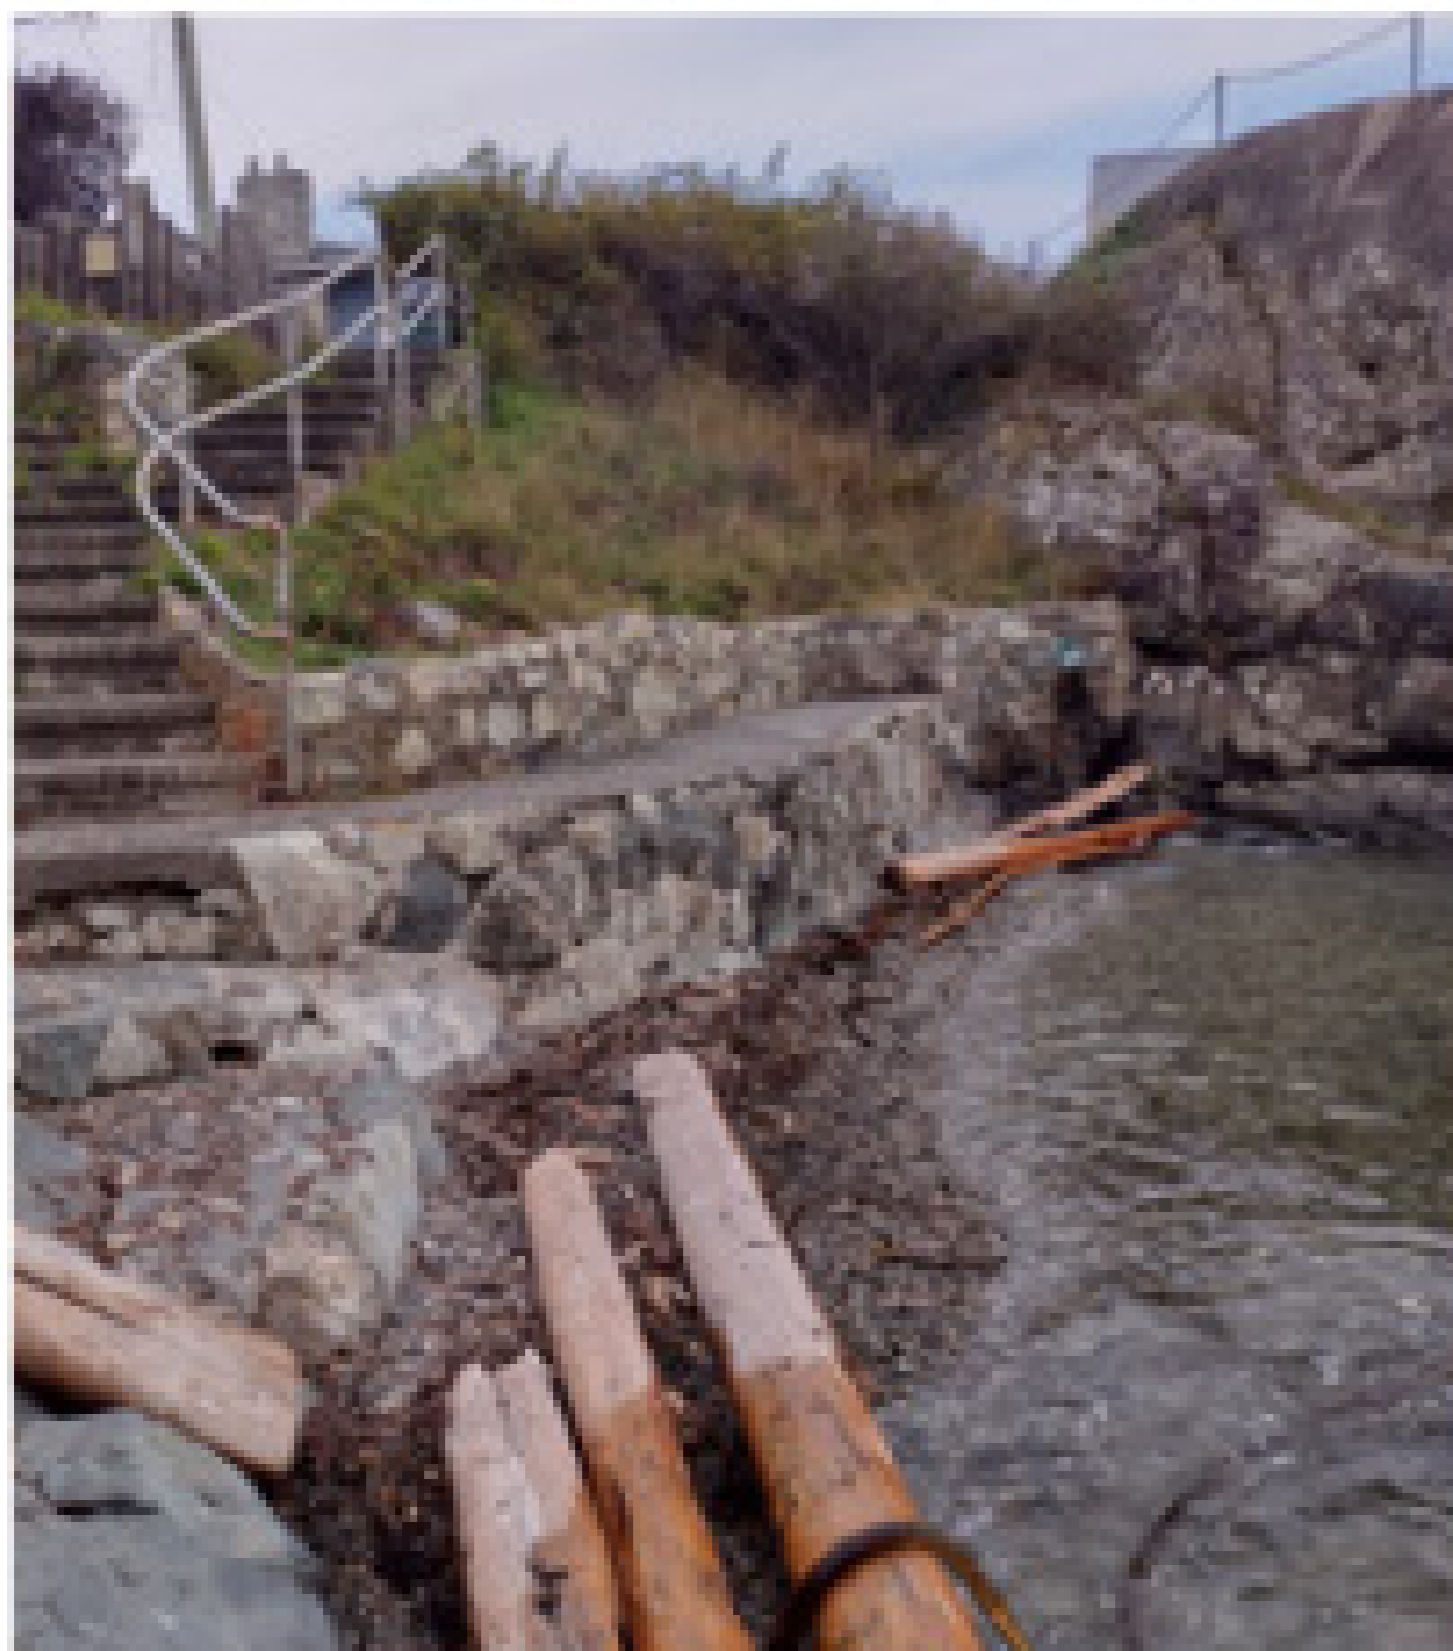
Foster Street

- 0 Exposure: Exposed to strong wind and wave activity
- 3 Proximity to Motor Boat Traffic: Motor boats in area
- 3 Human Health Rating of outfalls: Low risk

- 0 Conservation Concern: Northern abalone
- 0 Sensitive Vegetation: Bull kelp
- 3 Overhanging vegetation: No, rocky shoreline

- 3 Intertidal Slope: Steep angle
- 0 Upland Slope: Steep, navigated with stairs

- 0 Vehicle Parking: Limited street parking, no accessible stalls
- 0 Accessibility: Viewpoint is accessible, steps to water

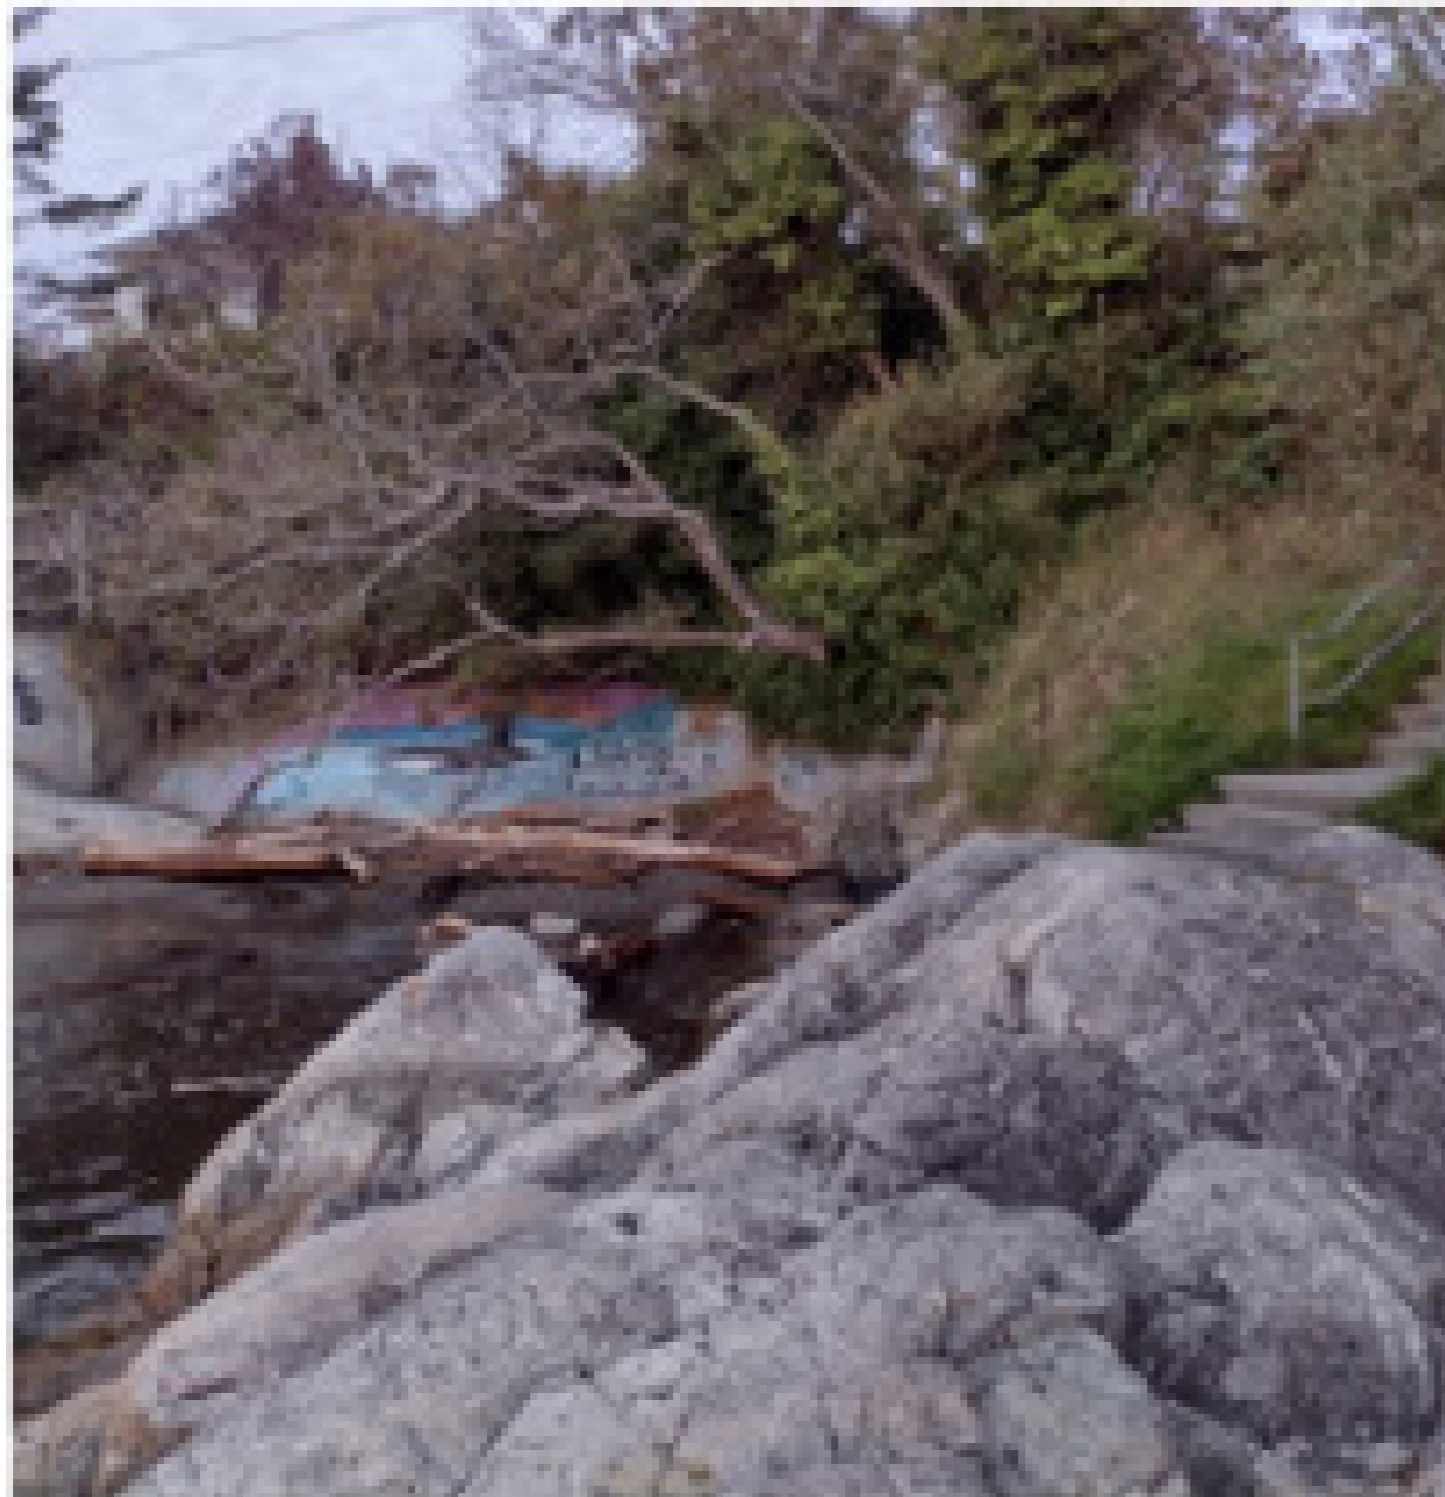
Sturdee Street

- 0 Exposure: Exposed to strong wind and wave activity
- 3 Proximity to Motor Boat Traffic: Motor boats in area
- 0 Human Health Rating of outfalls: High risk

- 0 Conservation Concern: Northern abalone
- 0 Sensitive Vegetation: Bull kelp
- 3 Overhanging vegetation: Yes, limited by rocky shore

- 3 Intertidal Slope: Steep angle
- 0 Upland Slope: Steep, navigated with stairs

- 0 Vehicle Parking: Limited street parking, no accessible stalls
- 0 Accessibility: Stairs to water, viewpoint is accessible

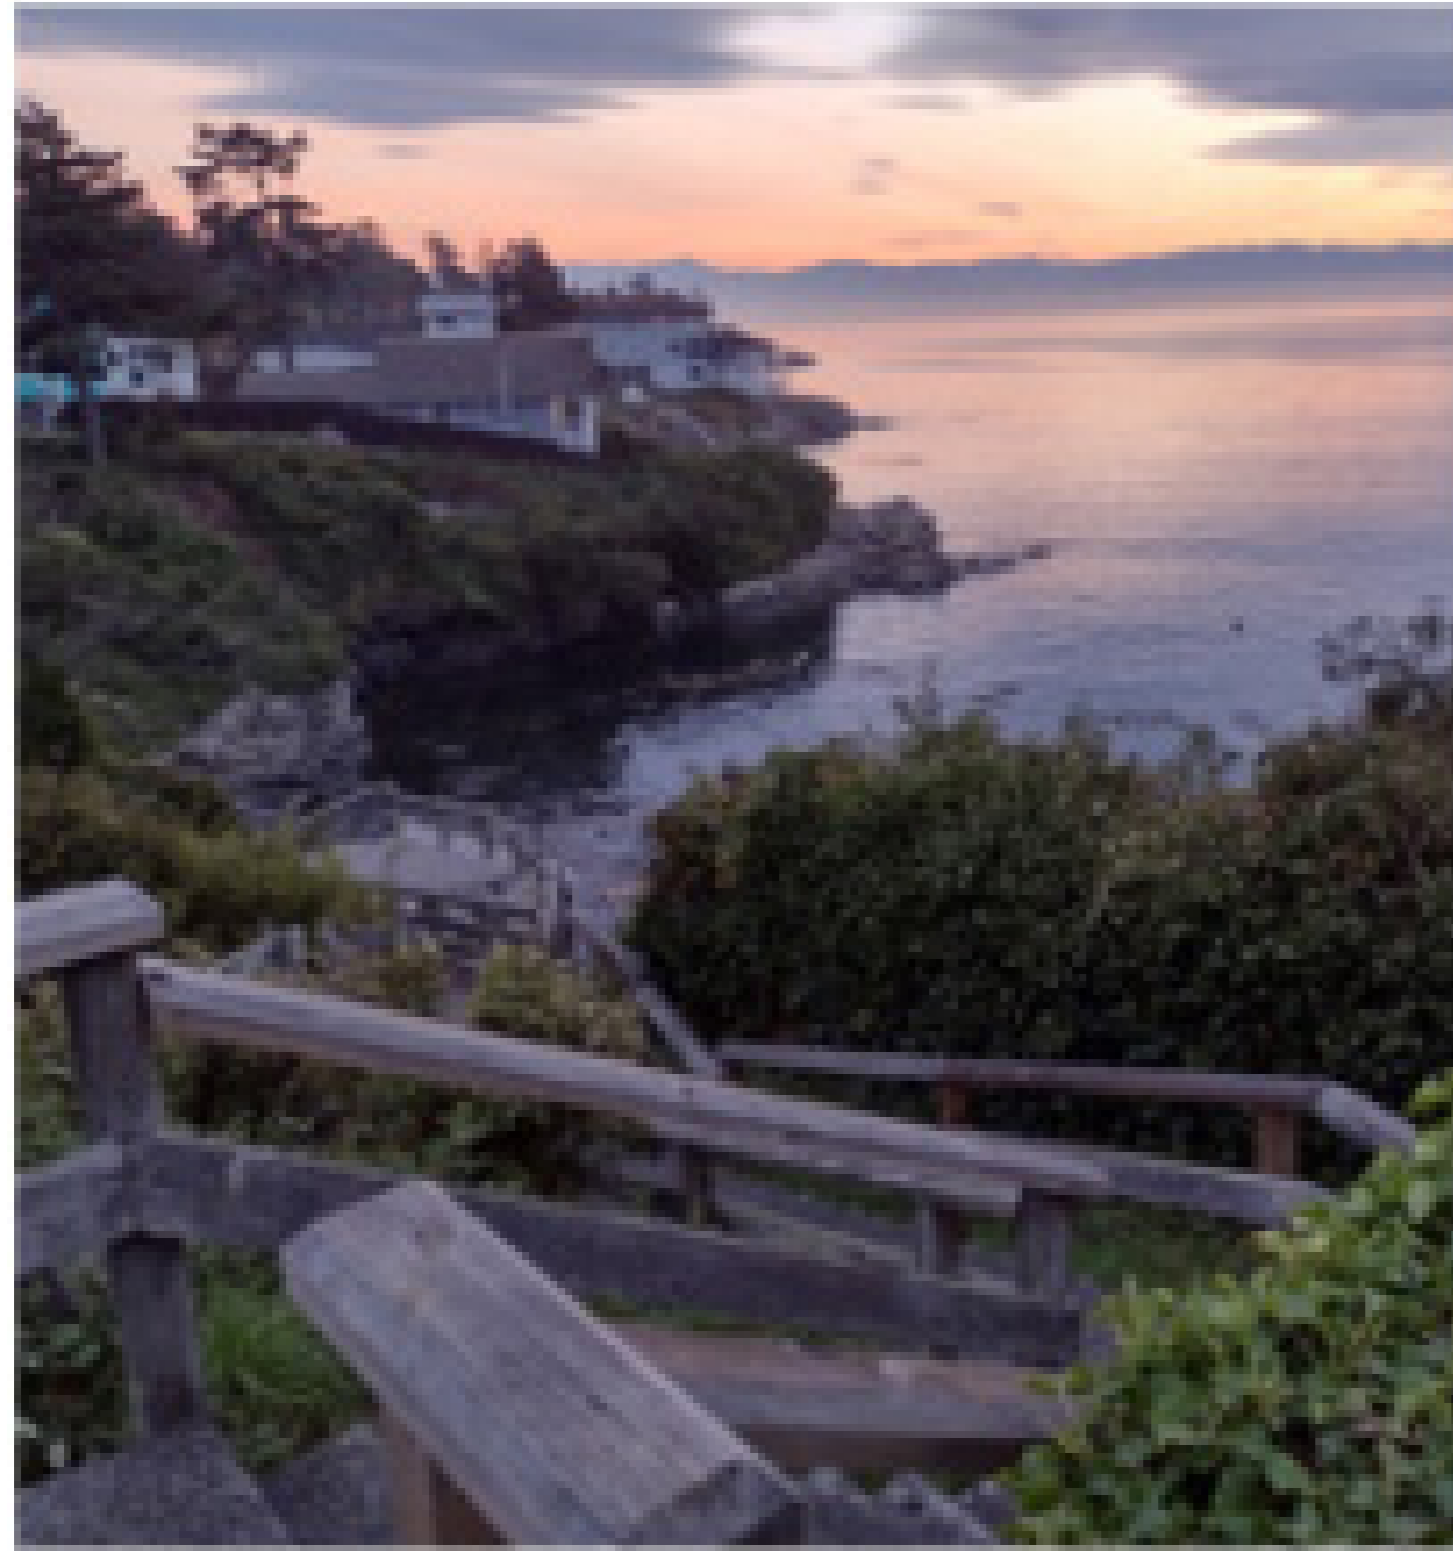
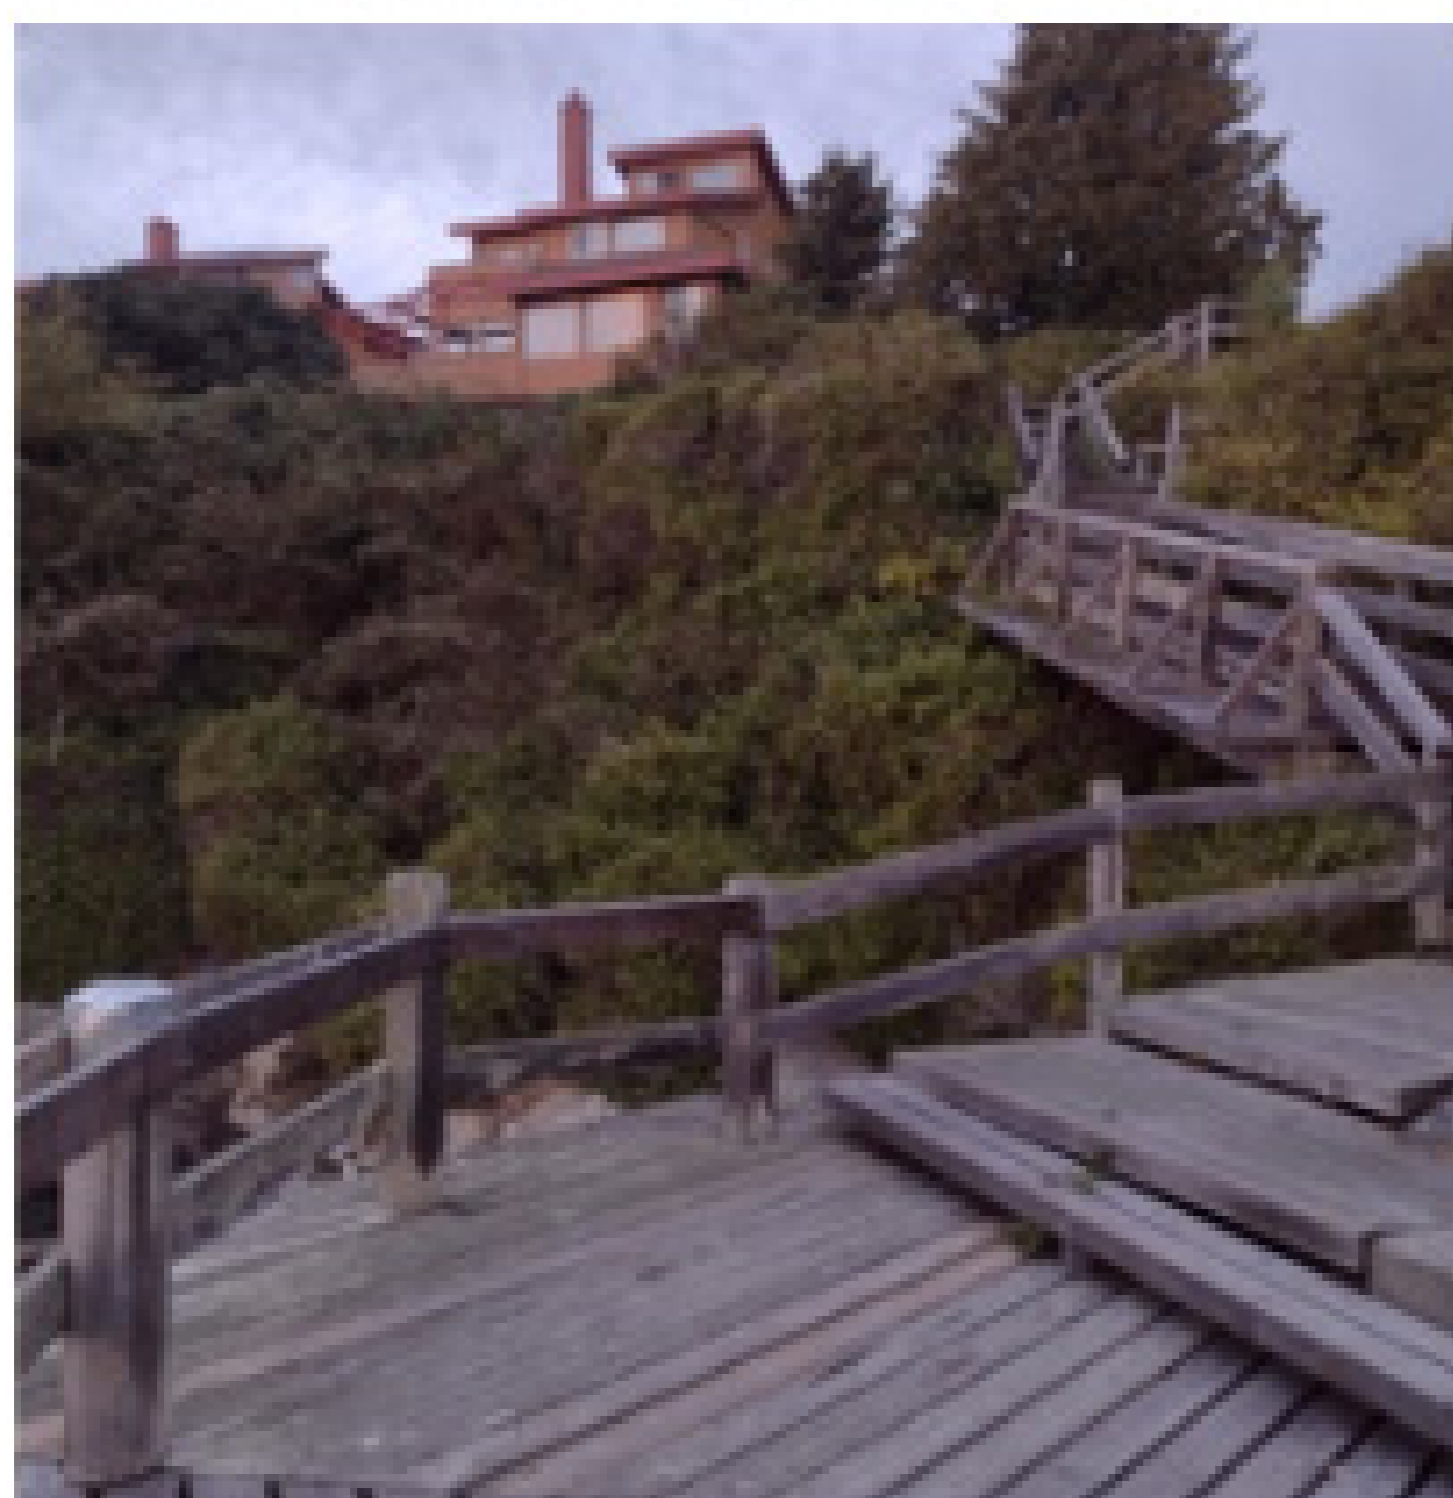
Nelson Street

- 0 Exposure: Exposed to strong wind and wave activity
- 3 Proximity to Motor Boat Traffic: Motor boats in area
- 0 Human Health Rating of outfalls: High risk

- 0 Conservation Concern: Northern abalone
- 0 Sensitive Vegetation: Bull kelp
- 3 Overhanging vegetation: Yes

- 3 Intertidal Slope: Steep angle
- 0 Upland Slope: Steep, navigated with stairs perched above shore

- 0 Vehicle Parking: Limited street parking, no accessible stalls
- 0 Accessibility: Many wood steps

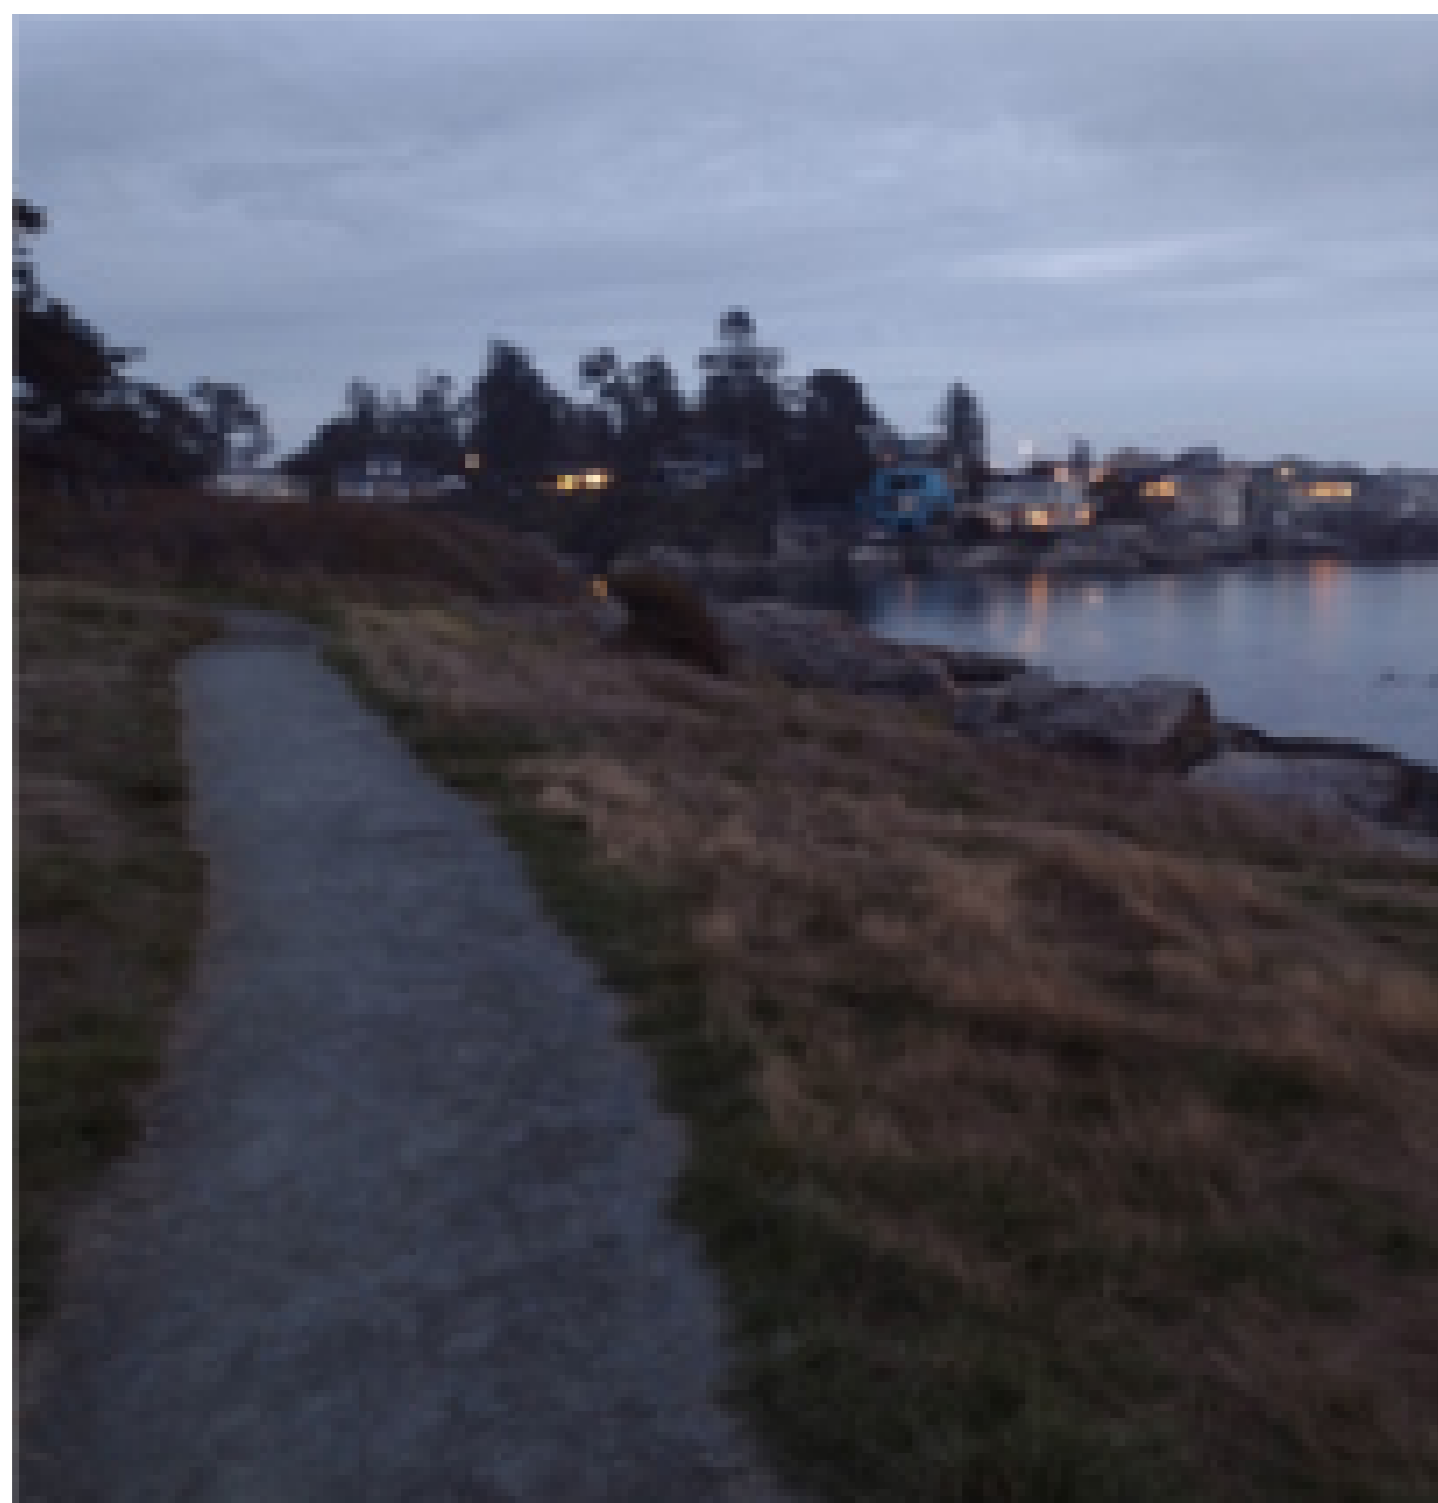
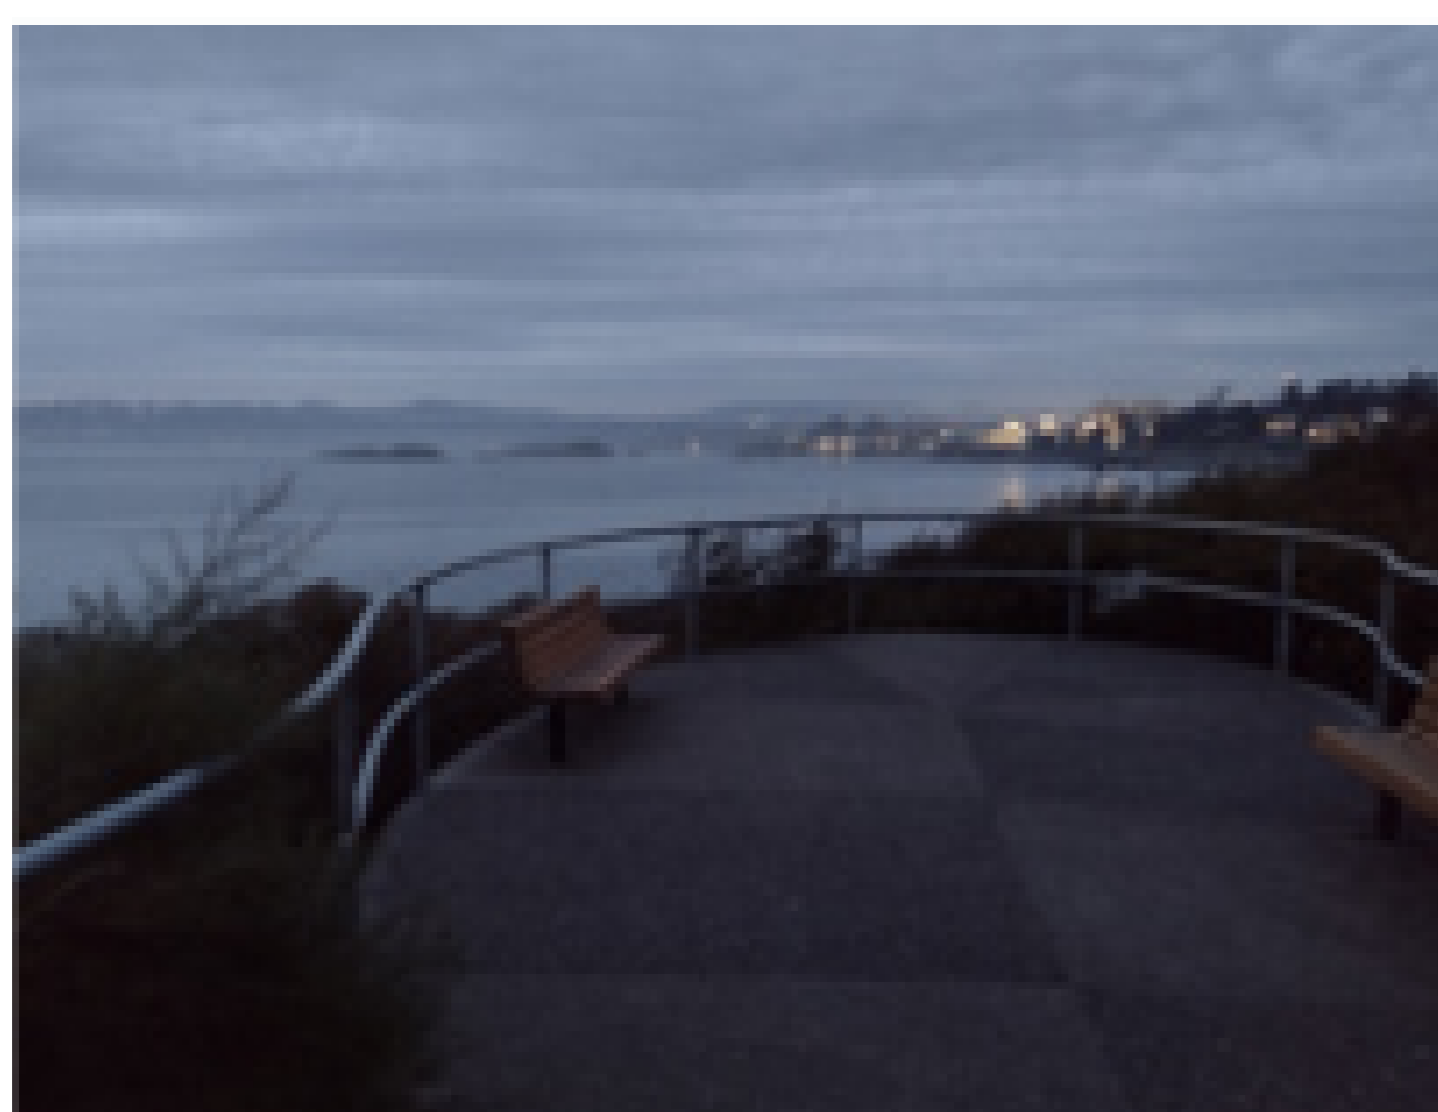
Saxe Point Park

- 0 Exposure: Exposed to strong wind and wave activity
- 3 Proximity to Motor Boat Traffic: Motor boats in area
- 3 Human Health Rating of outfalls: Low risk

- 0 Conservation Concern: Northern abalone
- 0 Sensitive Vegetation: Bull kelp
- 3 Overhanging vegetation: Varies from rocky to vegetated shore

- 3 Intertidal Slope: Shallow angle
- 3 Upland Slope: Gentle incline in park

- 3 Vehicle Parking: Plentiful, including accessible
- 3 Accessibility: Paths through park are paved or gravel, gentle slope

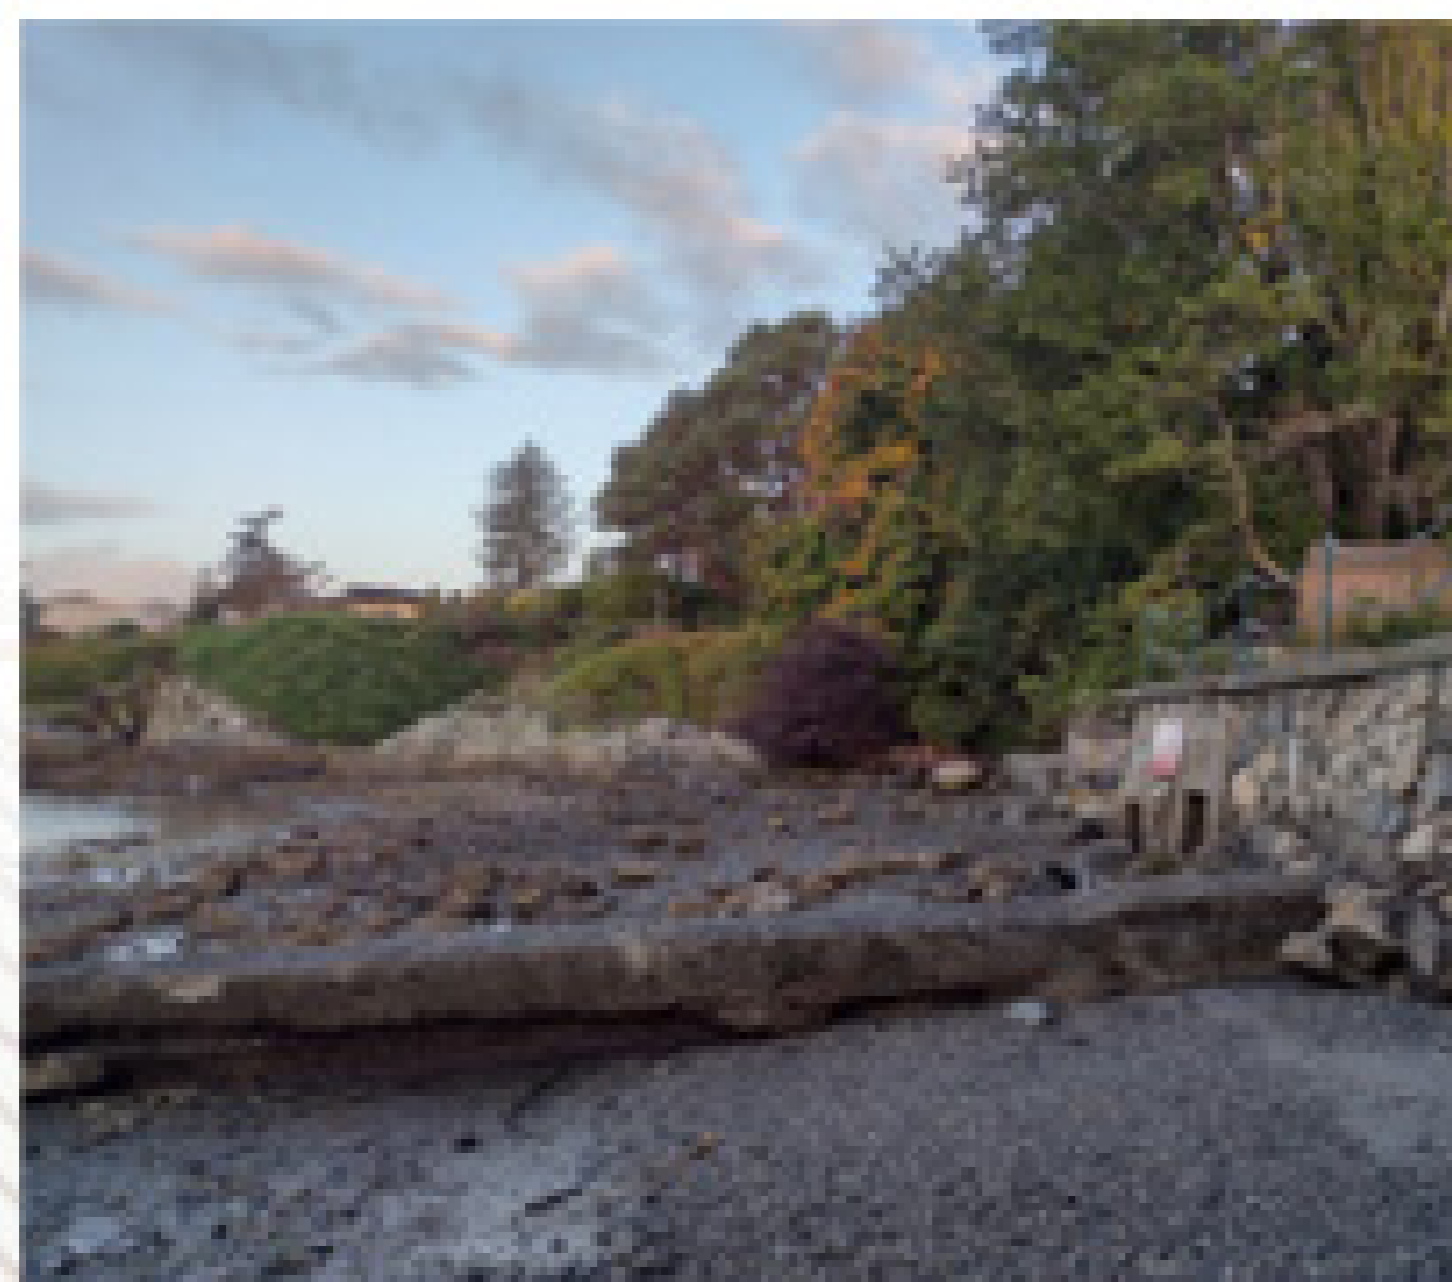
Kinver Street

- 3 Exposure: Protected by breakwater
- 3 Proximity to Motor Boat Traffic: Motor boats in area
- 0 Human Health Rating of outfalls: High risk

- 0 Conservation Concern: Northern abalone
- 3 Sensitive Vegetation: Bull kelp
- 3 Overhanging vegetation: None

- 0 Intertidal Slope: Shallow angle
- 3 Upland Slope: Gradual incline navigated with steps

- 0 Vehicle Parking: Limited parking, no accessible stalls
- 0 Accessibility: Concrete steps to access beach
