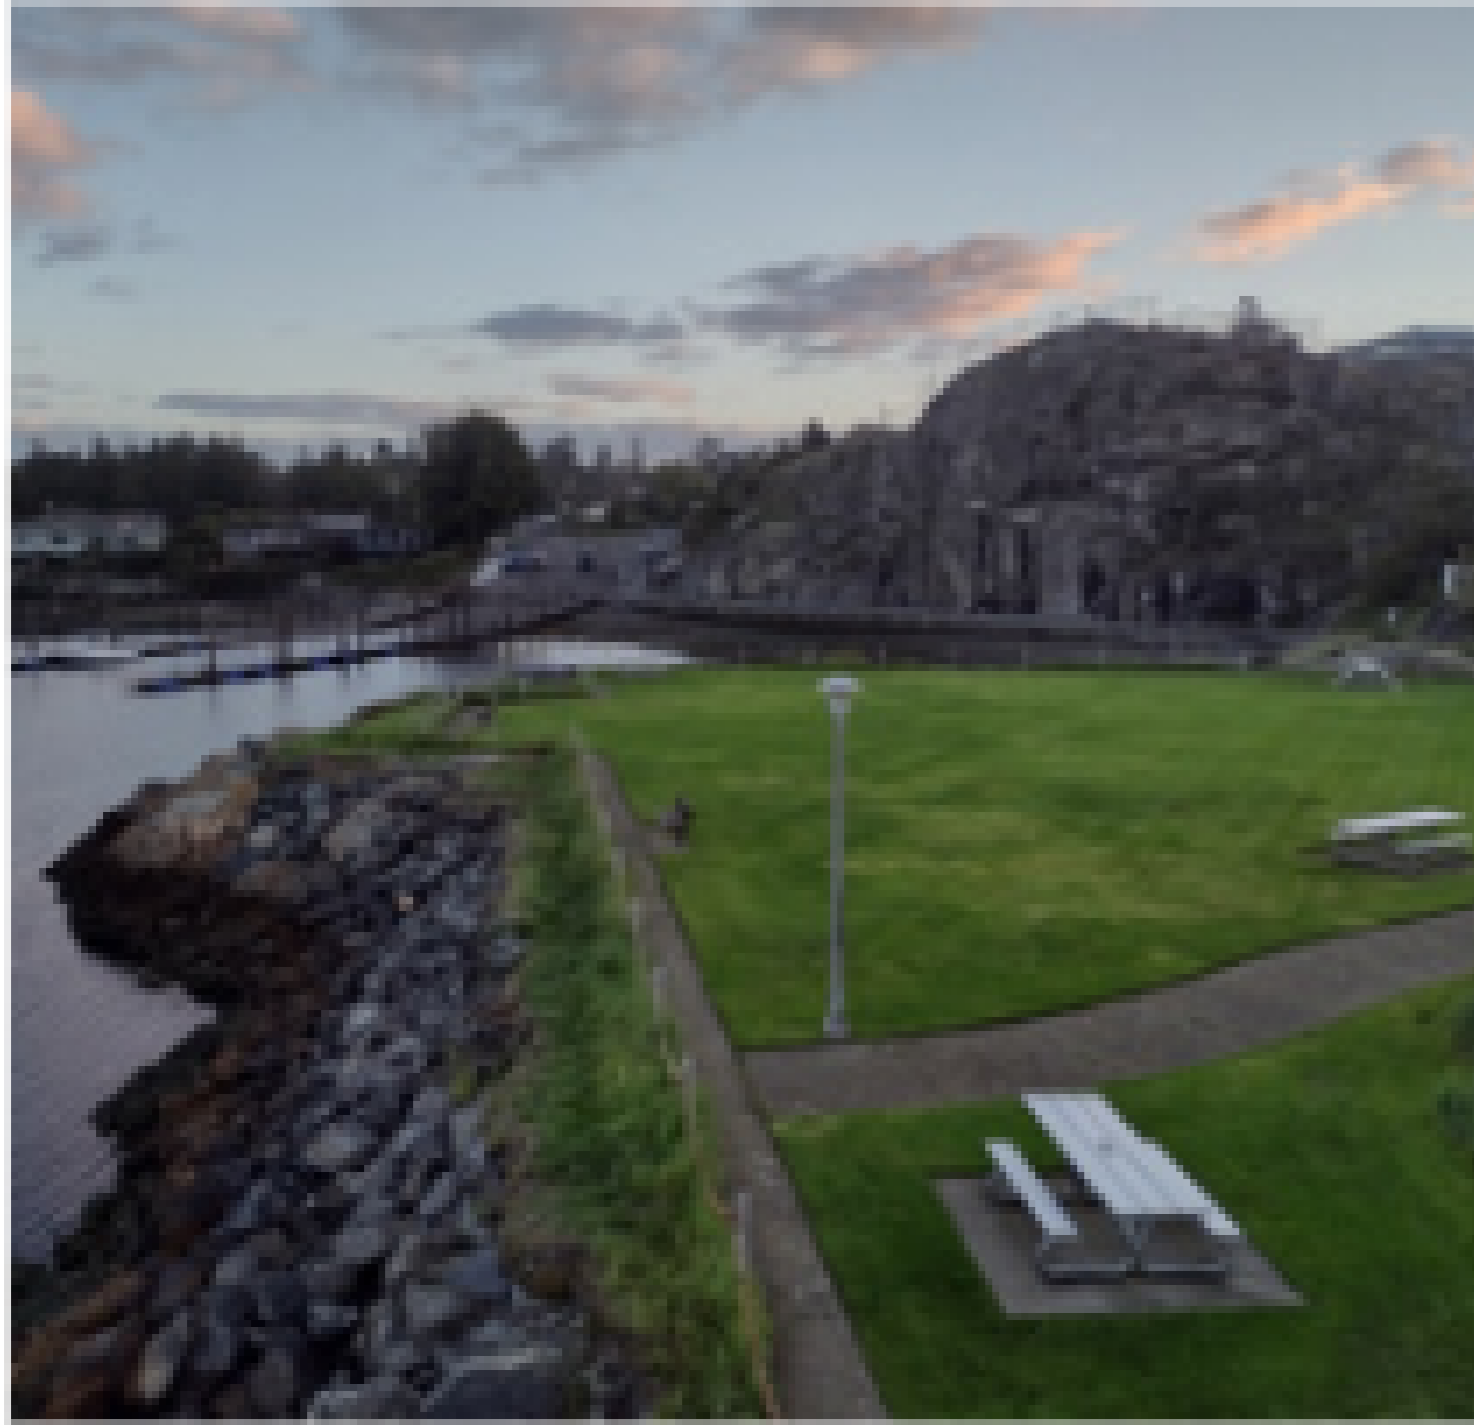
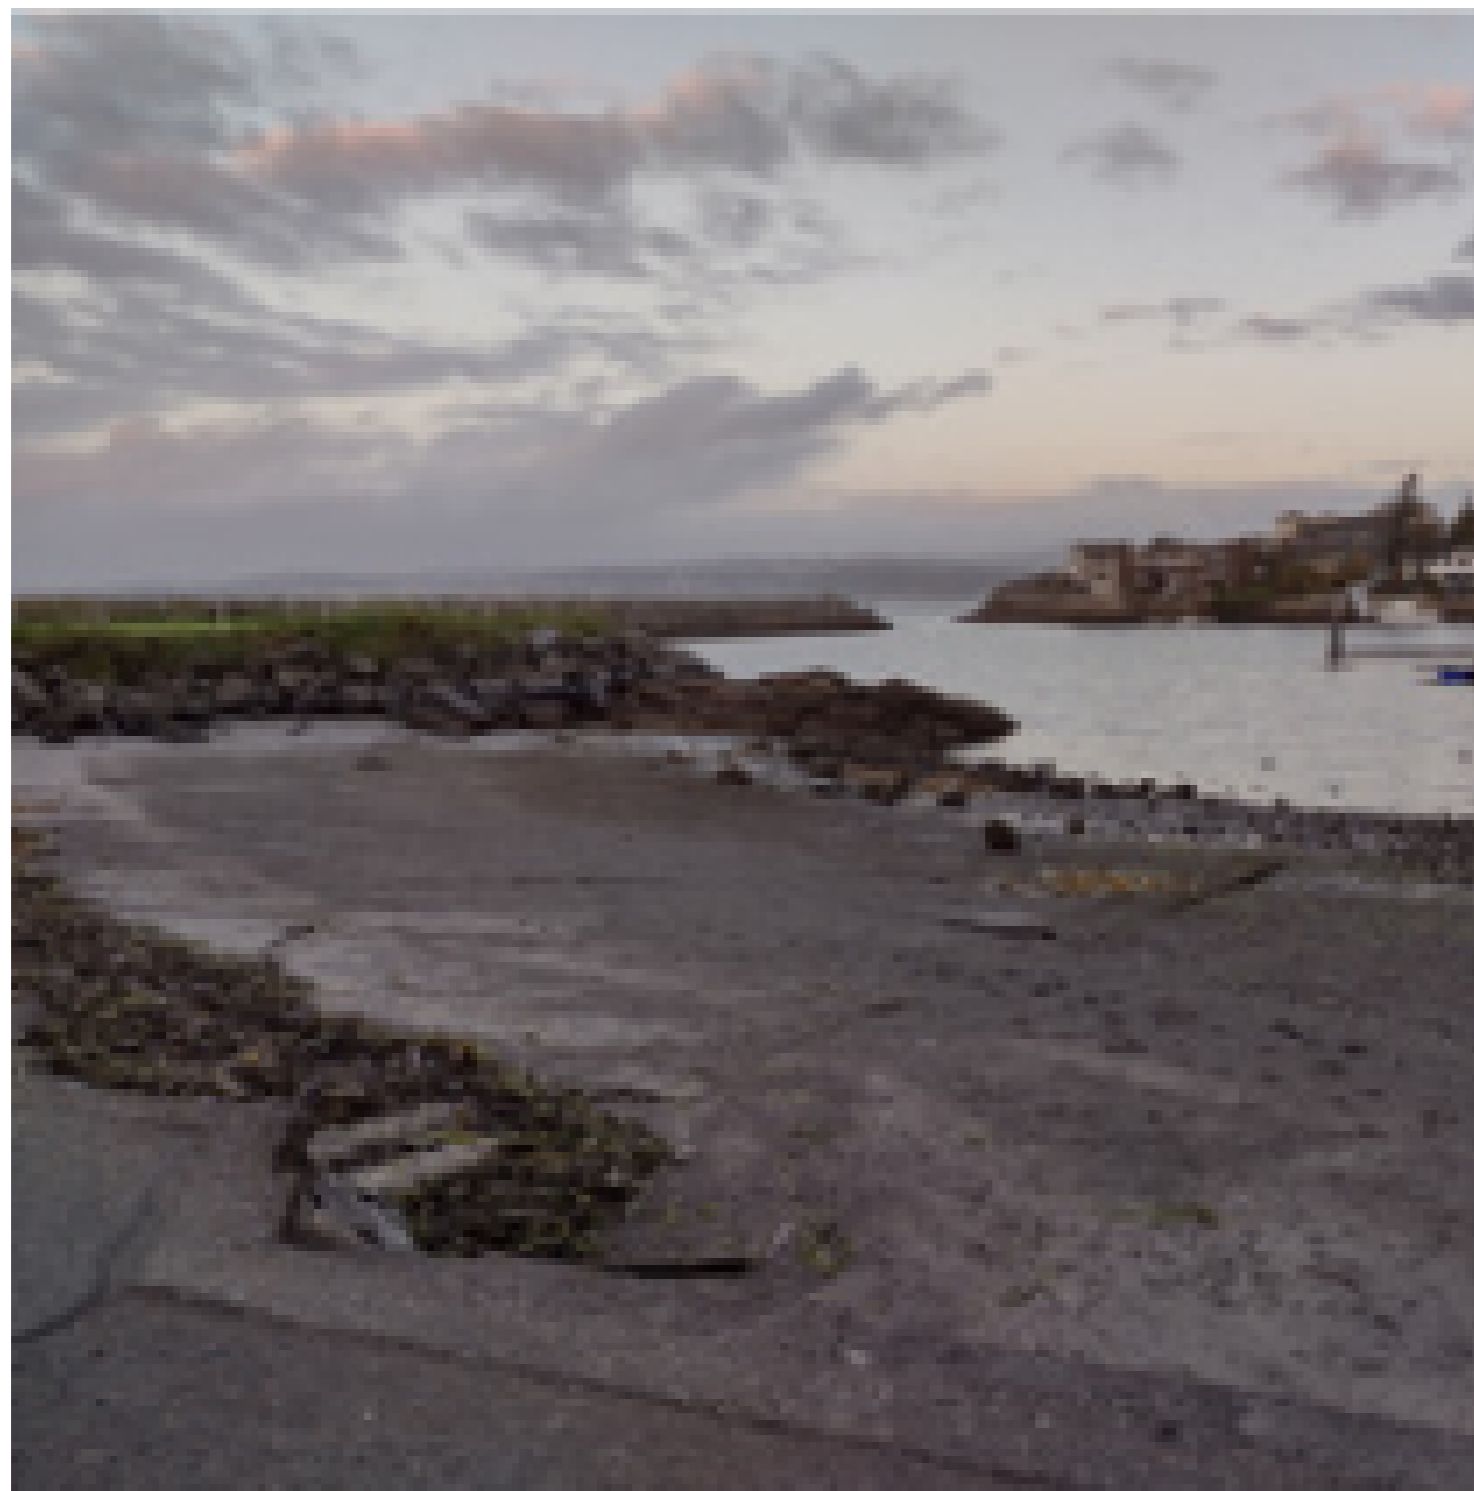
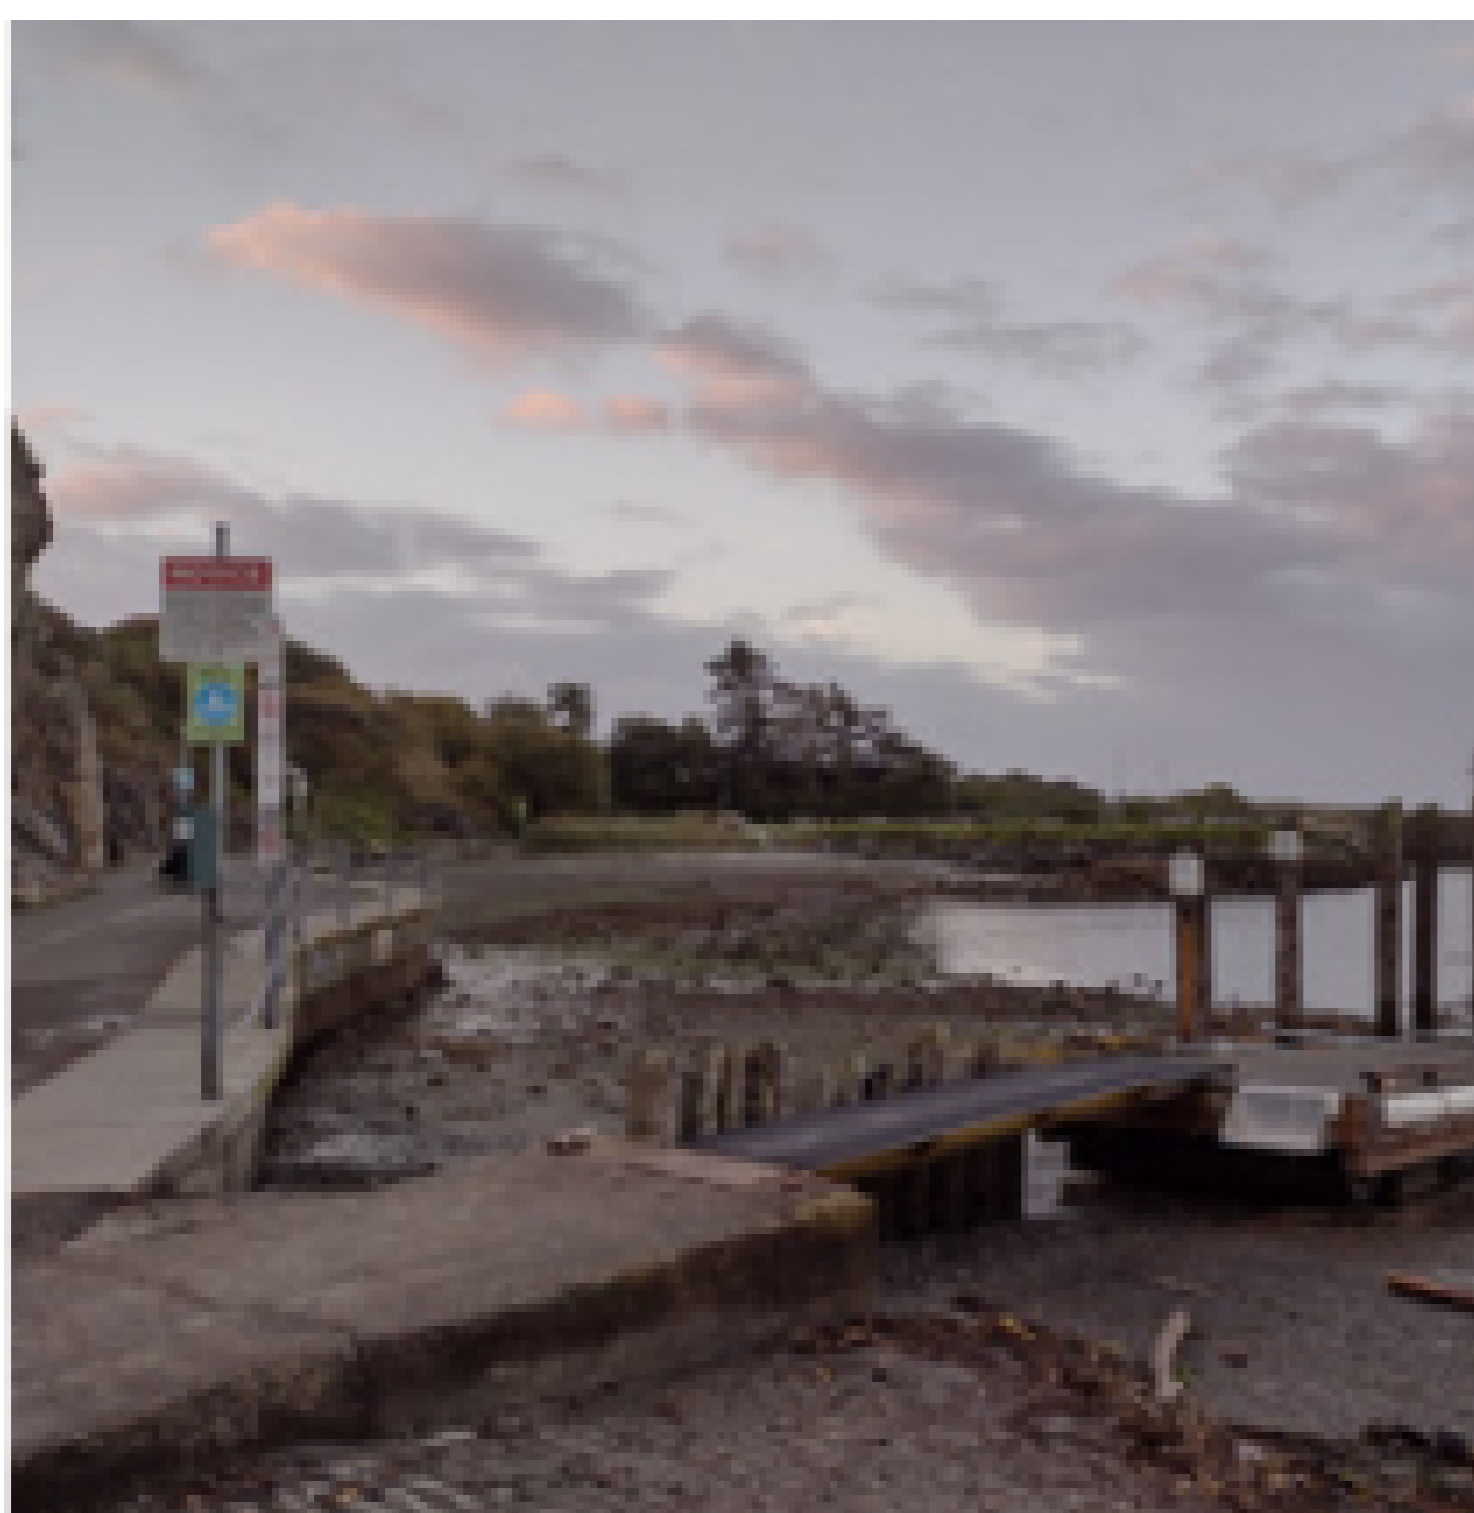
Fleming Beach / Buxton Green

- 3 Exposure: Protected by breakwater
- 0 Proximity to Motor Boat Traffic: Adjacent to boat launch
- 0 Human Health Rating of outfalls: High risk

- 0 Conservation Concern: Northern abalone
- 3 Sensitive Vegetation: Bull kelp
- 3 Overhanging vegetation: No

- 0 Intertidal Slope: Shallow angle
- 3 Upland Slope: Gradual

- 3 Vehicle Parking: Plentiful, space available for accessible parking
- 3 Accessibility: Paved path with gentle incline
